Optimizing Sonar Performance by Managing Acoustics

November 20, 2014

Marisa Yearta and Timothy Gates

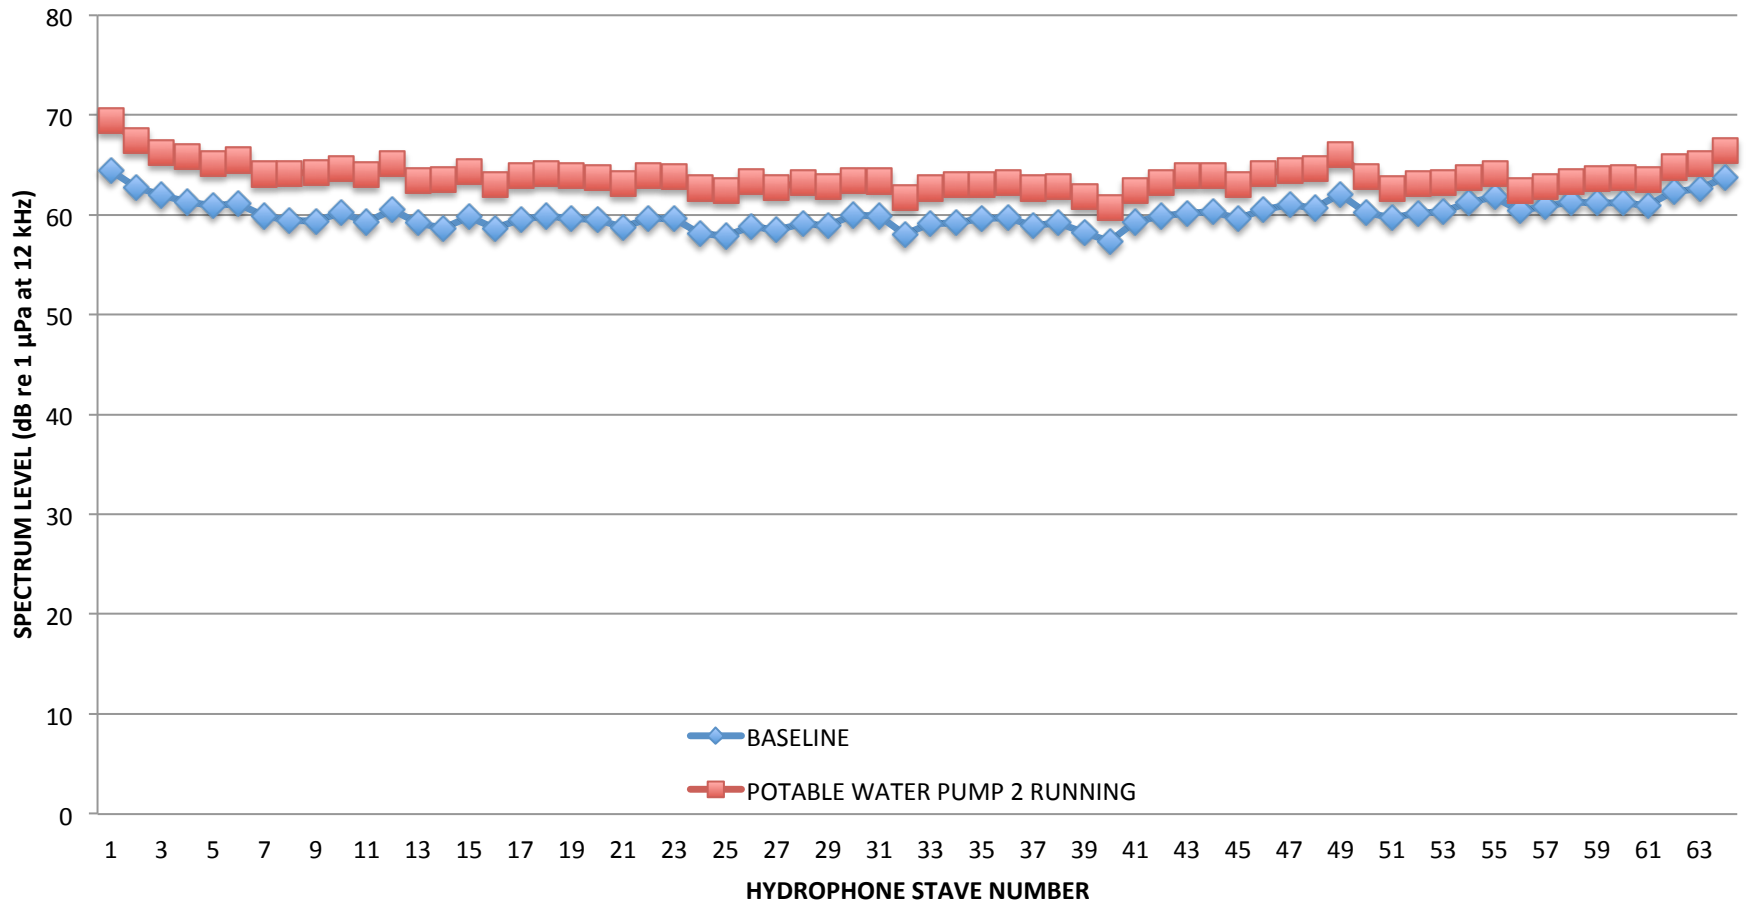
USCGC HEALY (WAGB 20)
EM 122 RX NOISE LEVEL
POTABLE WATER PUMP 2 RUNNING
16 AUGUST 2014

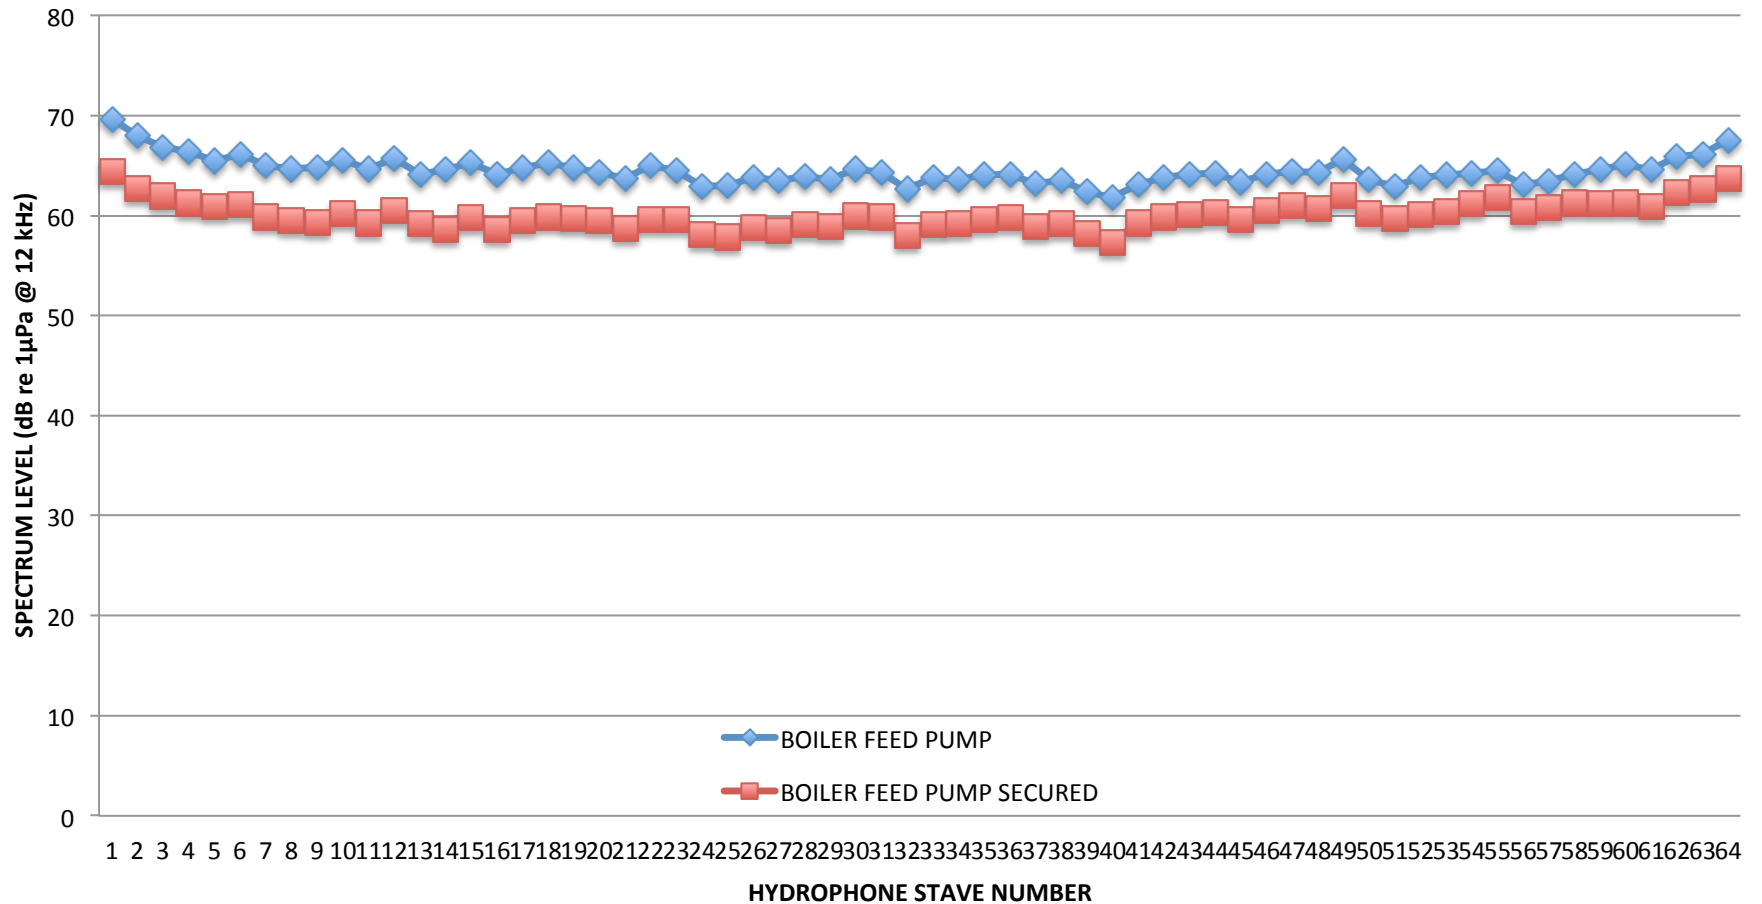
USCGC HEALY (WAGB-20)
BOILER FEED PUMP ON VS OFF
EM122 RX NOISE LEVEL
17 AUGUST 2014

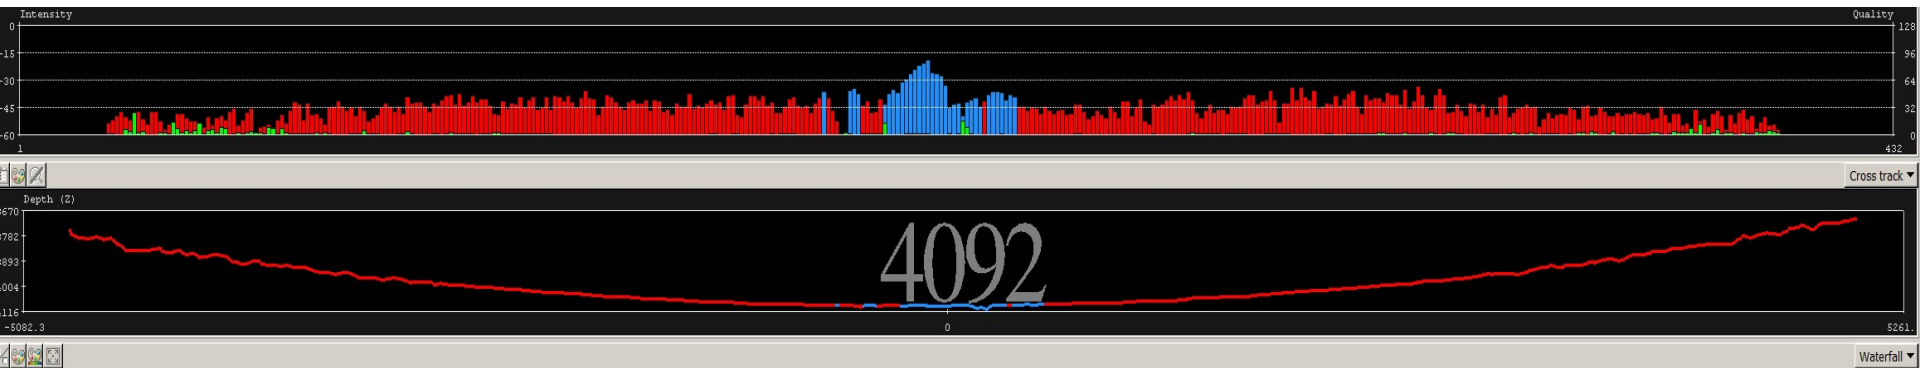
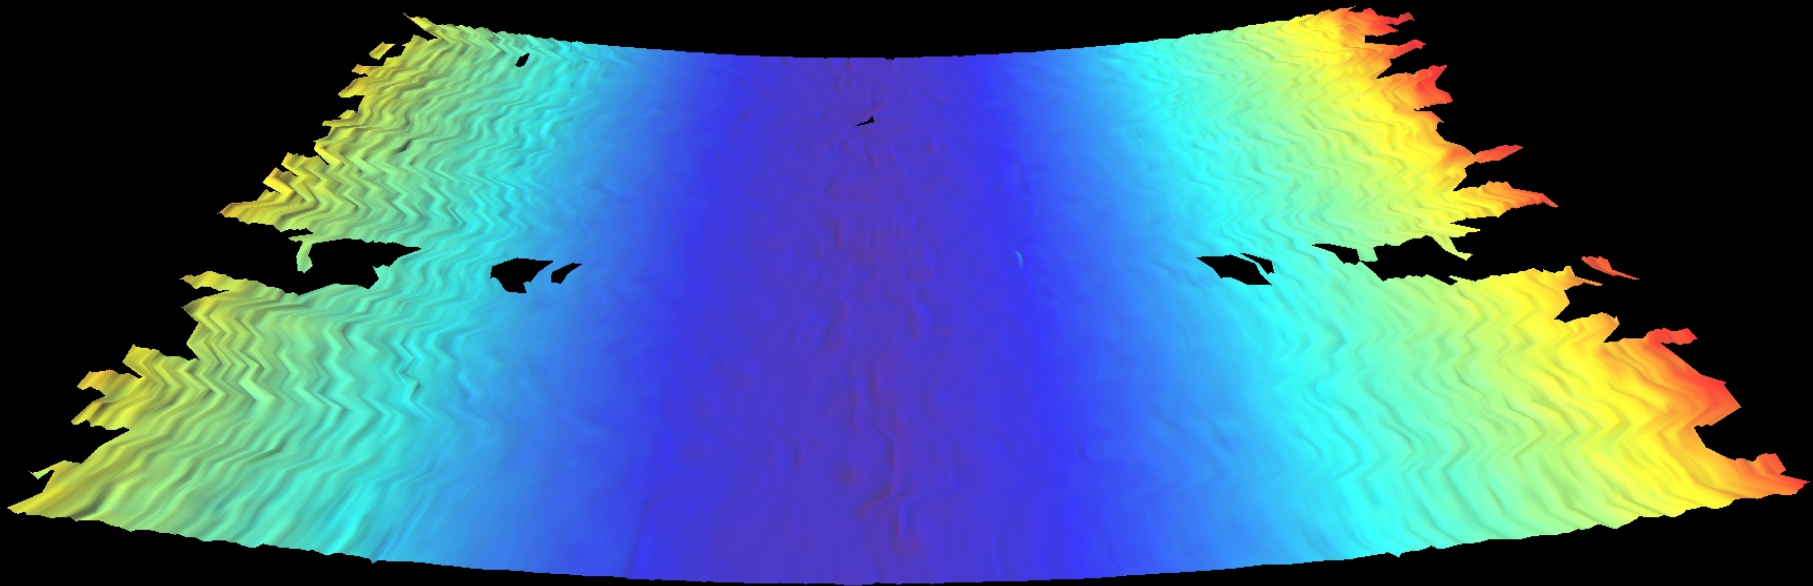
POTABLE WATER PUMP IMPACT

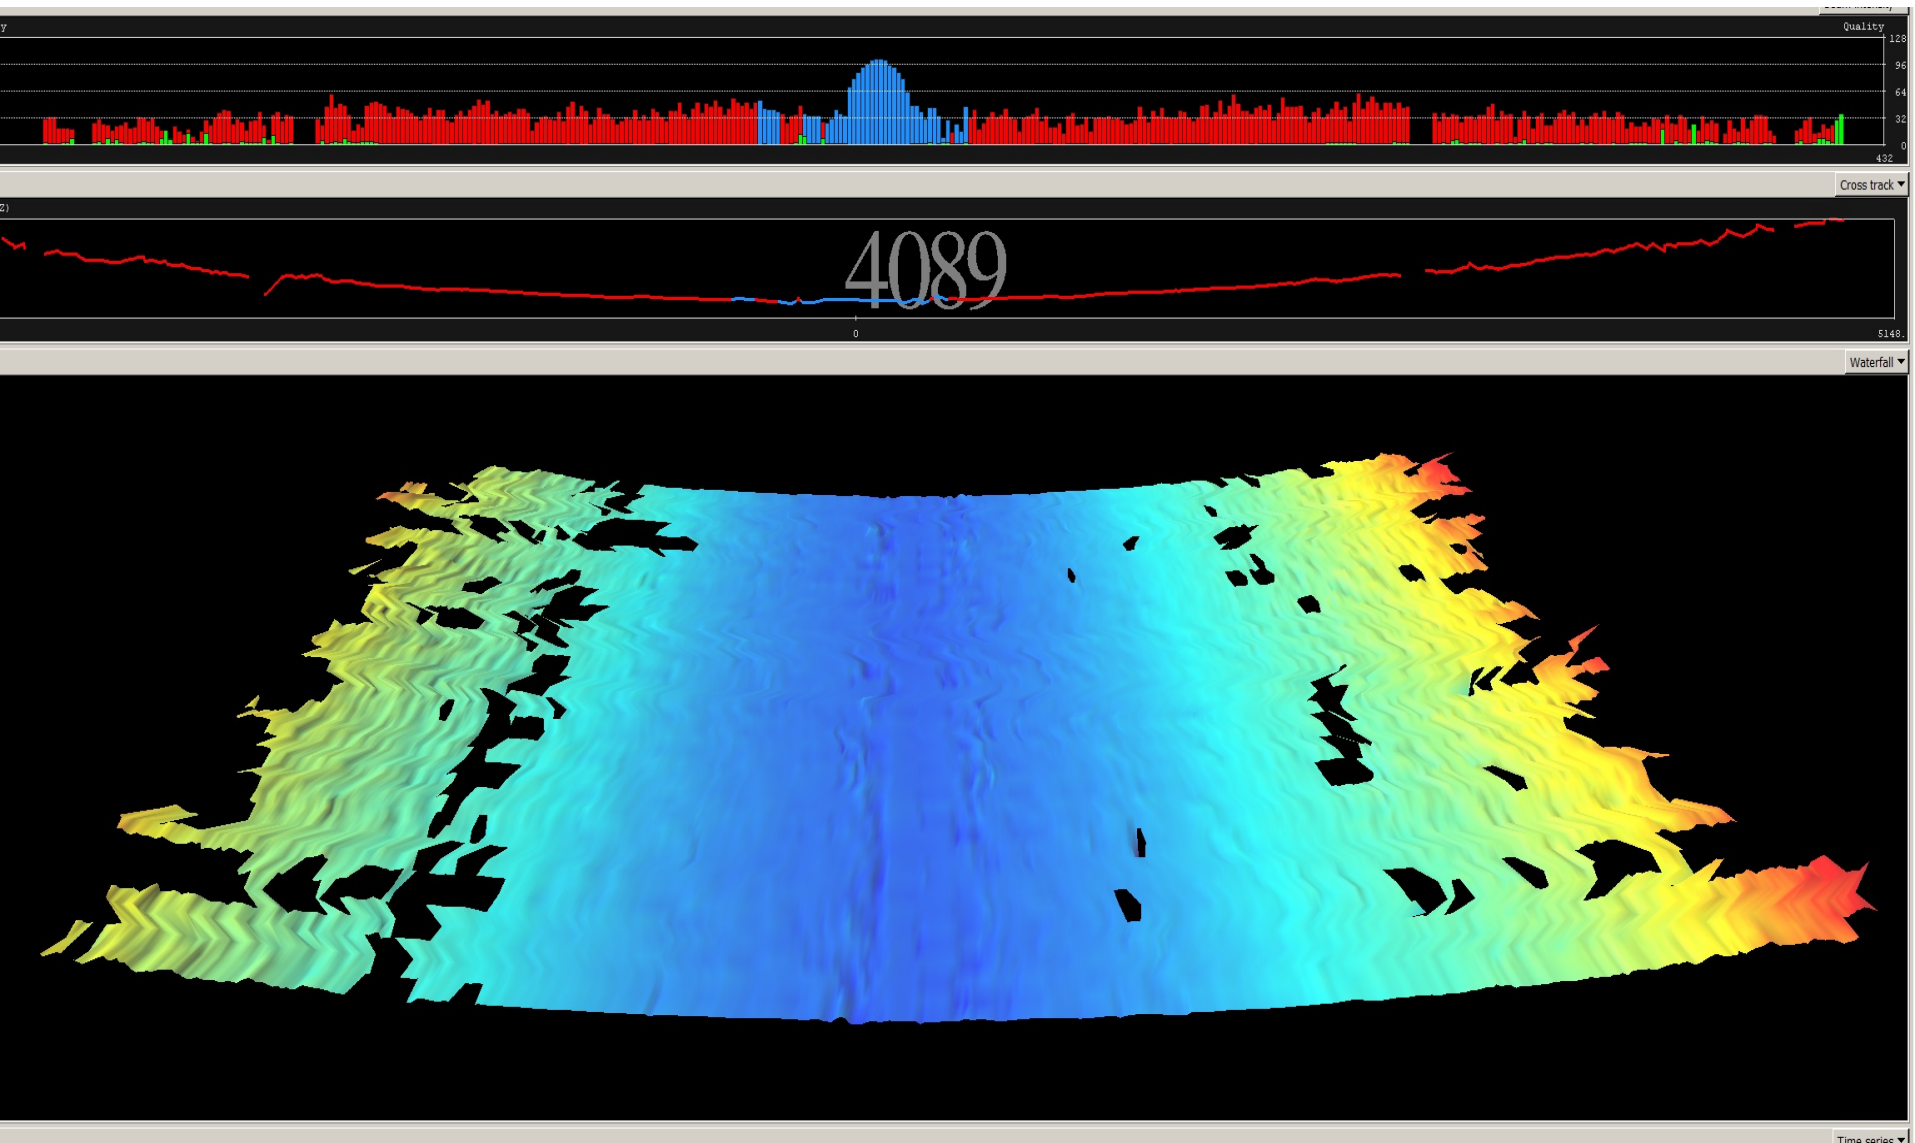
BOILER FEED PUMP 1 IMPACT

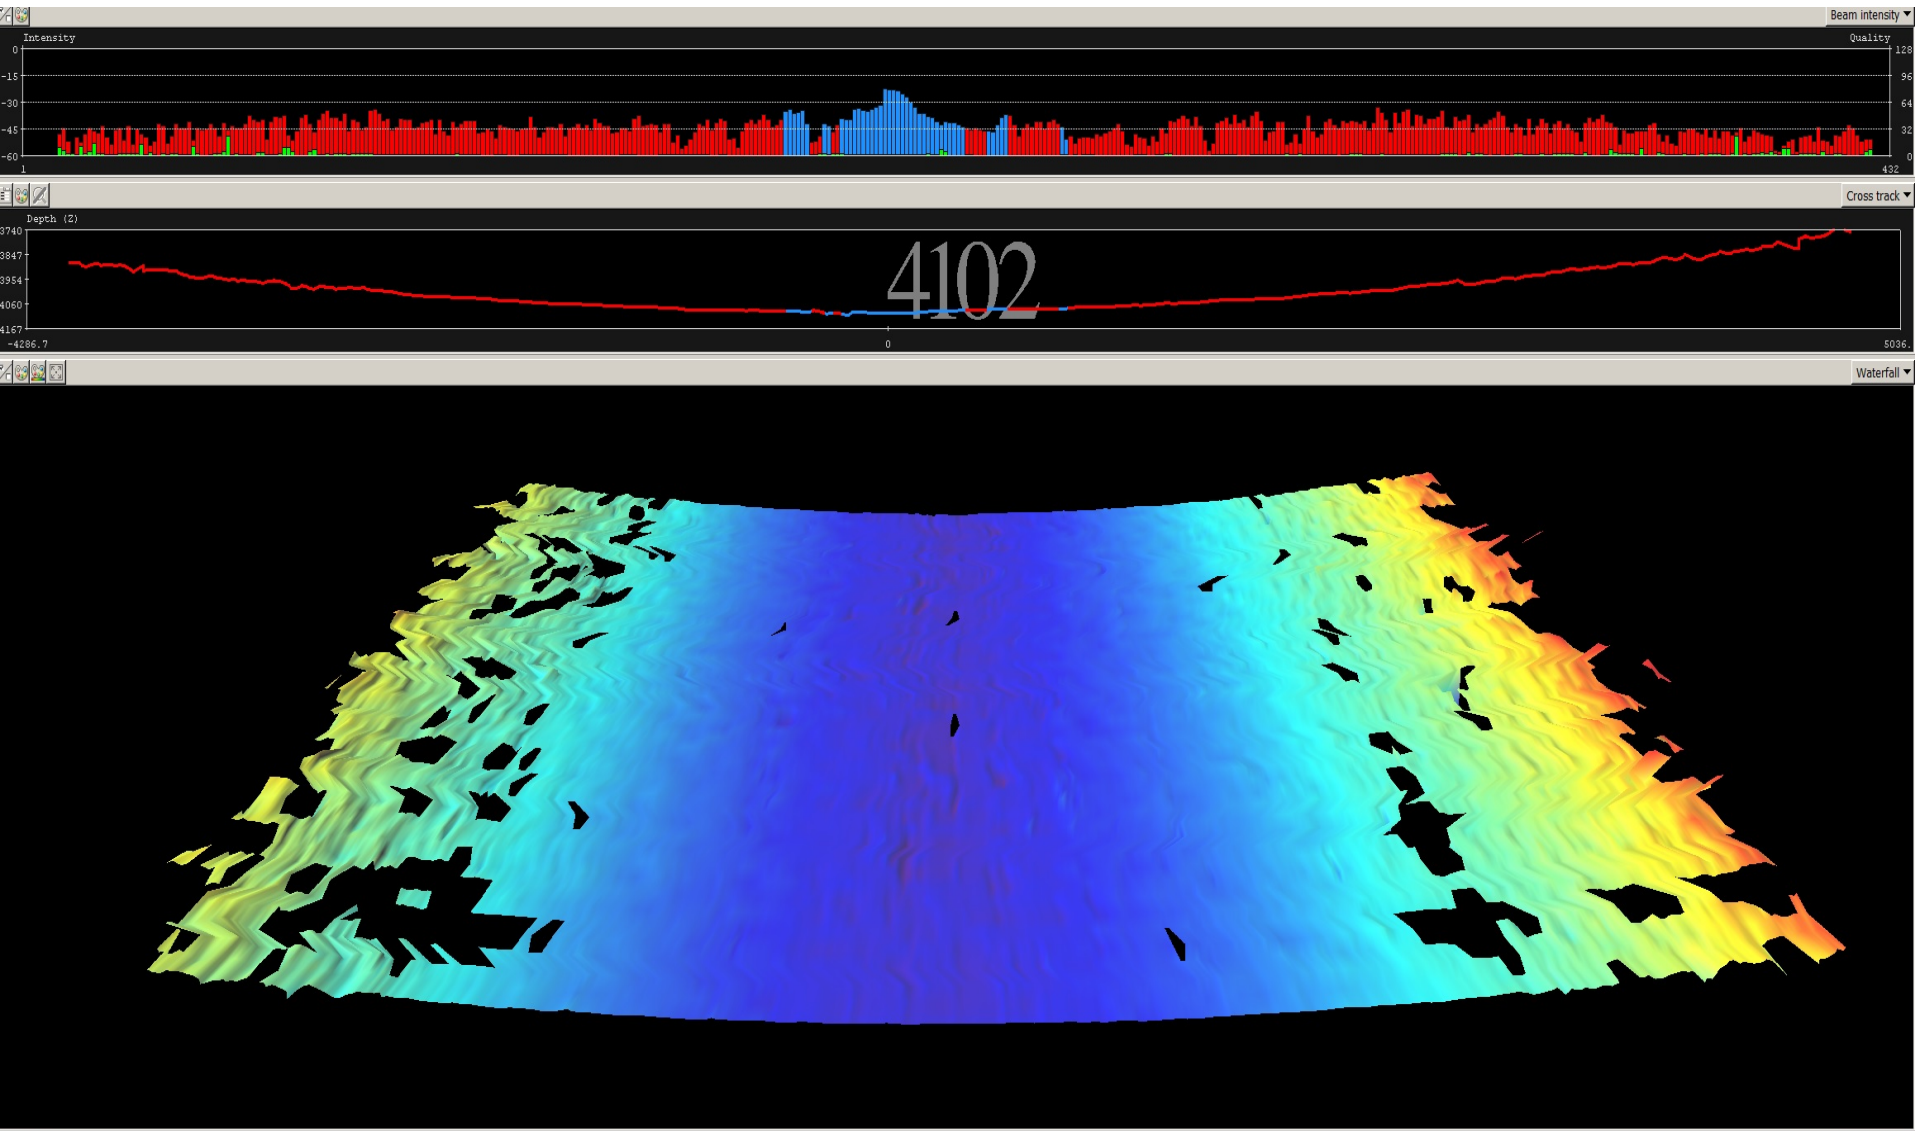
BOILER FEED PUMP 2 IMPACT

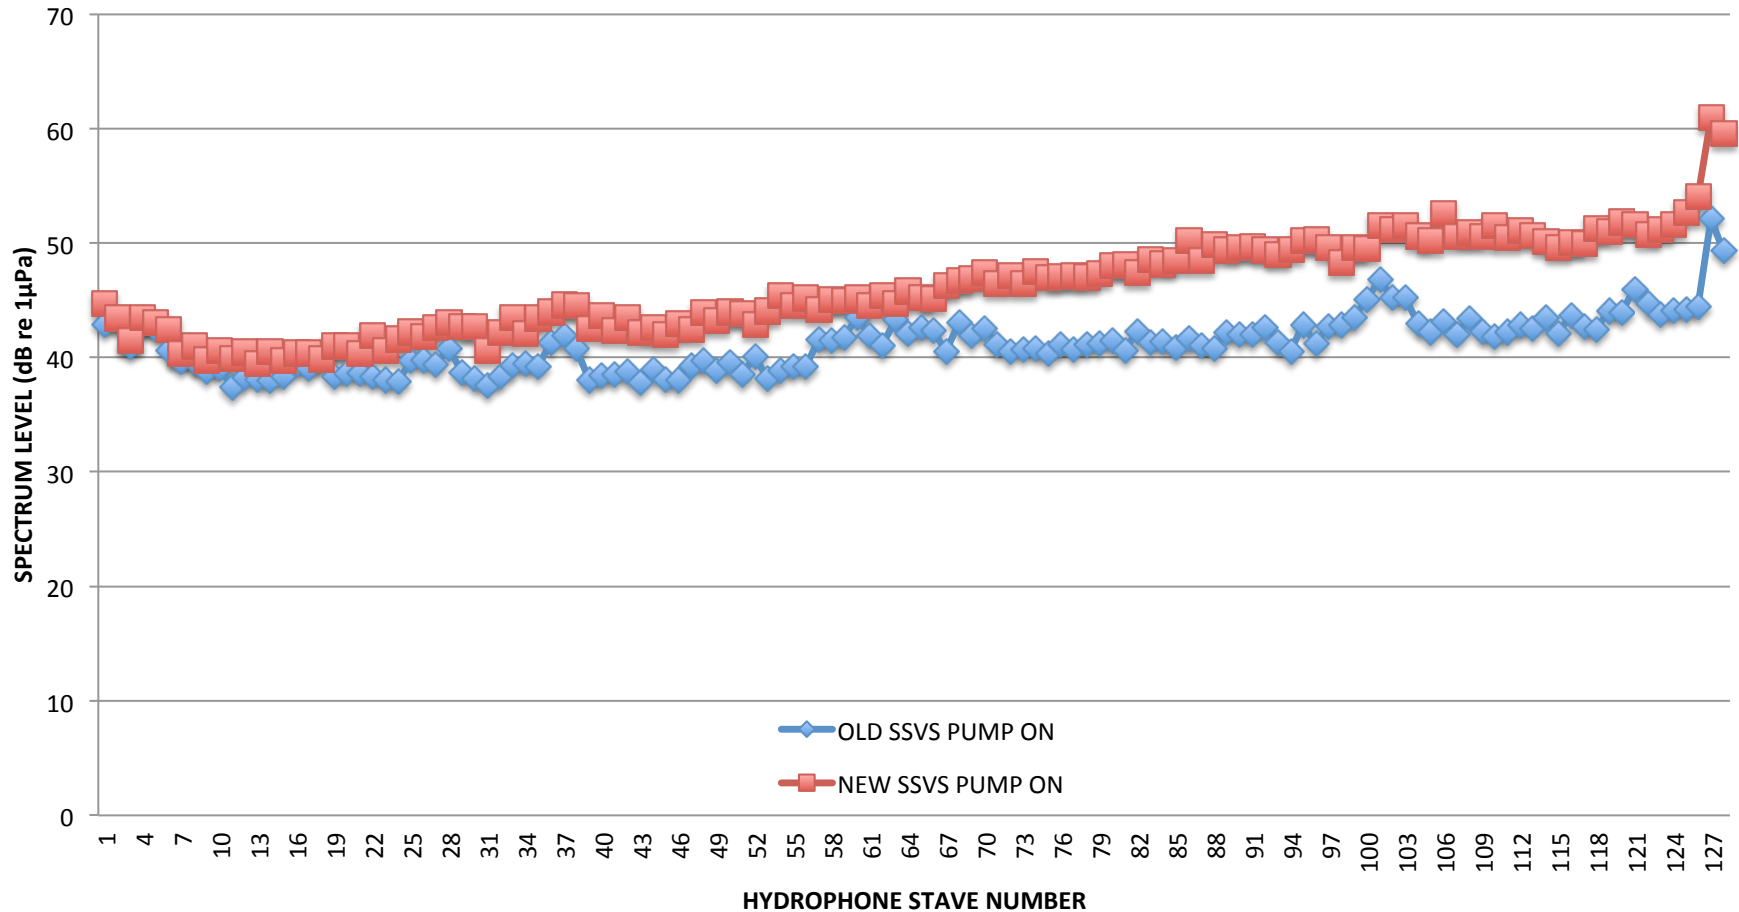
**E/V NAUTILUS
EM 302 RX NOISE LEVEL
OLD VS NEW SSVS PUMP COMPARISON
5 MAY 2014**

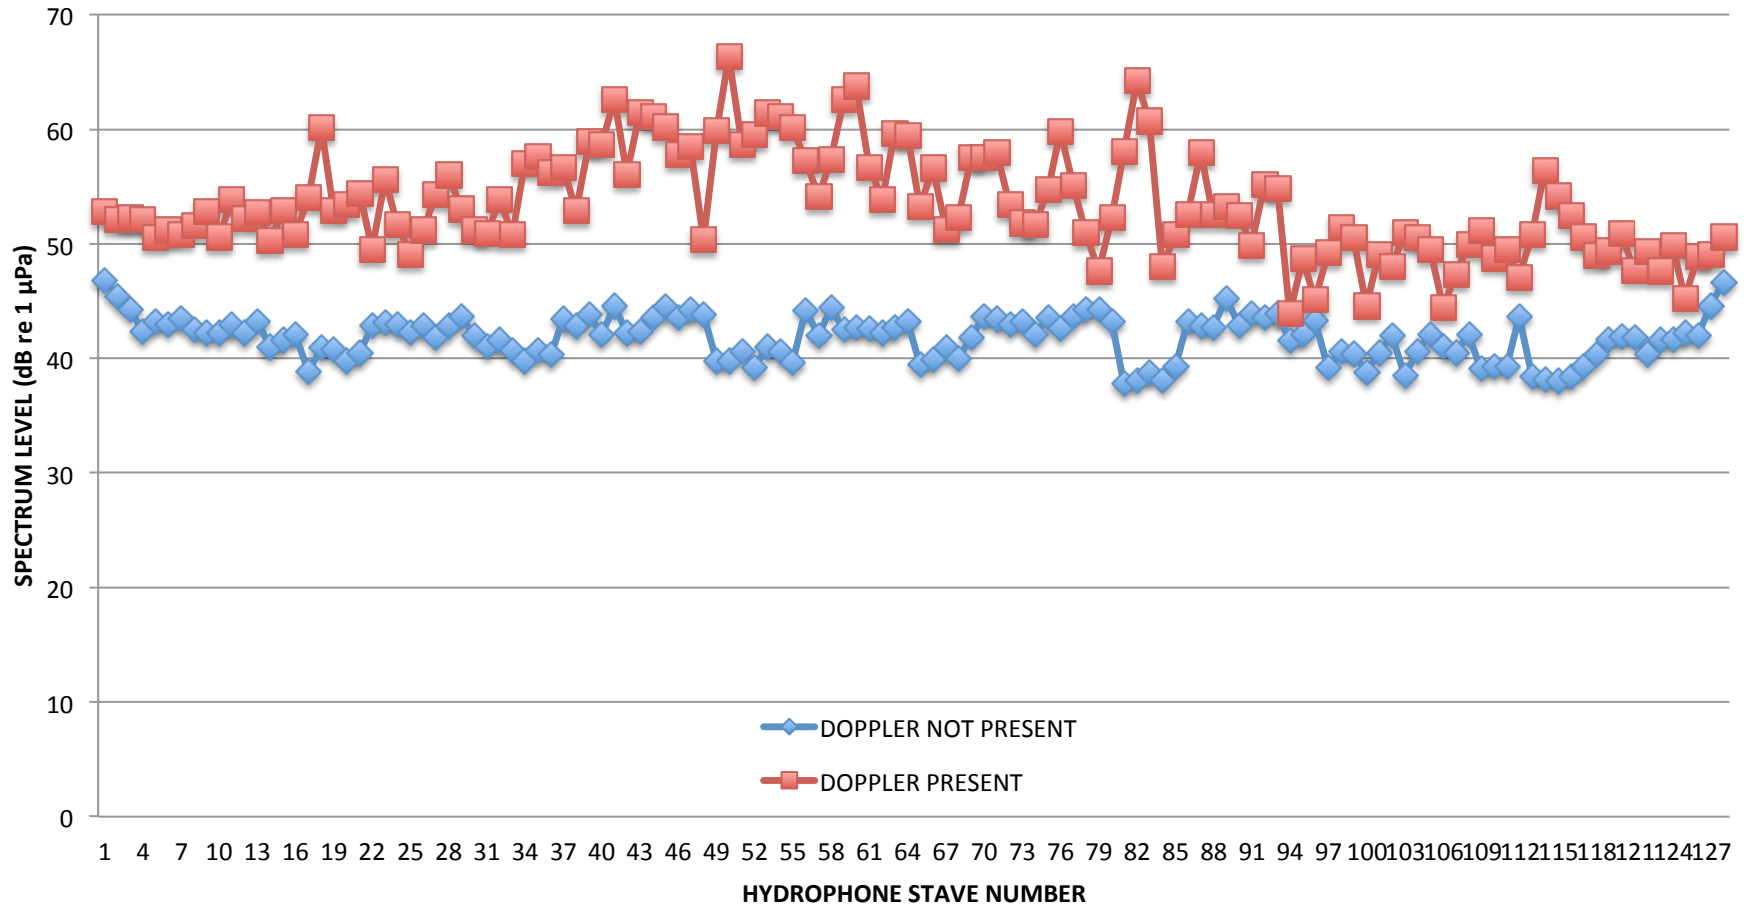
NOAA Ship *OKEANOS EXPLORER* (R-337)
DOPPLER SPEED LOG IMPACT - 8 KNOTS
EM 302 RX NOISE LEVEL
7 FEBRUARY 2014

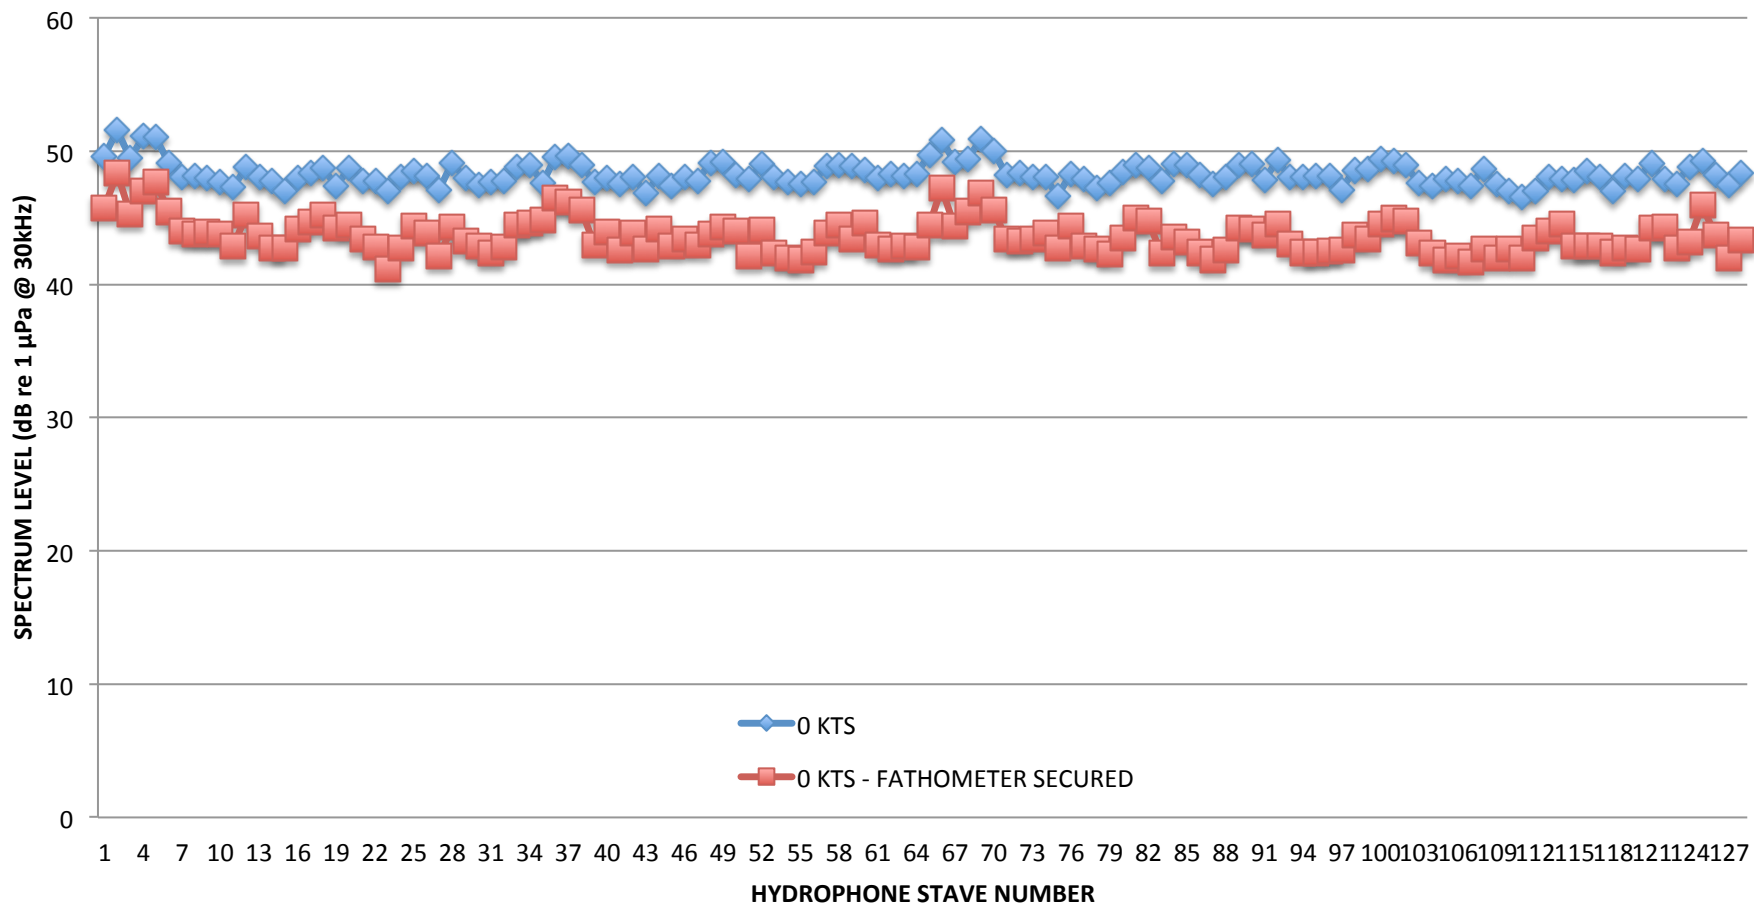
**R/V SIKULIAQ
EM302 RX NOISE LEVEL
0 KTS - FATHOMETER ON VS SECURED
16 JULY 2014**

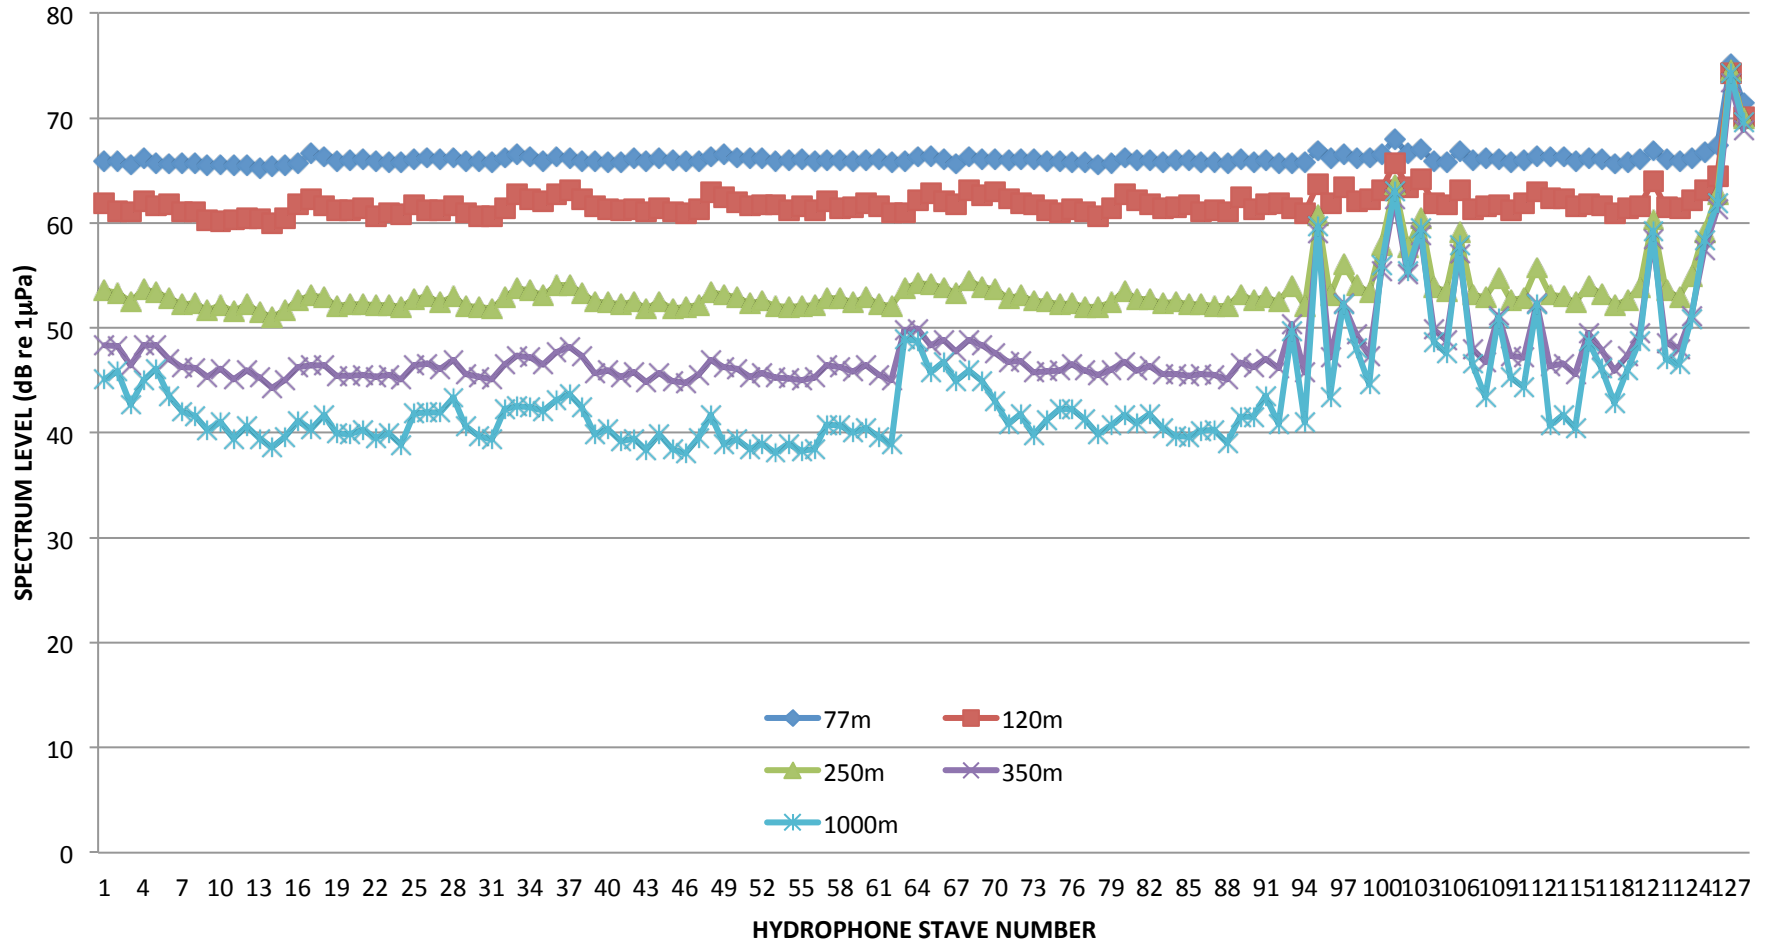
**E/V NAUTILUS
EM302 RX NOISE LEVEL
DEPTH COMPARE - 25 PITCH
10 APRIL 2013**

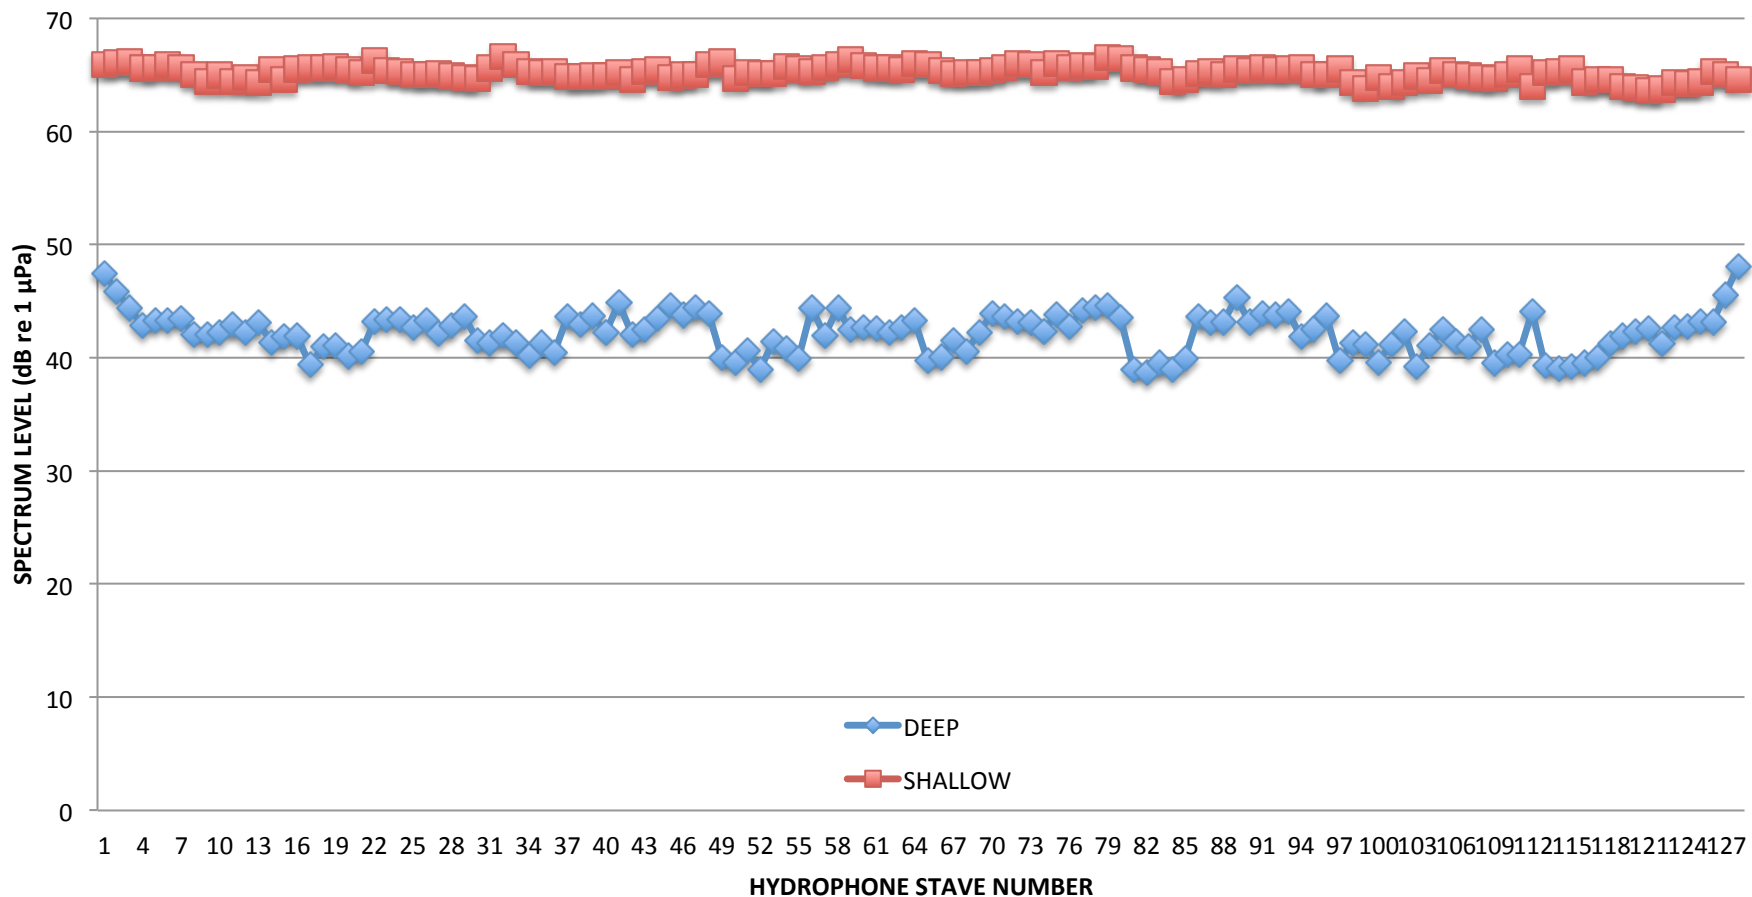
NOAA Ship *OKEANOS EXPLORER* (R-337)
8 KNOTS - DEEP VS SHALLOW WATER
EM 302 RX NOISE LEVEL
6 FEBRUARY 2014

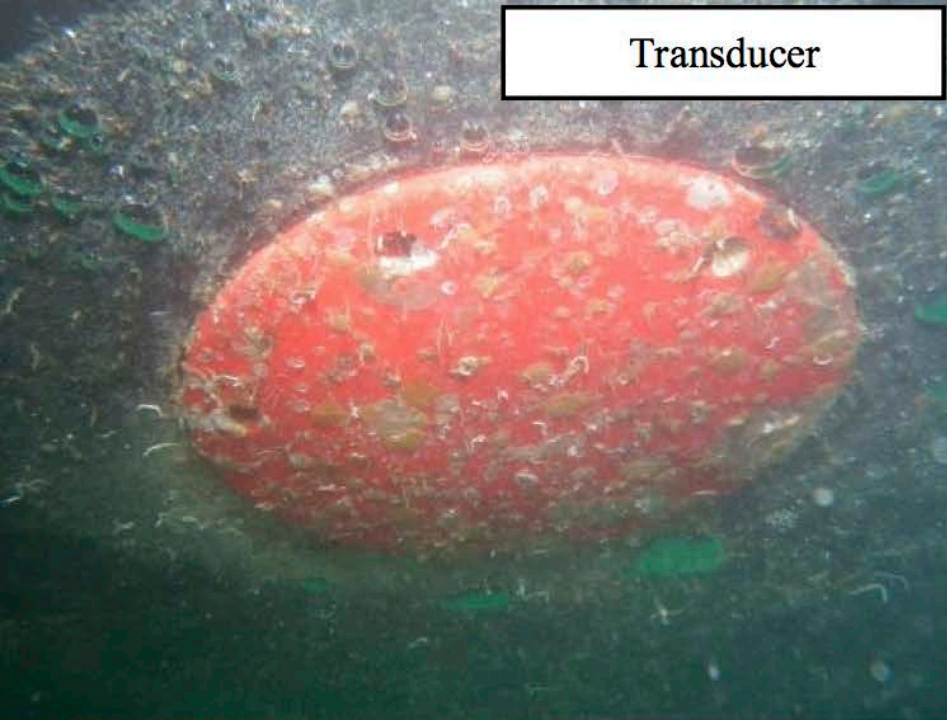
Transducer

- M/V FALKOR reported significant degradations to sonar performance
- RX Noise levels were significantly increased
- Underhull inspection revealed poor conditions associated with bio-fouling
