Optimizing Sonar Performance by Managing Acoustics

November 20, 2014

Marisa Yearta and Timothy Gates

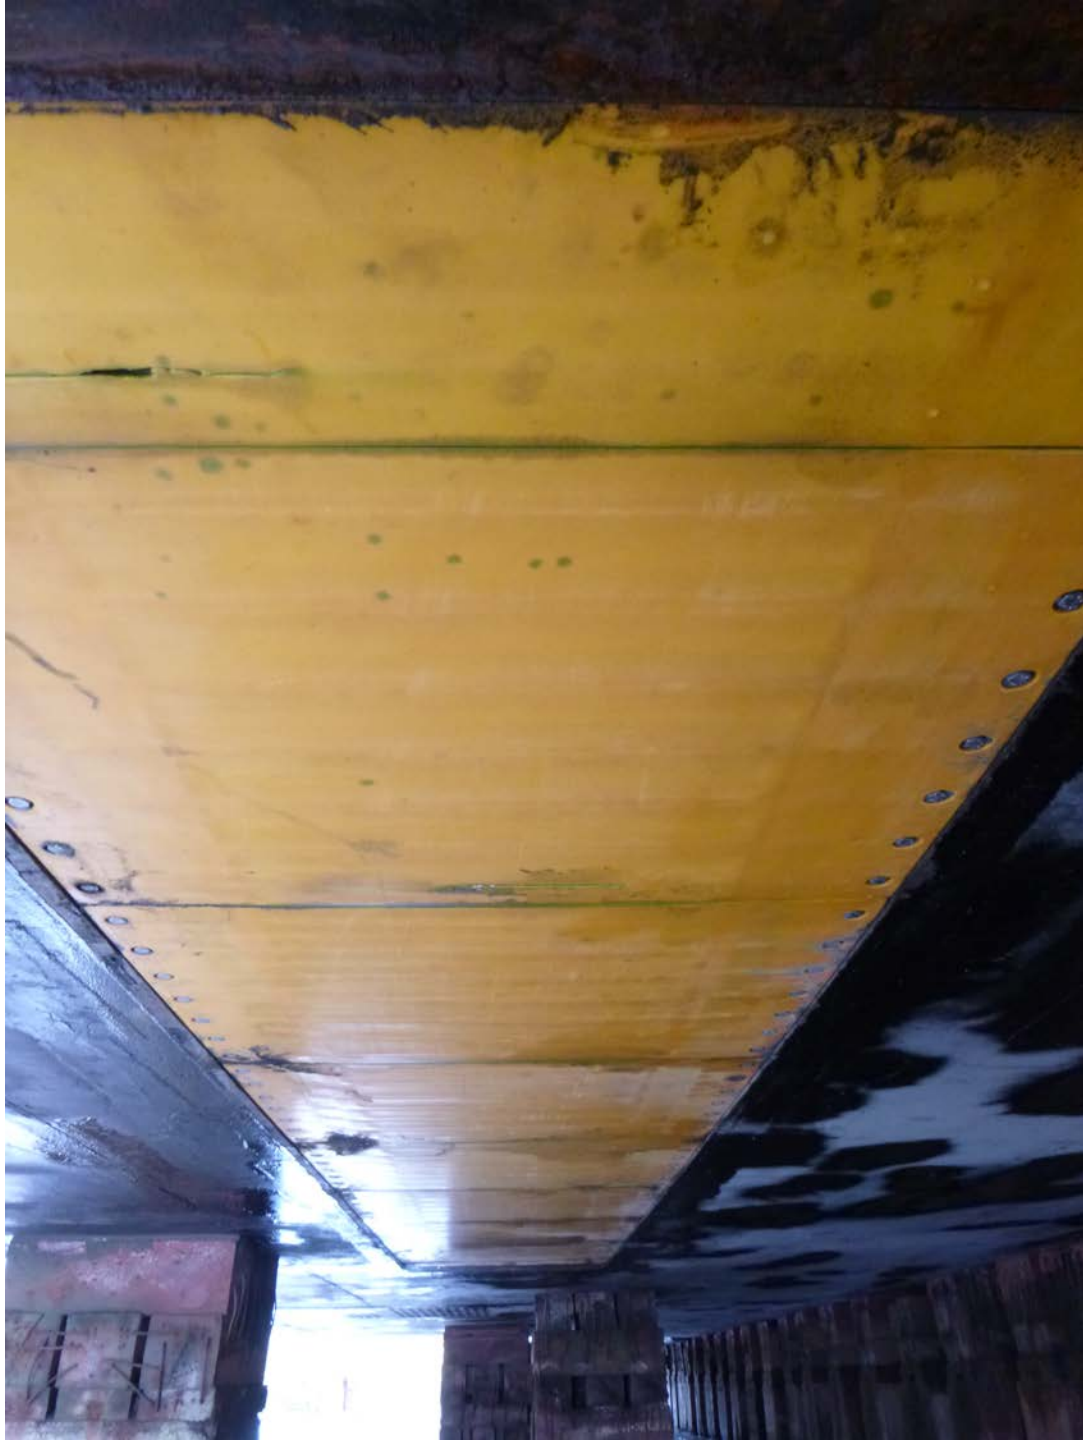
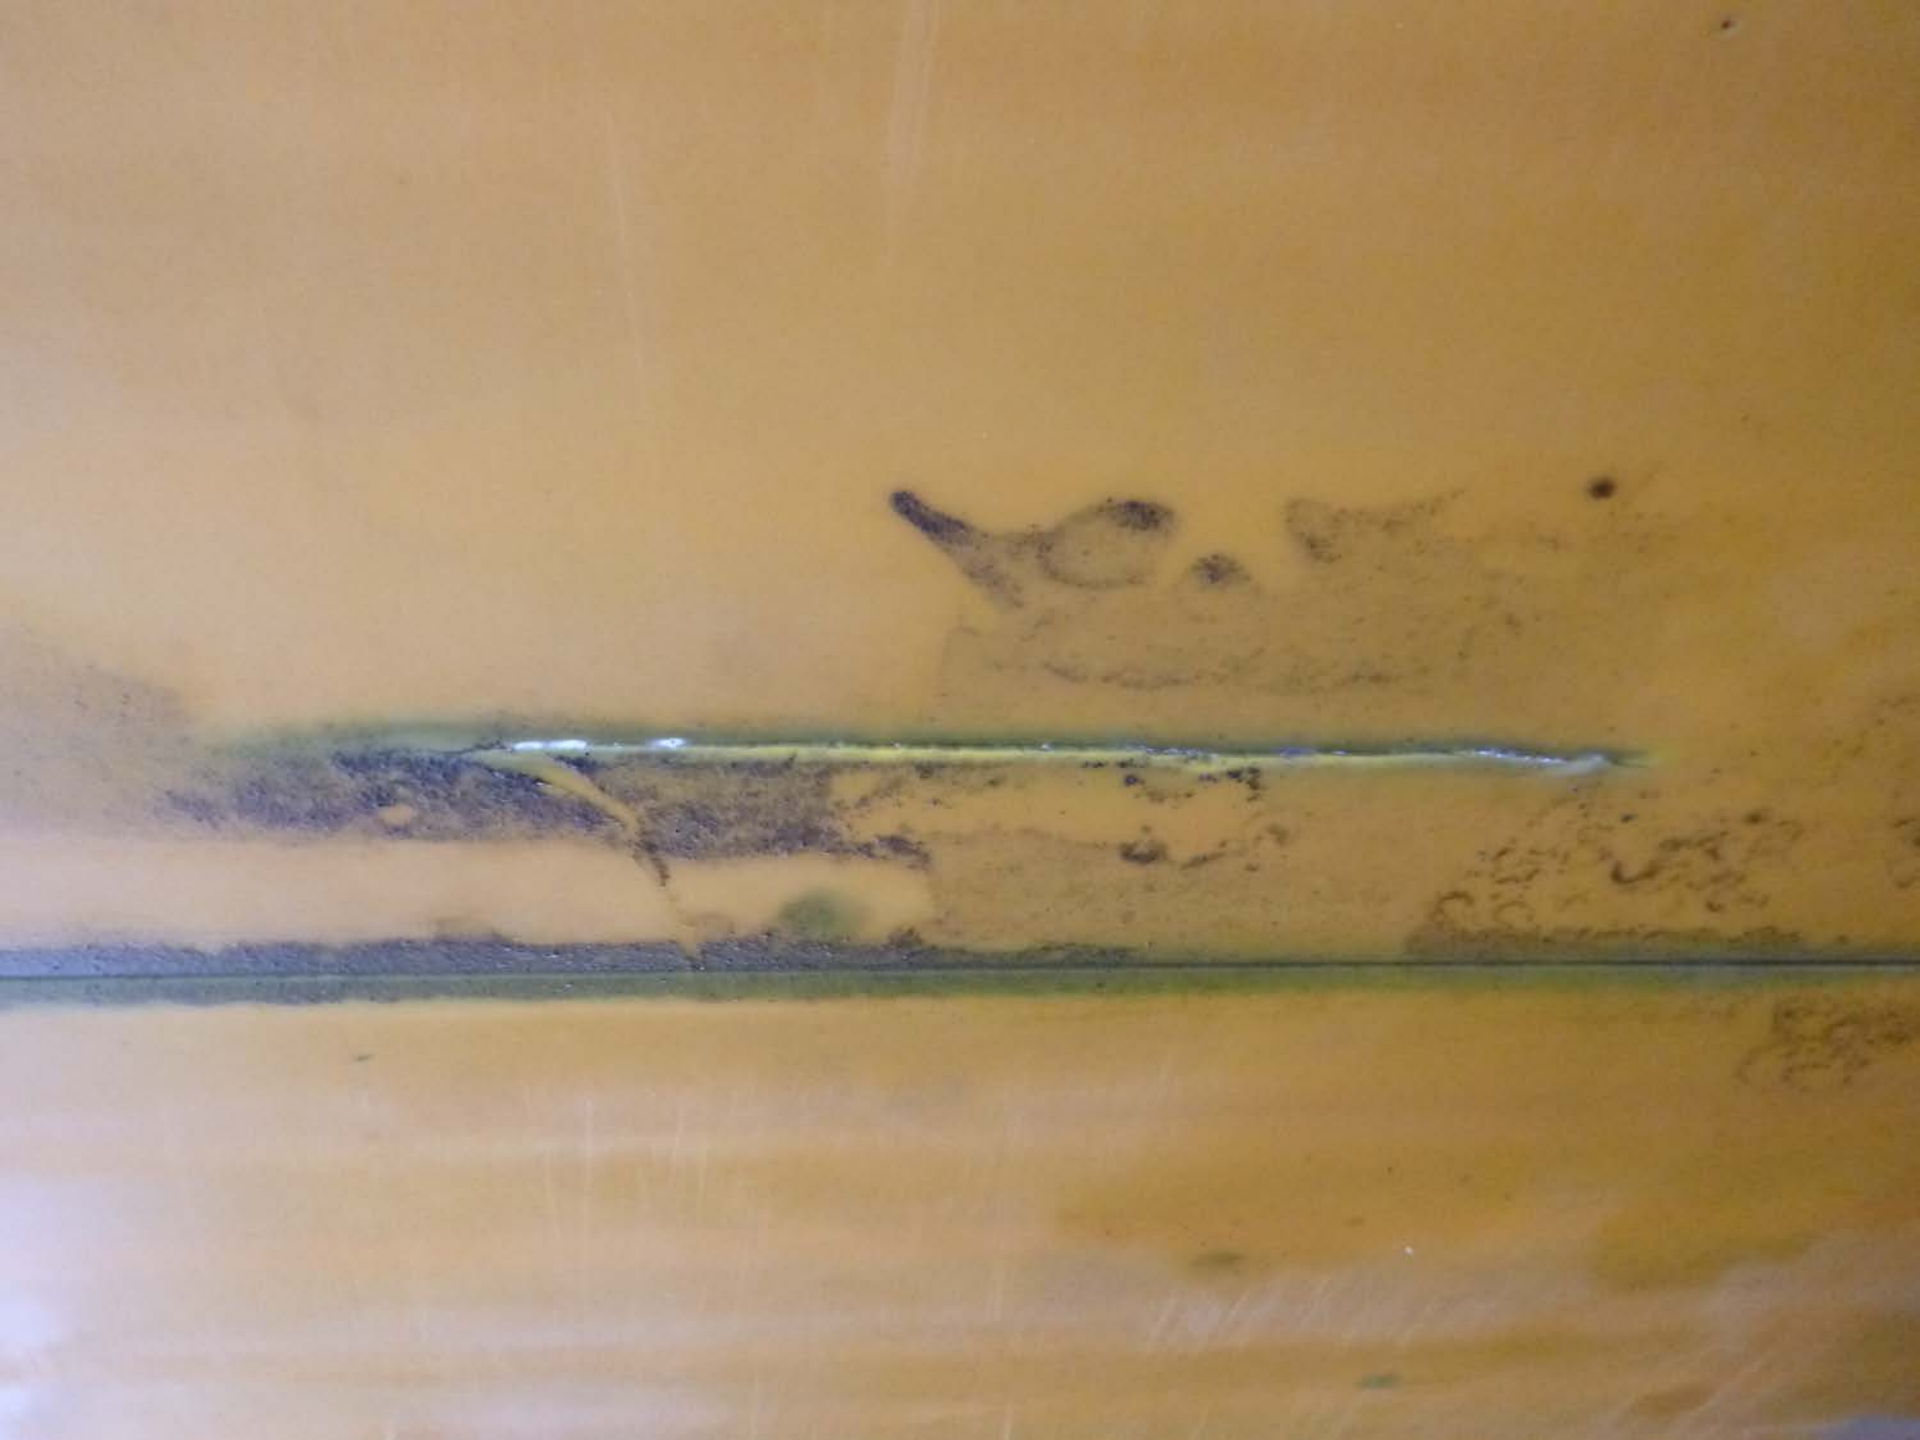
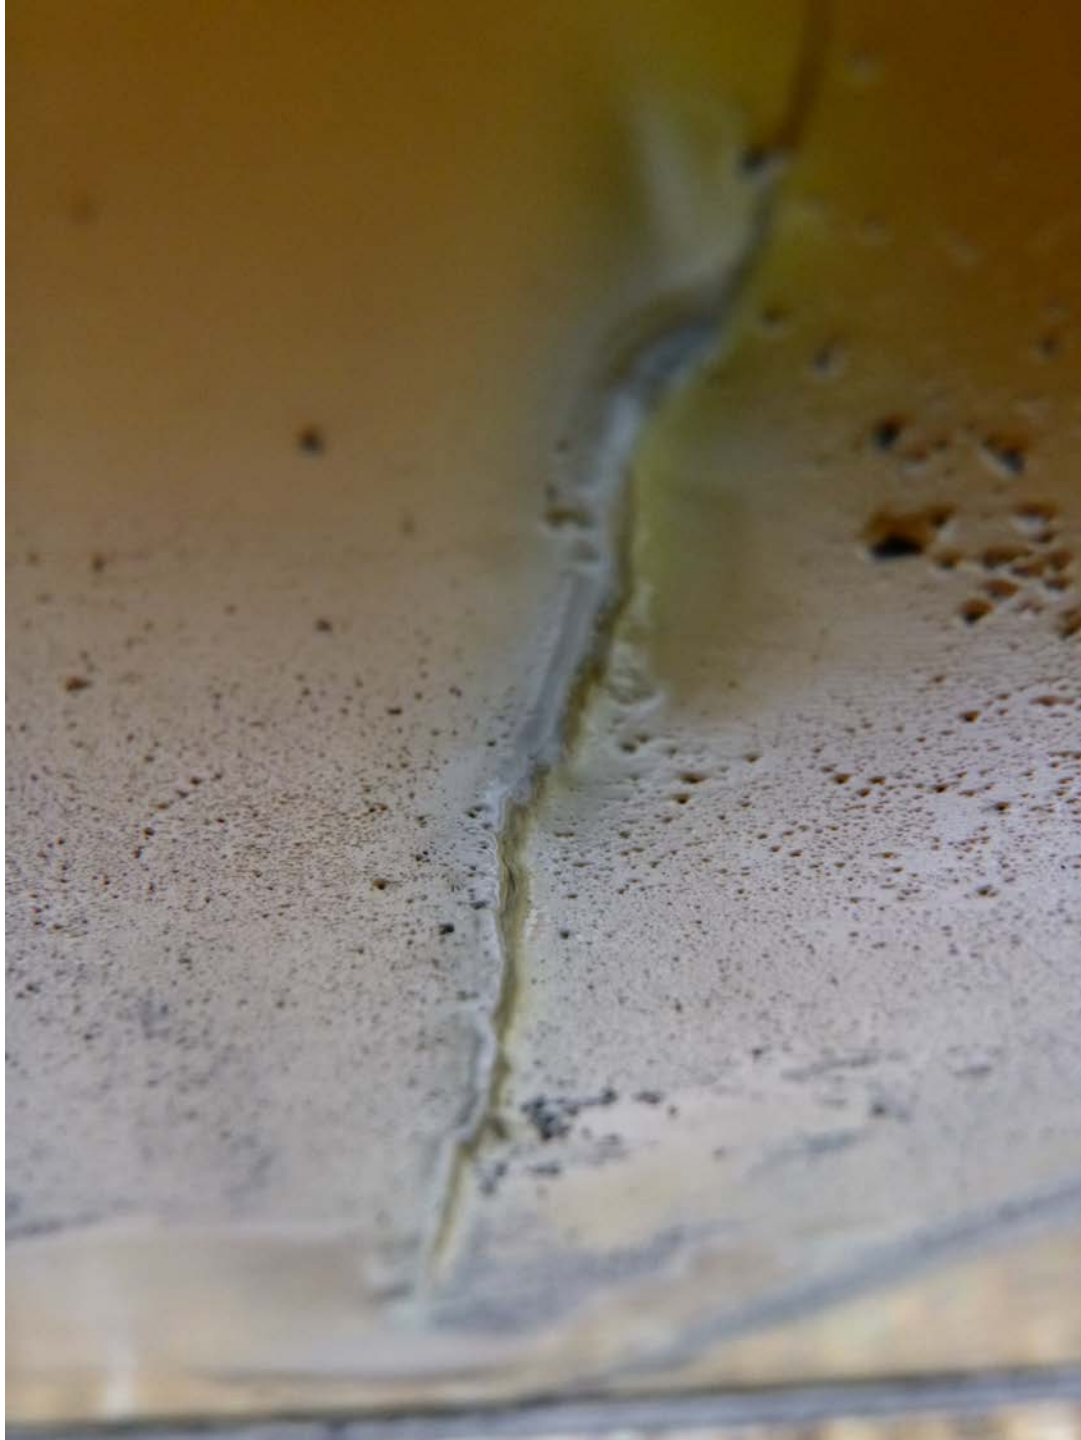
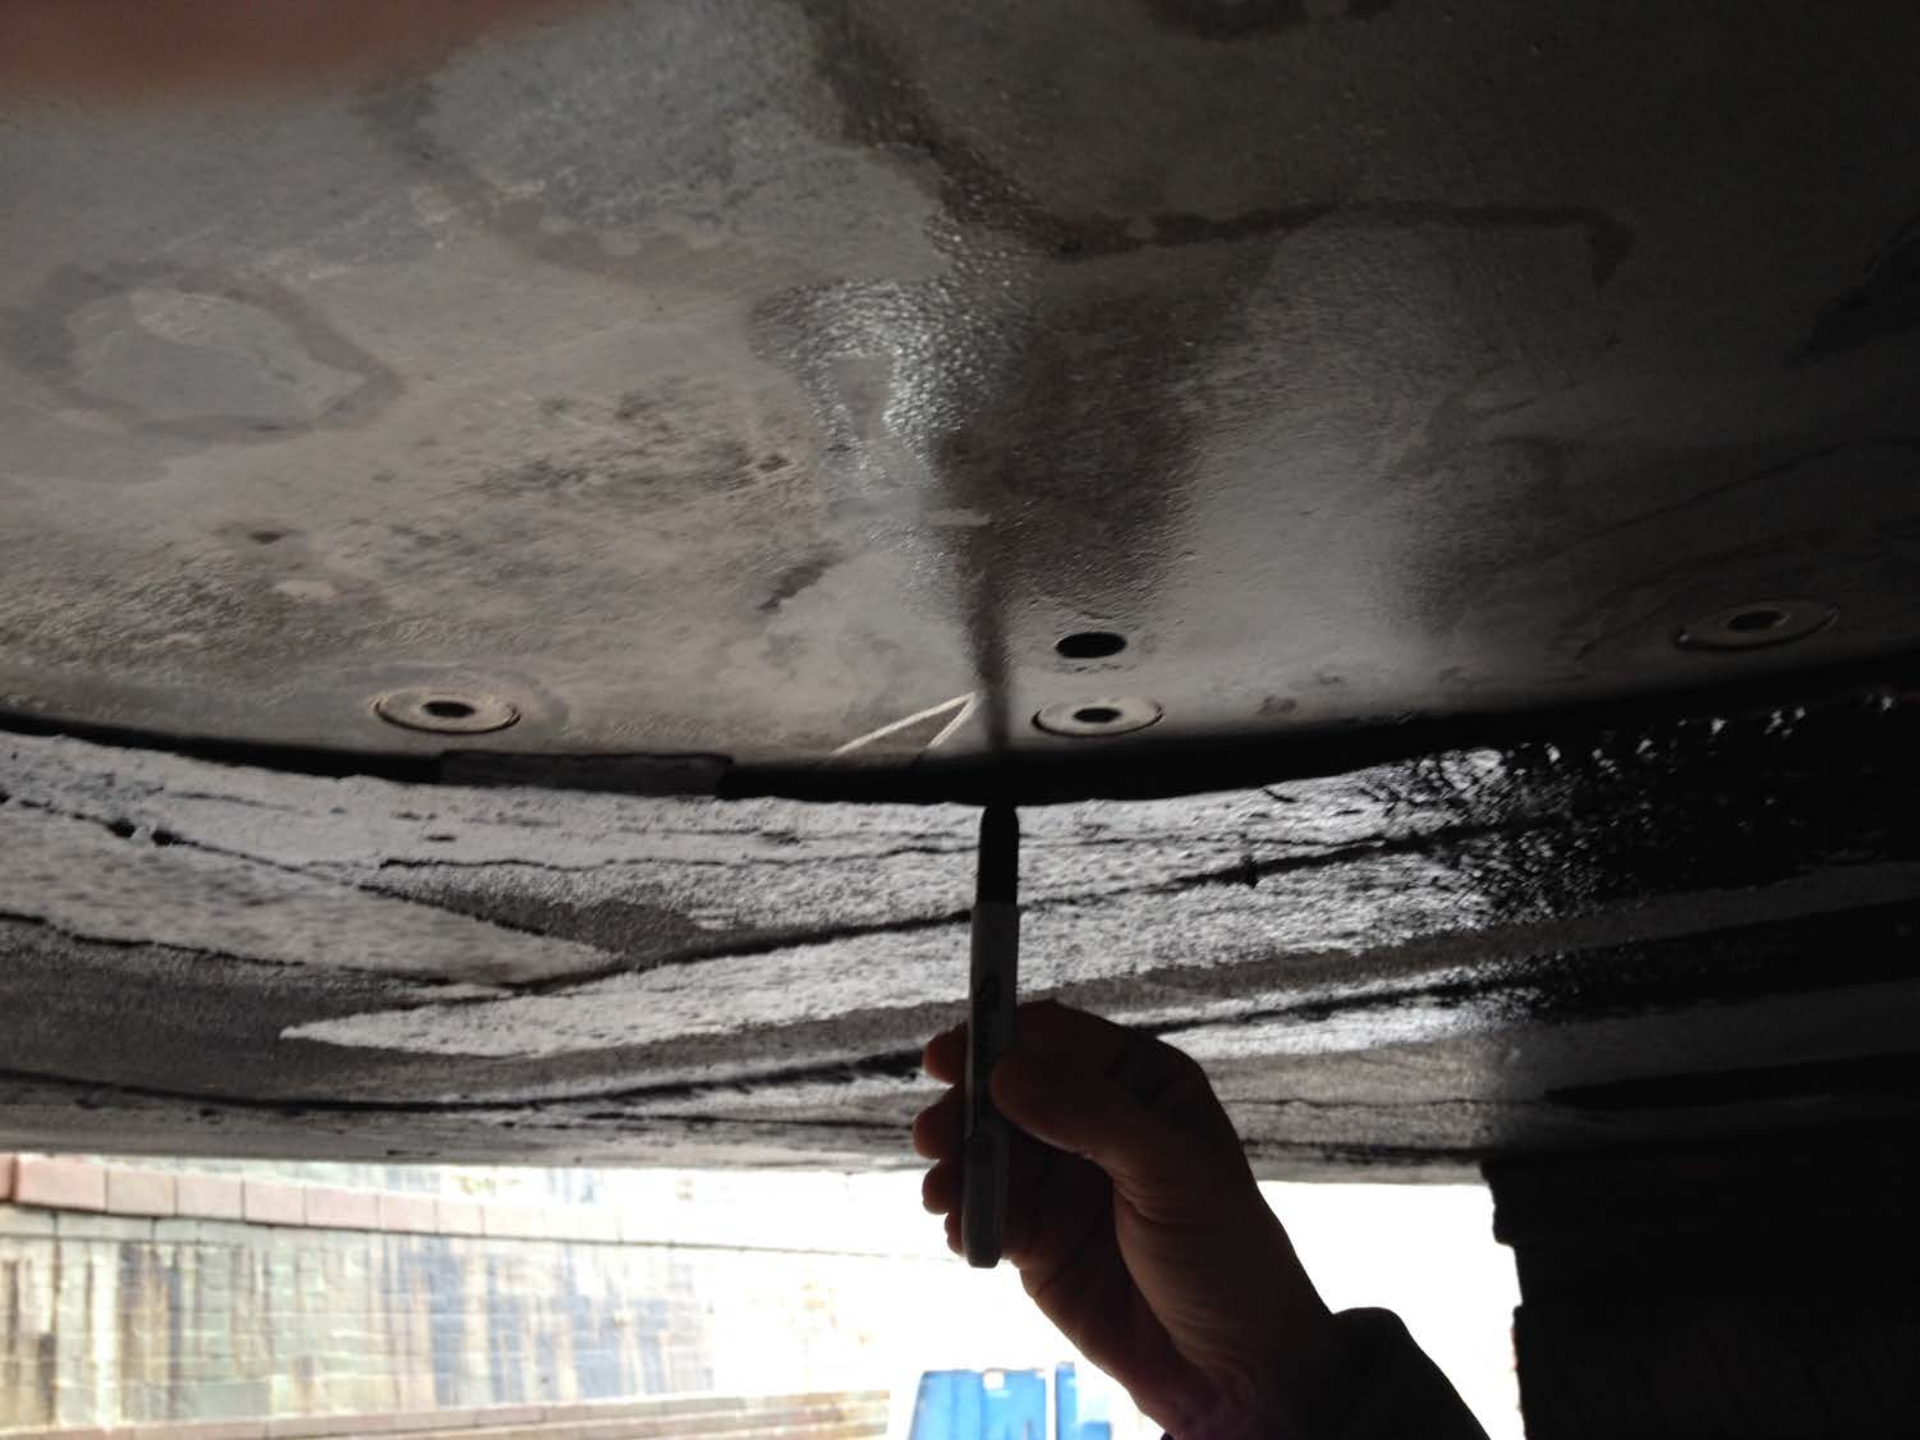
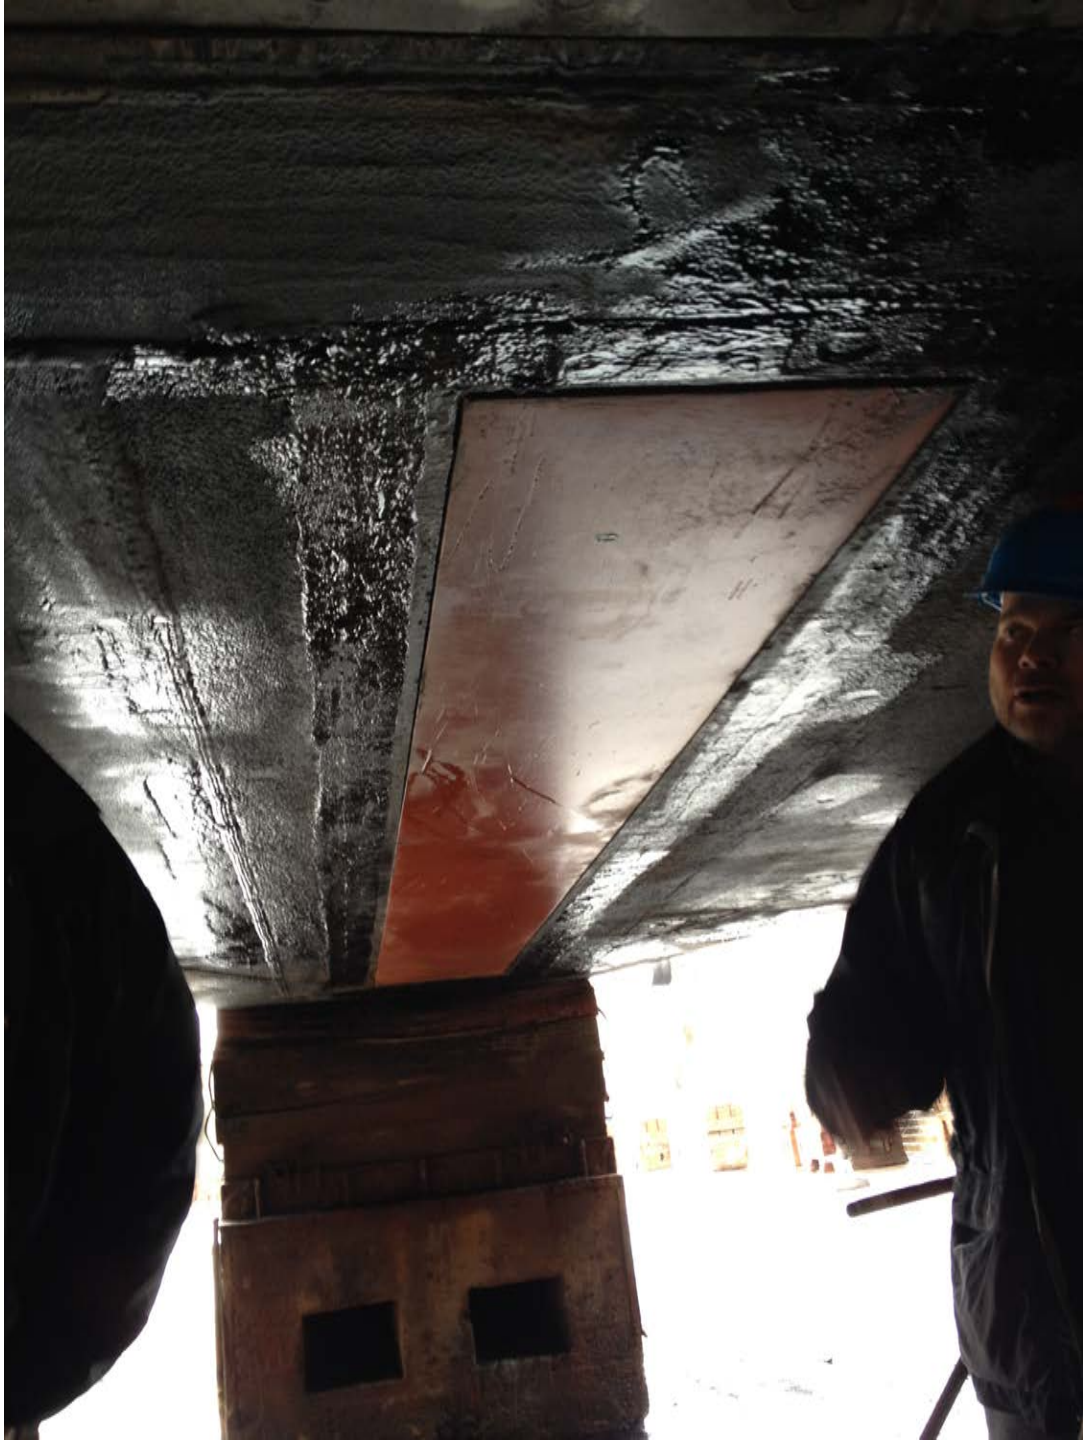
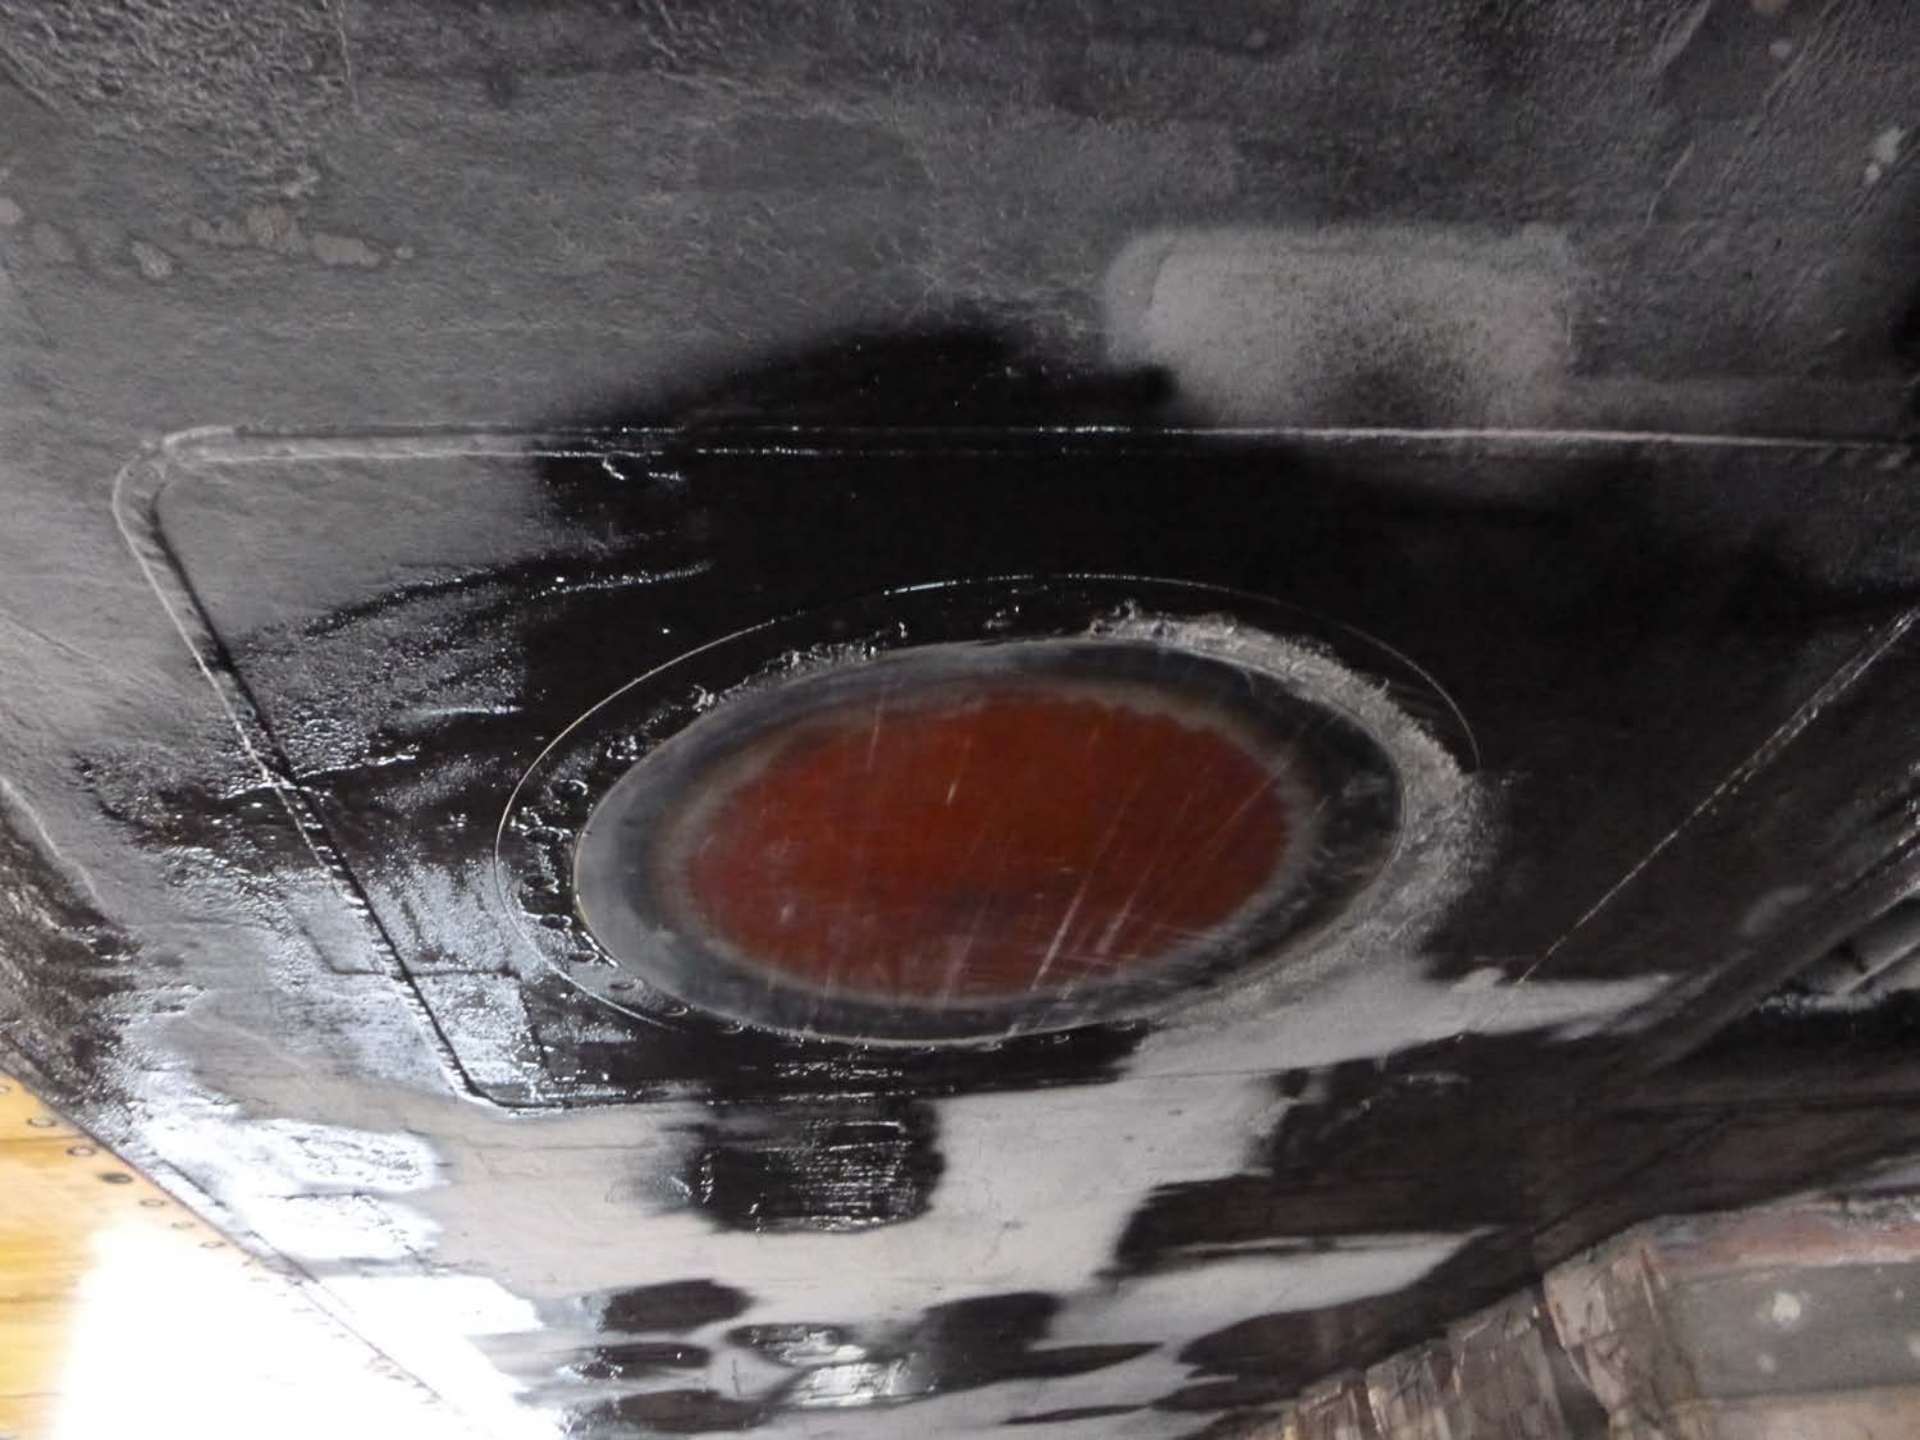
- Drydock inspection revealed extremely poor conditions near sonar transducers
- Gaps were noted between transducer faces and ships hull
- Paint conditions were terrible
- Sonar acoustic windows possessed major cracks
- These conditions will significantly degrade hydrodynamic flow noise levels

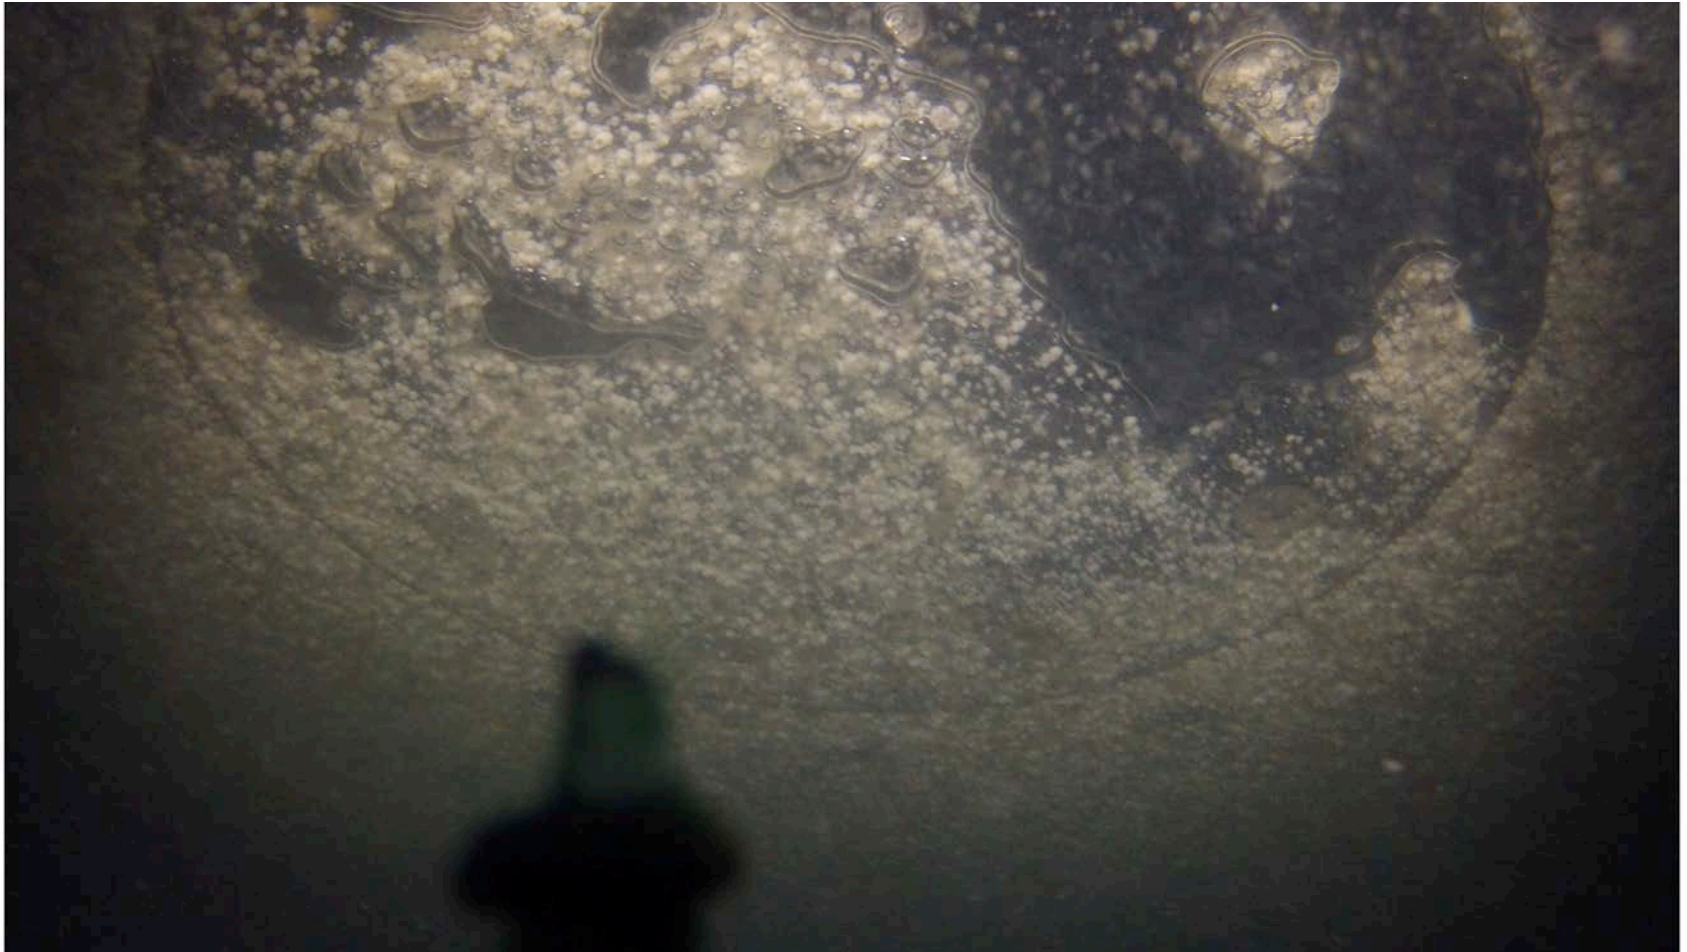
R/V SIKULIAQ - ADCP

- SIKULIAQ was significantly fouled during baseline acoustic testing
- Sonar levels were completely controlled by hydrodynamic flow noise at vessel of 3 knots and above

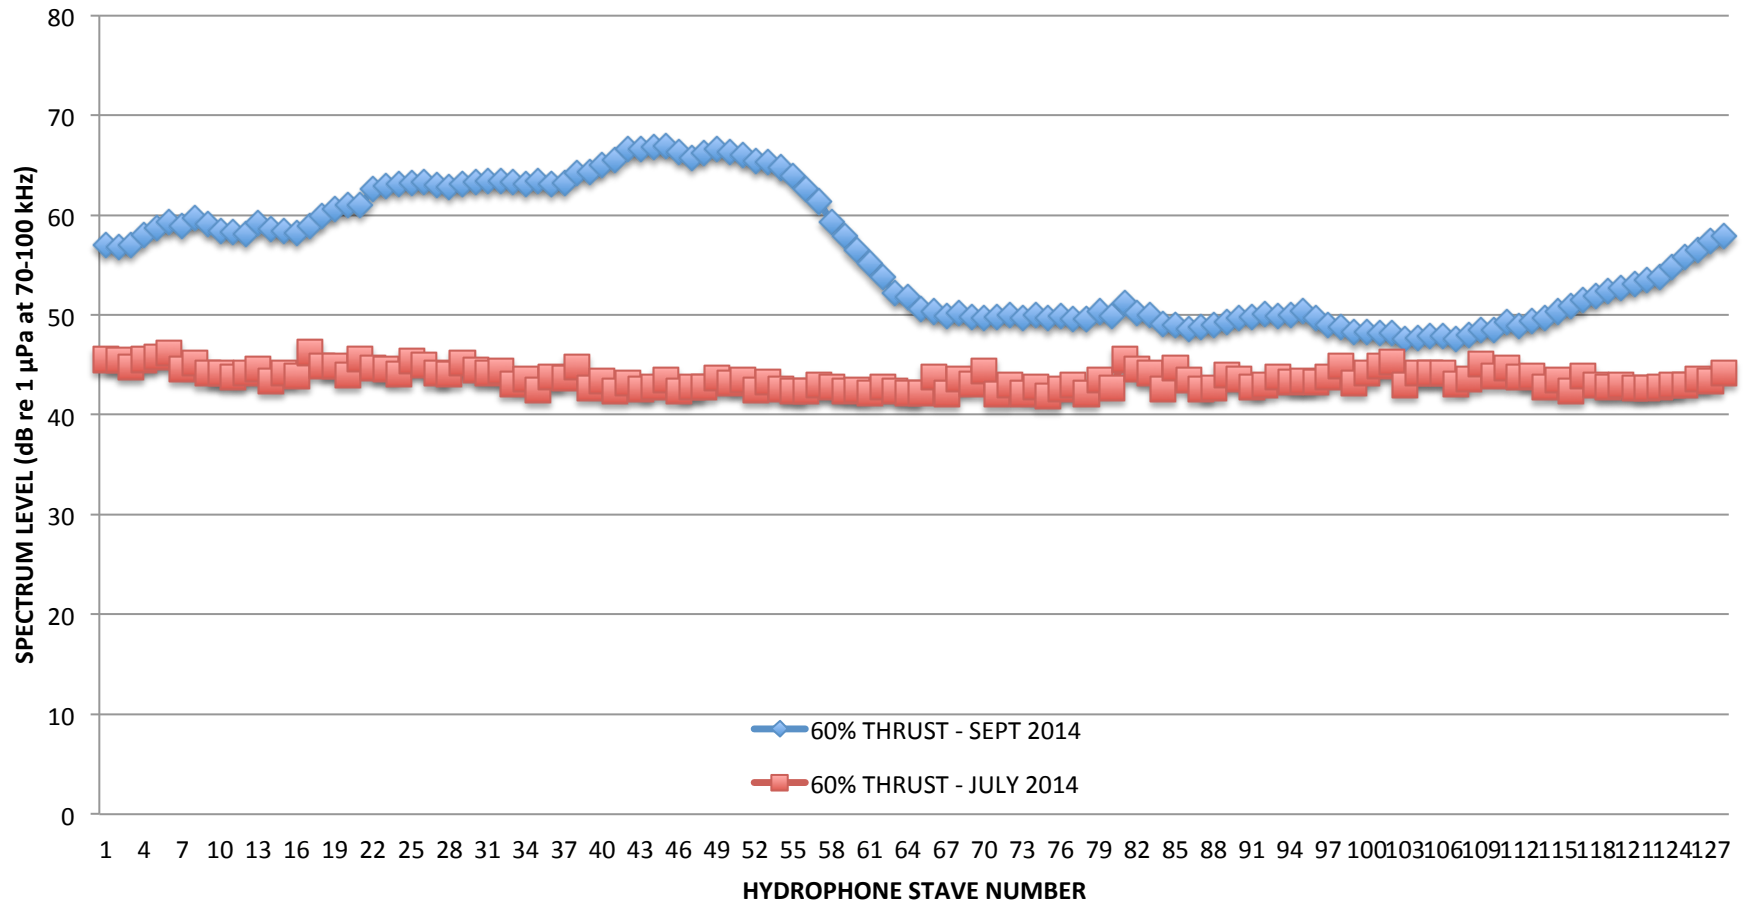
**R/V SIKULIAQ
EM 710 RX NOISE LEVEL
60% THRUST - JULY VERSUS SEPTEMBER 2014
15 SEPTEMBER 2014**

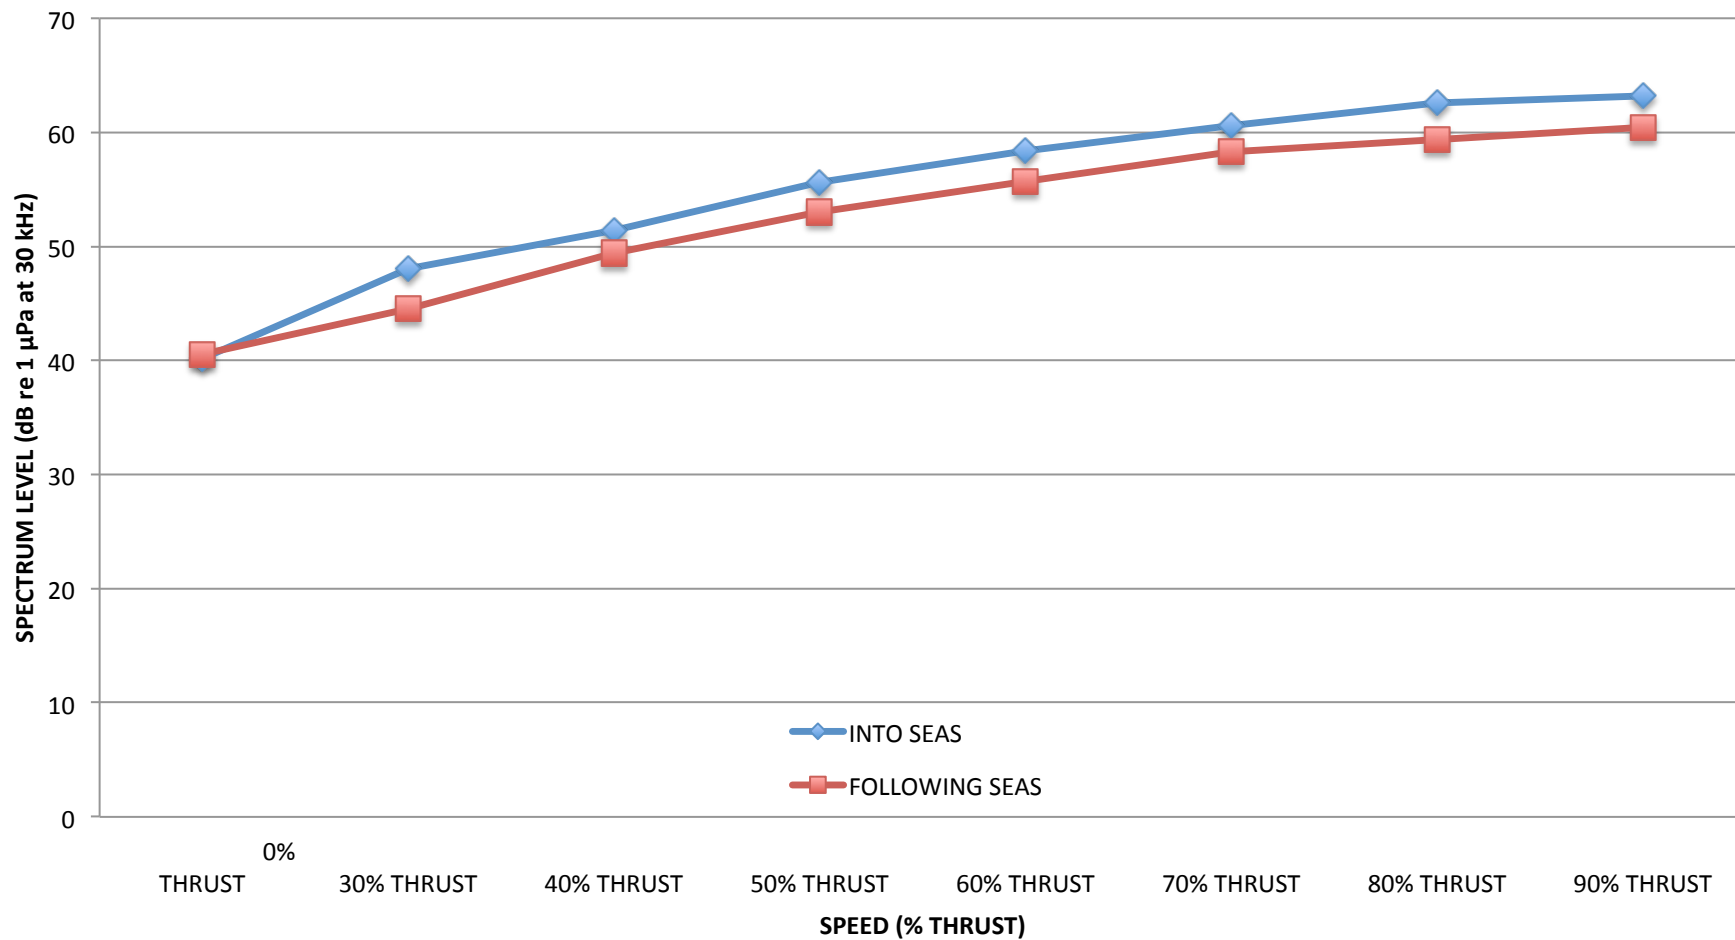
R/V SIKULIAQ
EM 302 RX NOISE LEVEL
SPEED VS 30 kHz LEVEL - INTO VS FOLLOWING SEAS
15 SEPTEMBER 2014

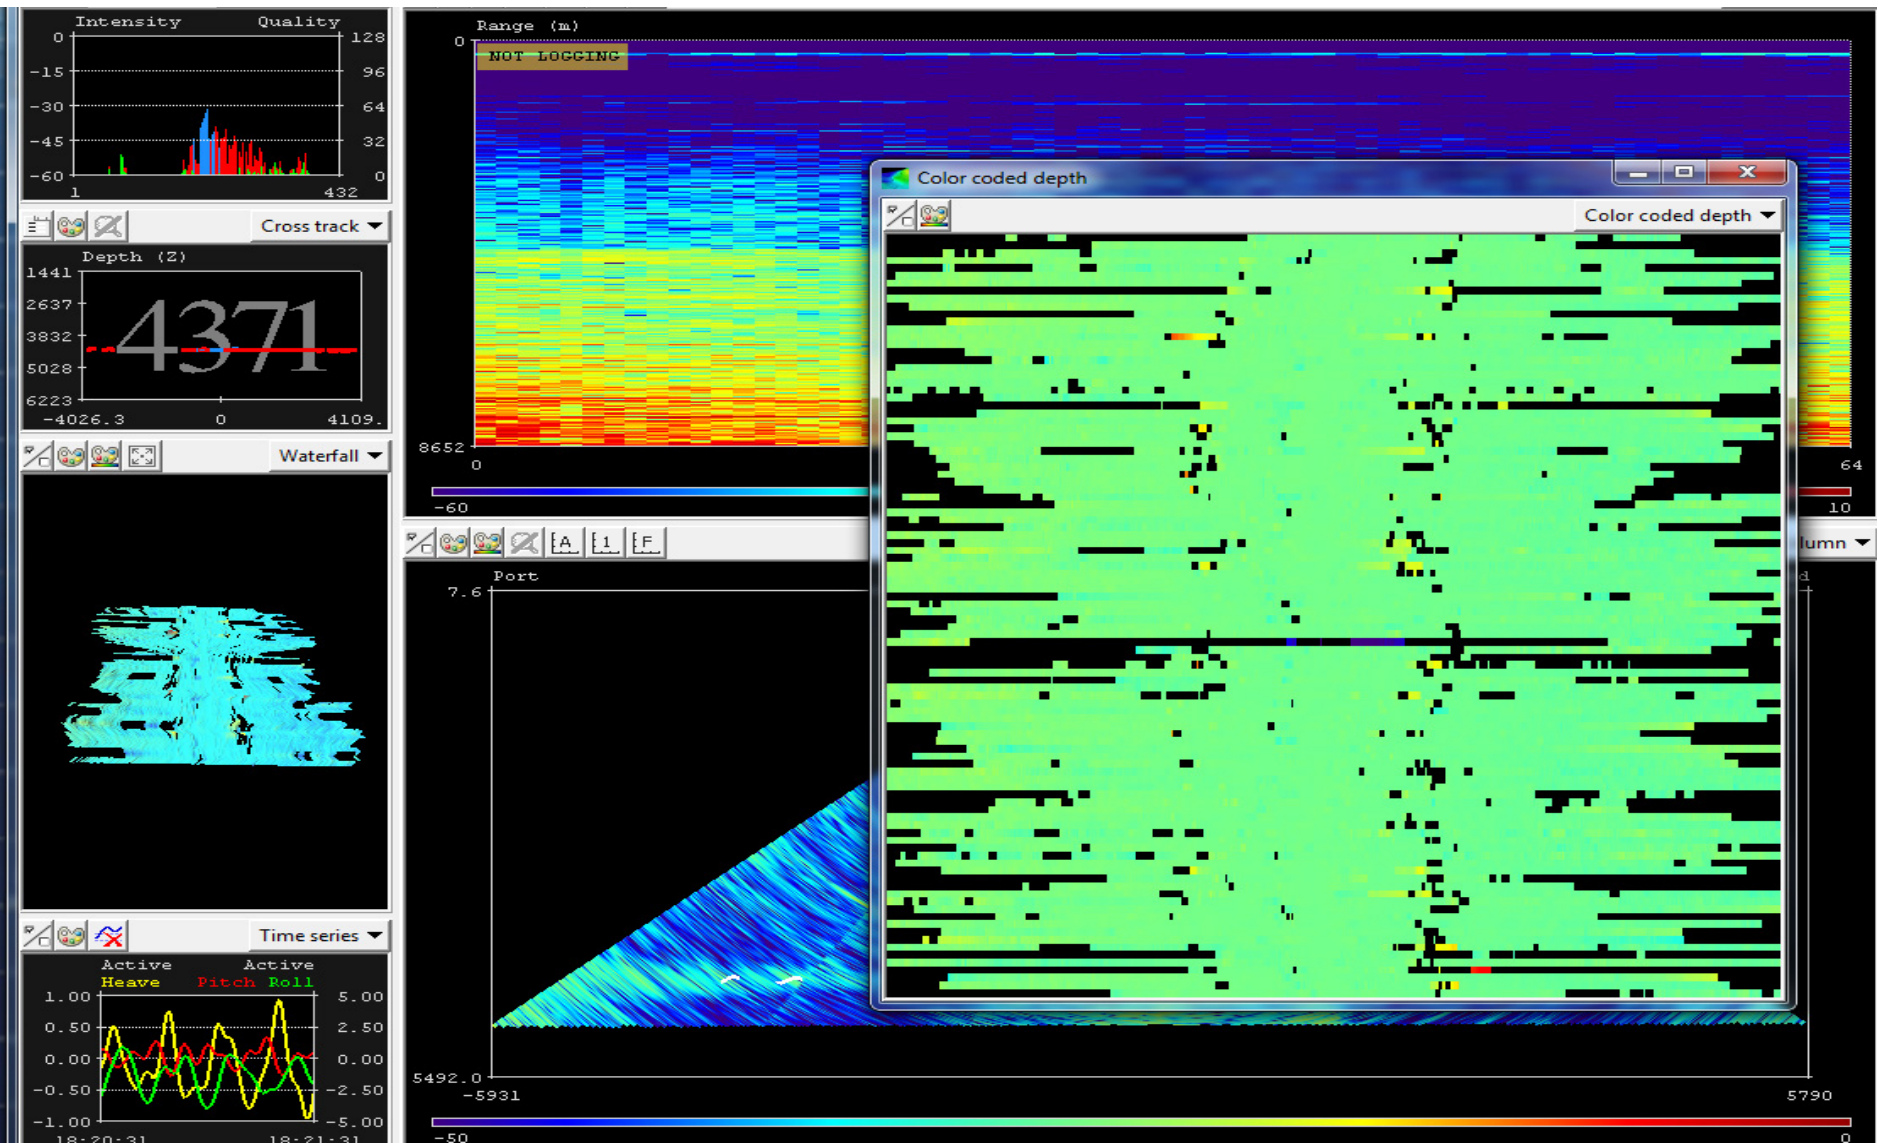
PALMER BUBBLE IMPACT
