Optimizing Sonar Performance by Managing Acoustics

November 20, 2014

Marisa Yearta and Timothy Gates

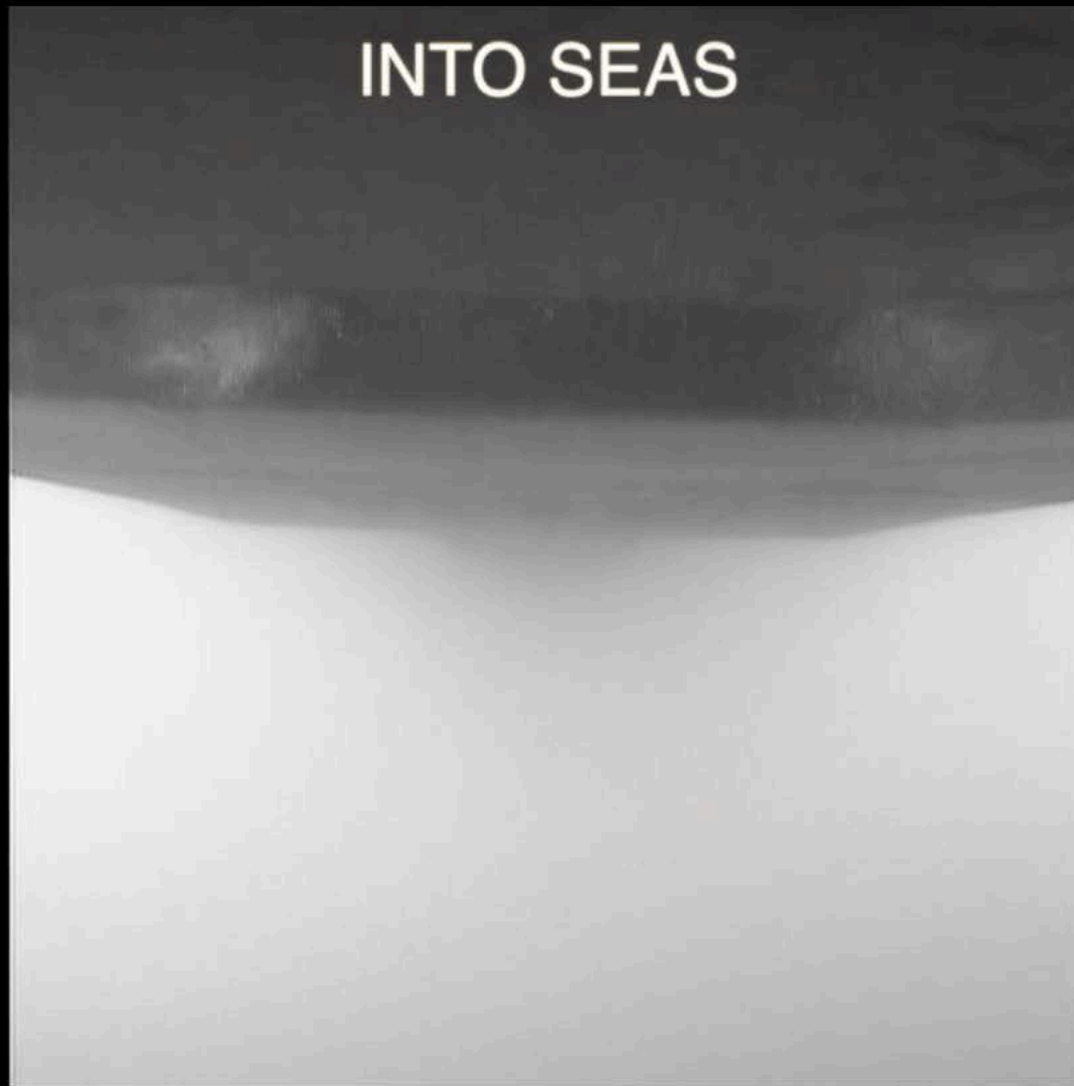
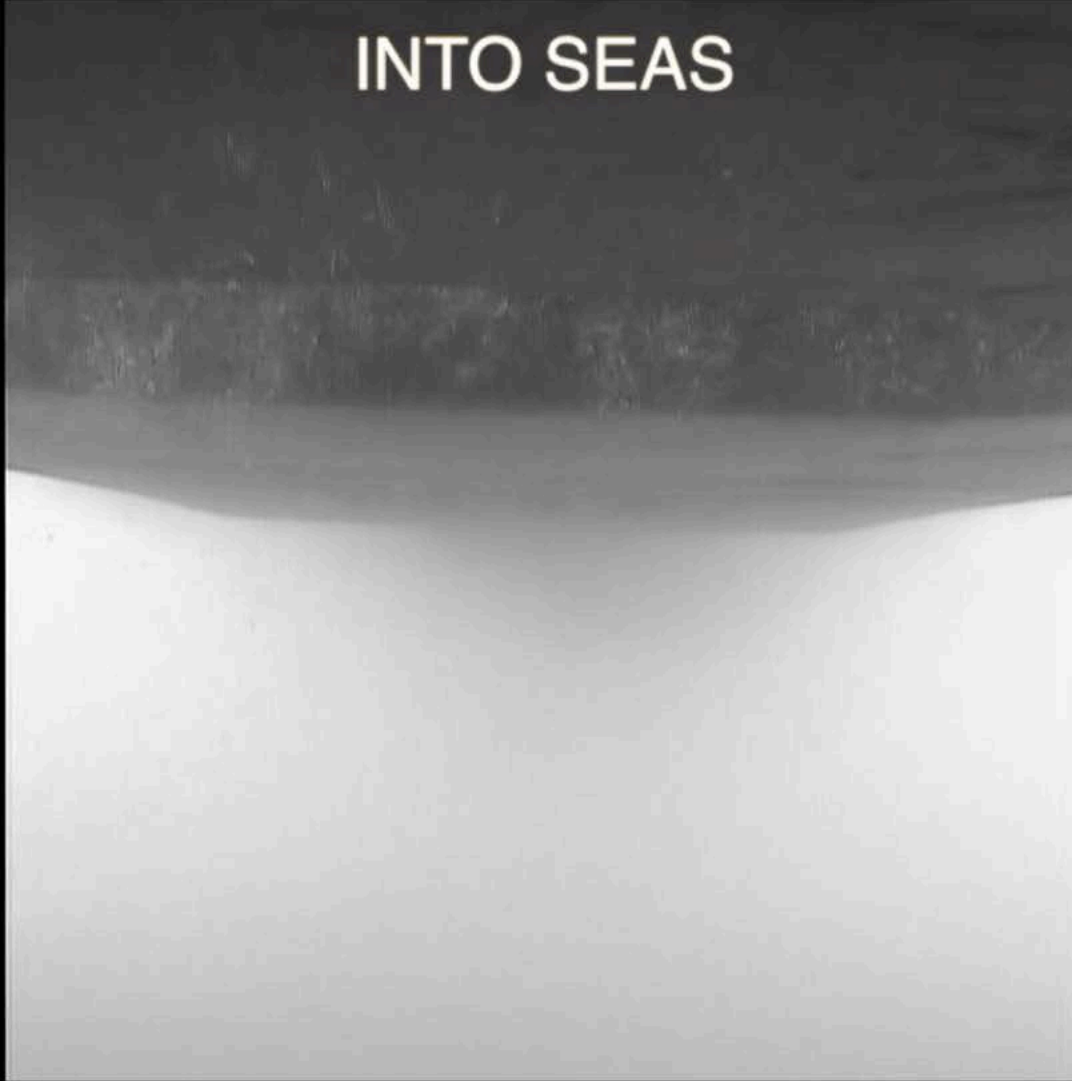
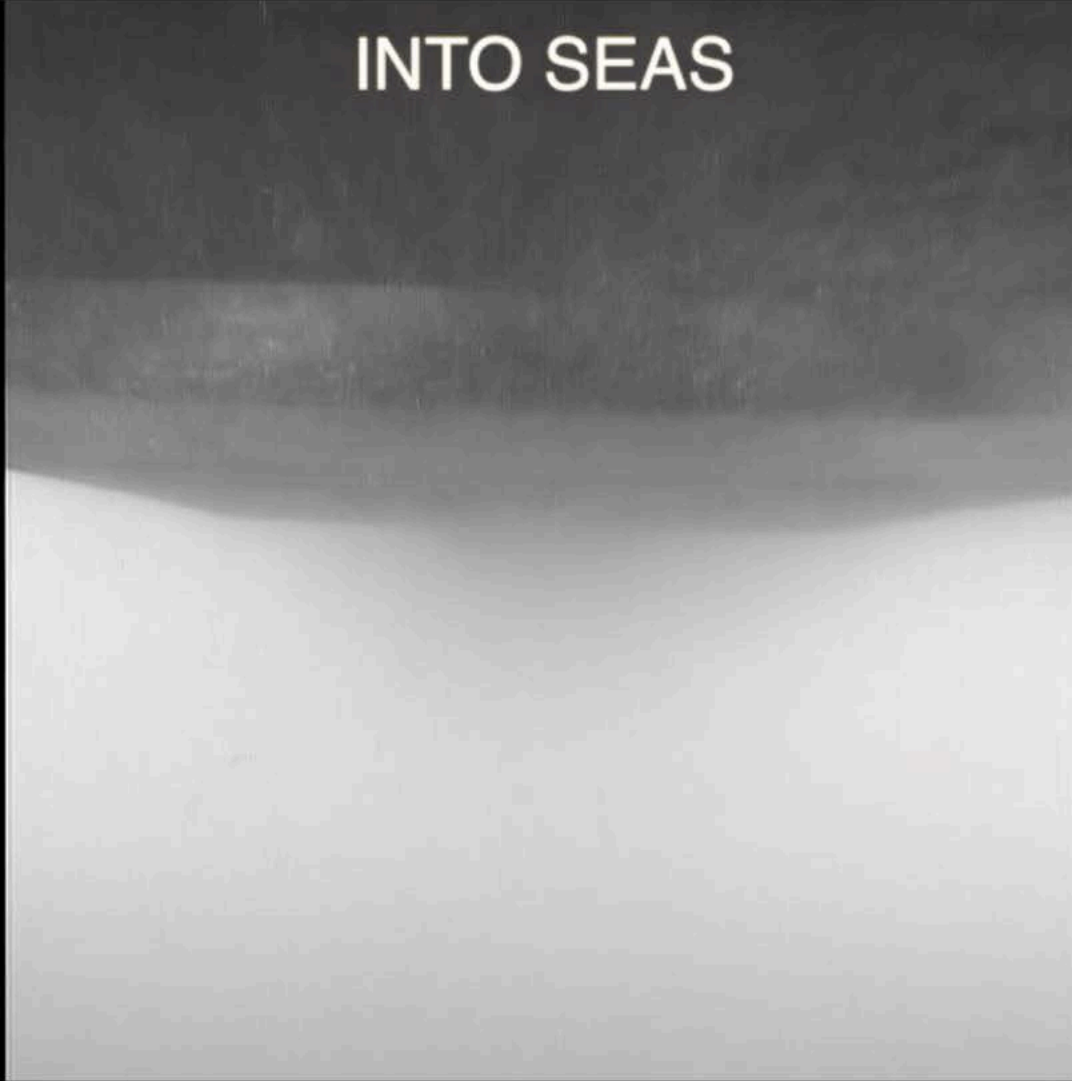
- Testing conducted on Irish ship R/V CELTIC EXPLORER discovered major bubble sweepdown events
- CELTIC EXPLORER has a bulbous bow (bubble generator)

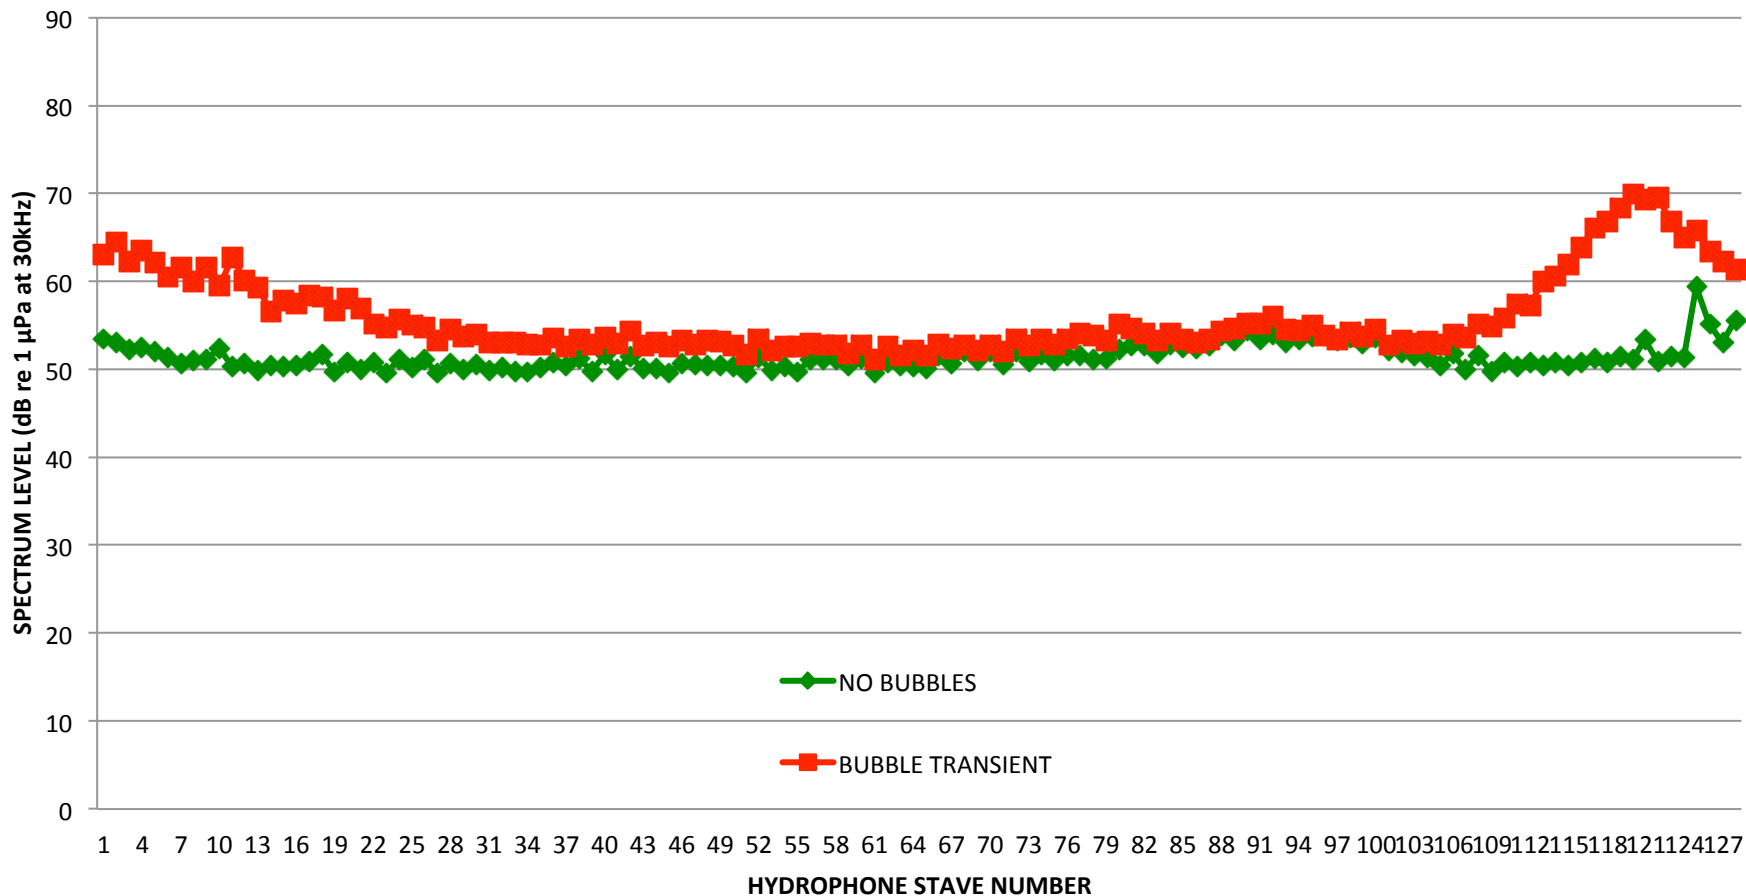
- SIKULIAQ has a lot of bubbles
- SIKULIAQ has an icebreaker hull (notorious for bubbles)
- Bubbles were present at all headings

**R/V SIKULIAQ
EM 302 RX NOISE LEVEL
7.5 KTS - 60% THRUST - INTO SEAS
12 SEPTEMBER 2014**

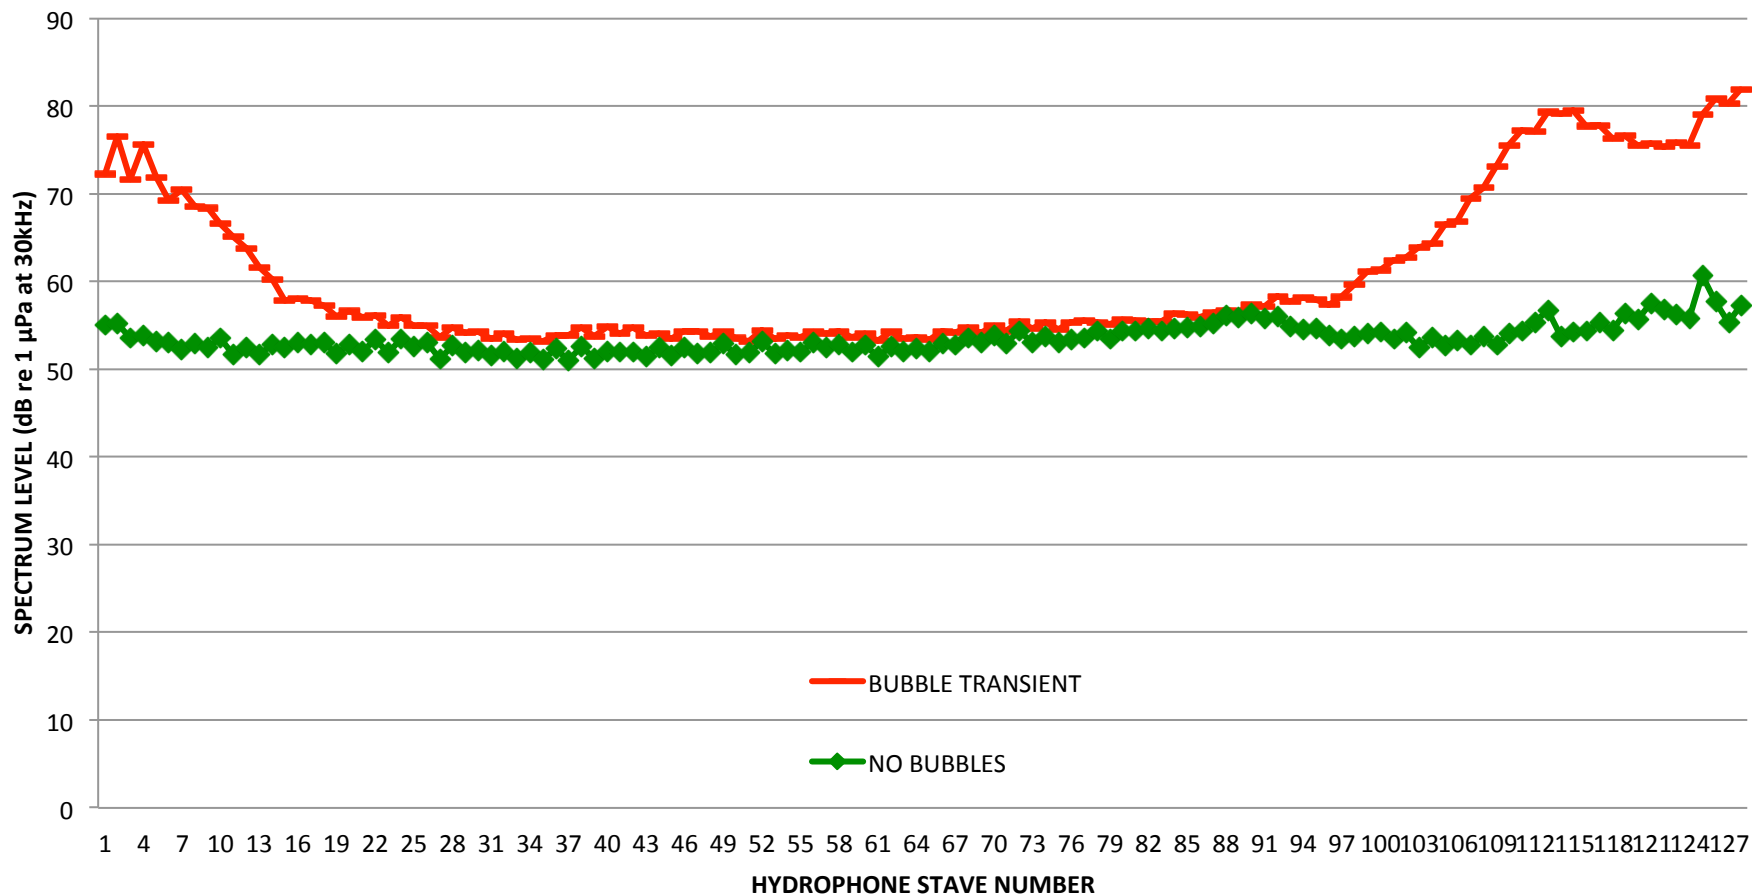
**R/V SIKULIAQ
EM 302 RX NOISE LEVEL
8.4 KTS - 60% THRUST - FOLLOWING SEAS
12 SEPTEMBER 2014**

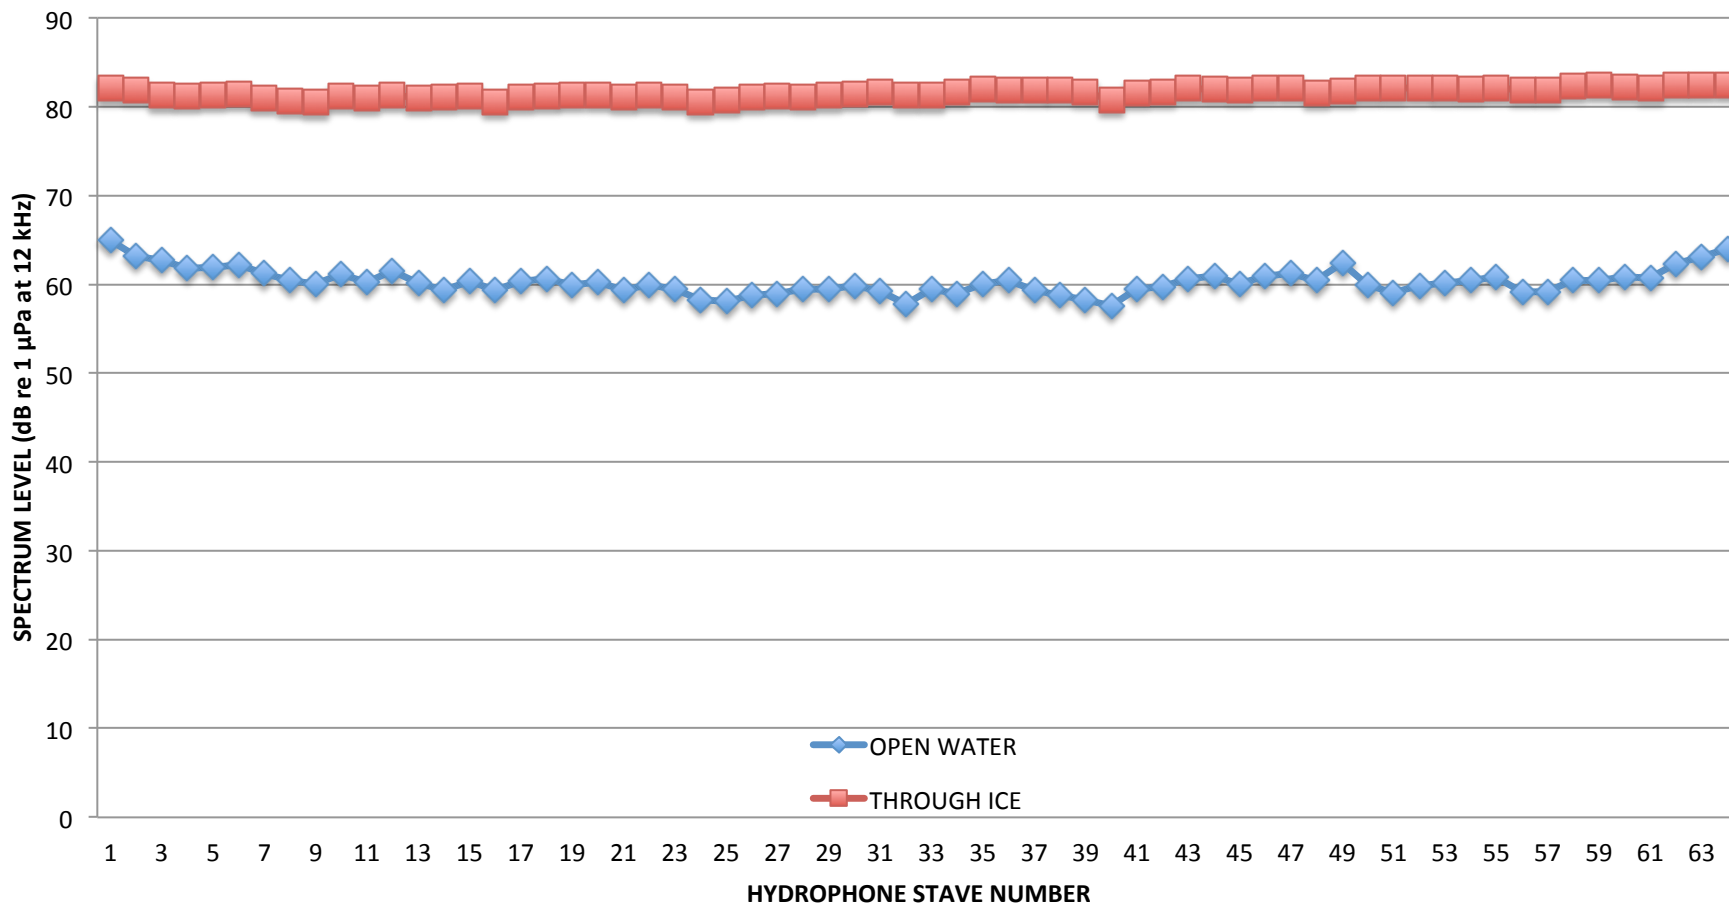
USCGC HEALY (WAGB-20)
EM 122 RX NOISE LEVEL
80 RPM - OPEN WATER VS THROUGH THIN ICE
17 AUGUST 2014

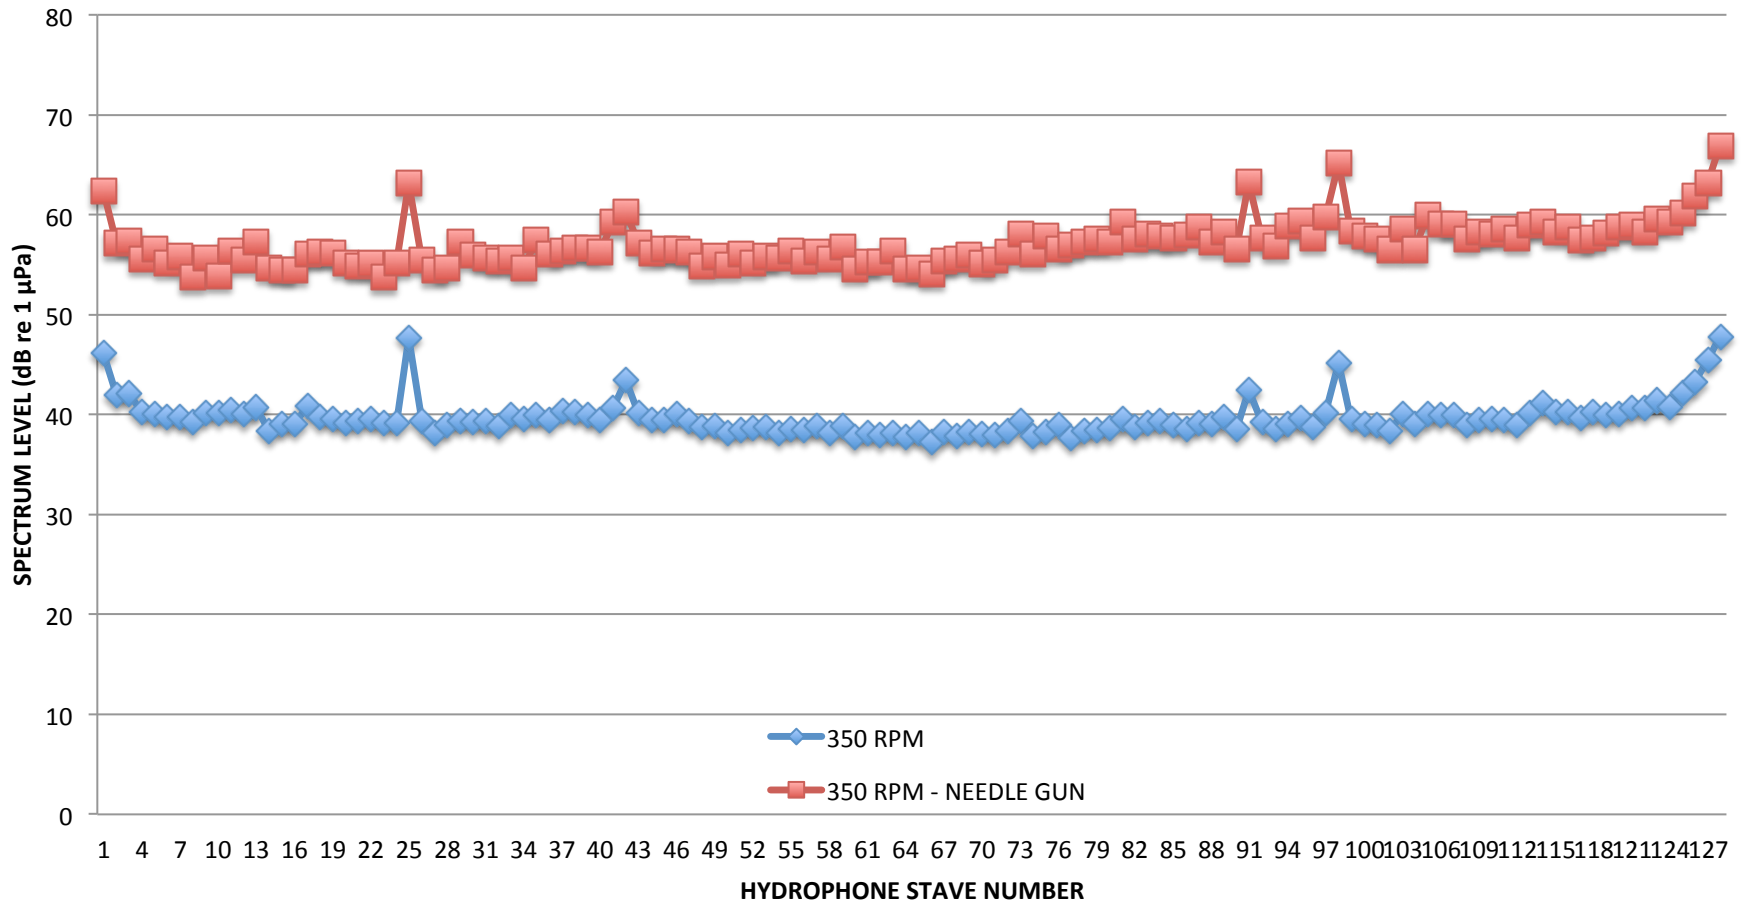
- During an acoustic evaluation of USNS BRUCE C. HEEZEN (T-AGS 64) high levels were noted in the RX Noise Level
- Acoustic monitoring system aurally revealed the presence of deck work being done
- A ship inspection discovered needle gun activity being conducted

USNS BRUCE C. HEEZEN (T-AGS 64)
EM 122 RX NOISE LEVEL
NEEDLE GUN OPERATION IMPACT
14 APRIL 2014

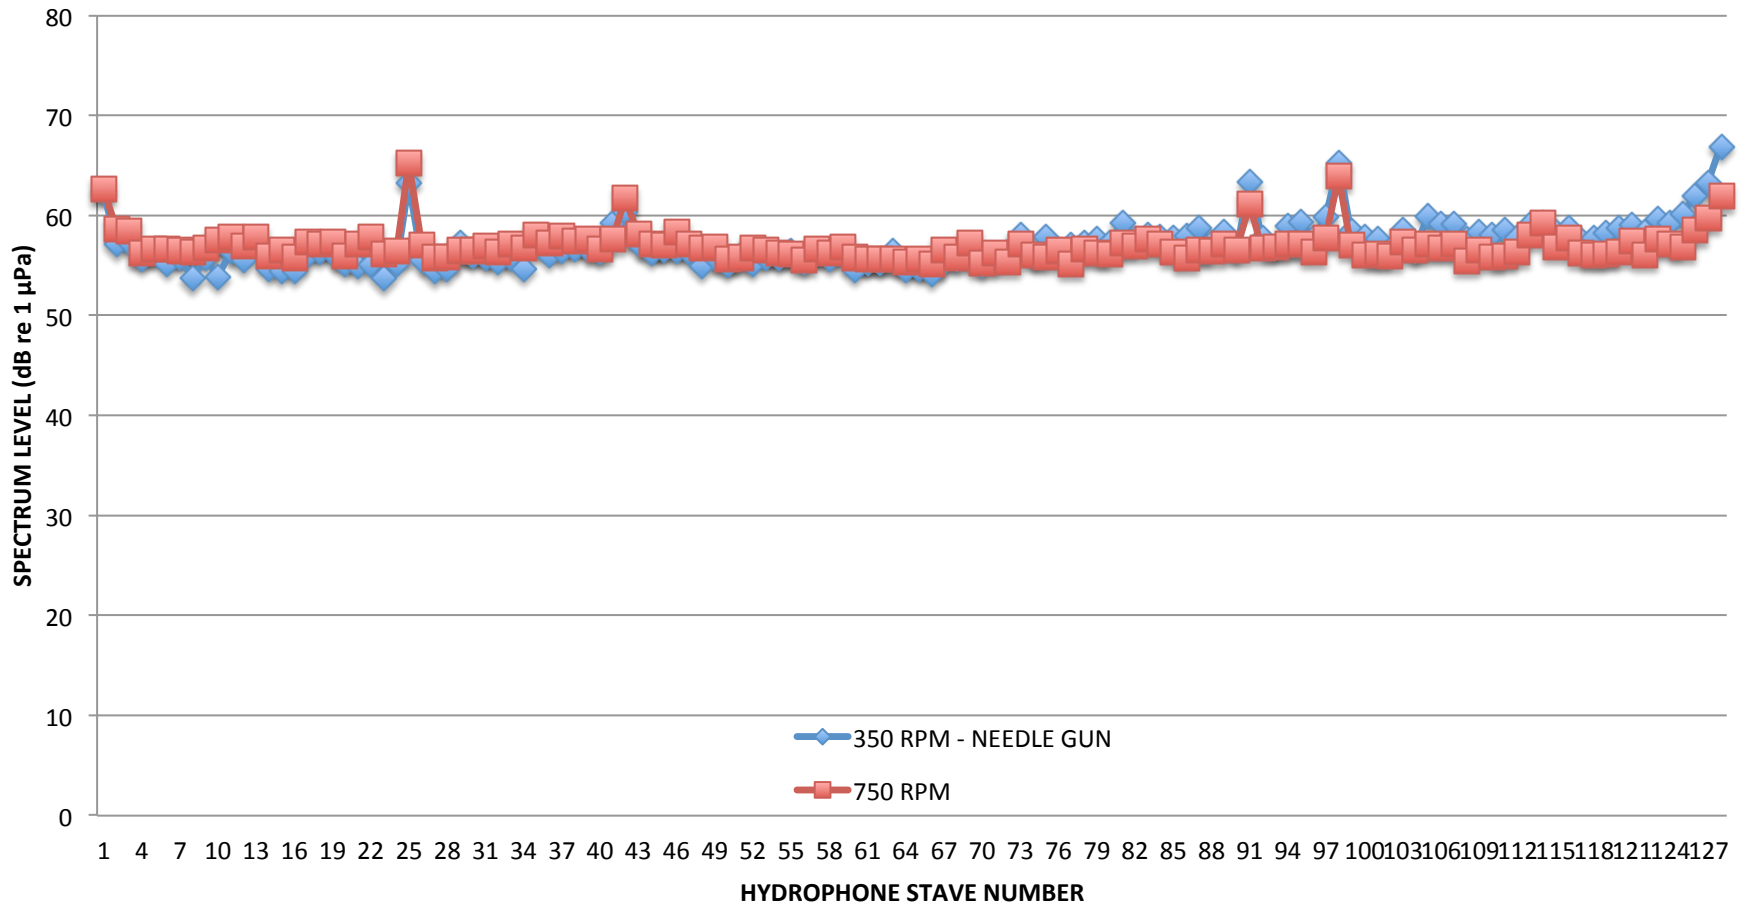
USNS BRUCE C. HEEZEN (T-AGS 64)
EM 122 RX NOISE LEVEL
NEEDLE GUN OPERATION IMPACT
14 APRIL 2014

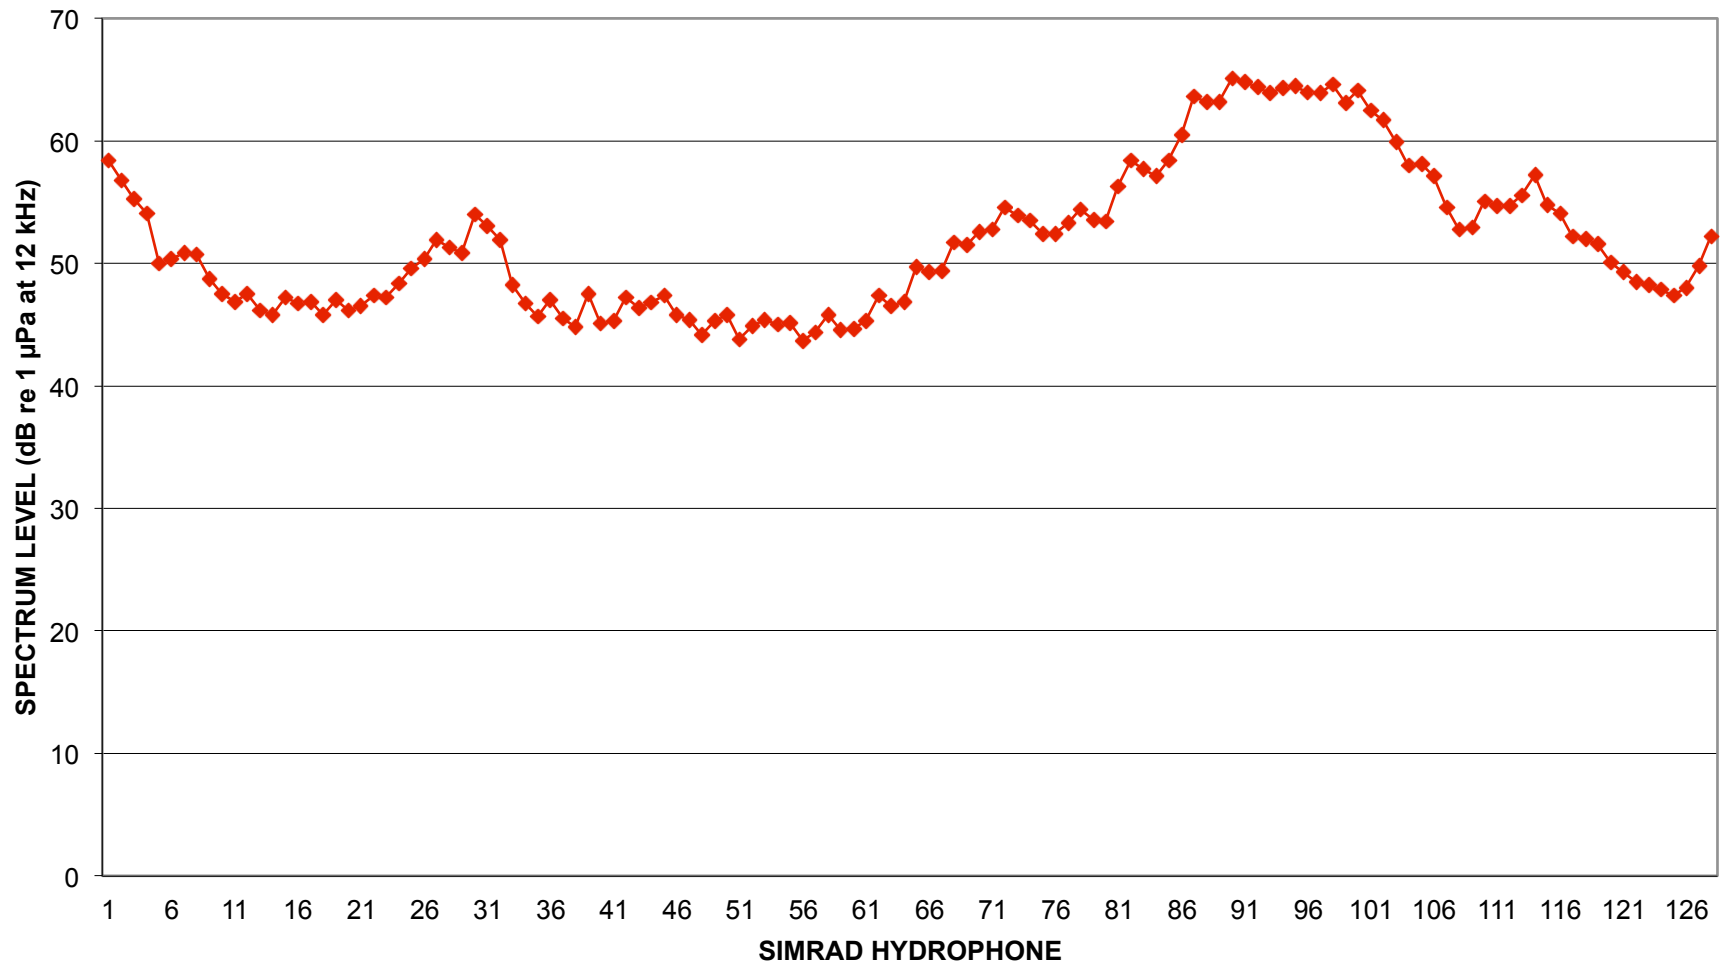
USNS MARY SEARS (T-AGS 65)
RX NOISE LEVEL
TRANSIENT NOISE

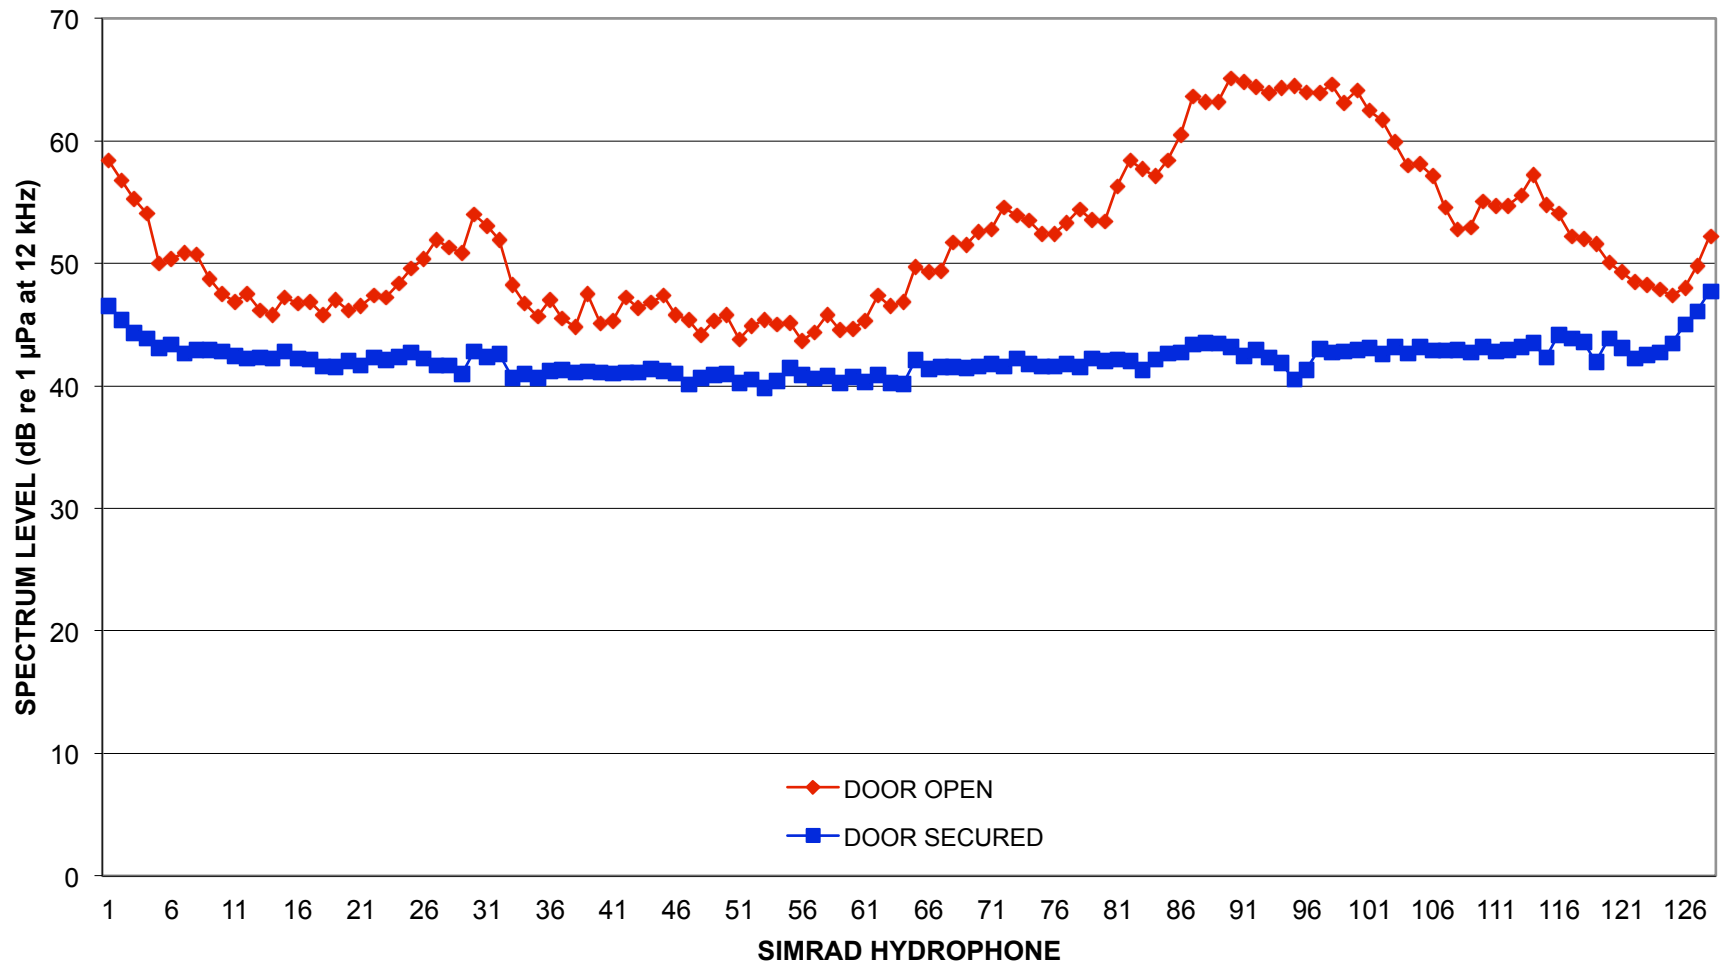
USNS MARY SEARS (T-AGS 65)
RX NOISE LEVEL
TRANSIENT NOISE
