R/V KILO MOANA (AGOR 26)

ACOUSTIC TRIAL RESULTS

Tim Gates – tim@gatesacoustics.com
Marisa Yeara – marisa@gatesacoustics.com
AUGUST 2015

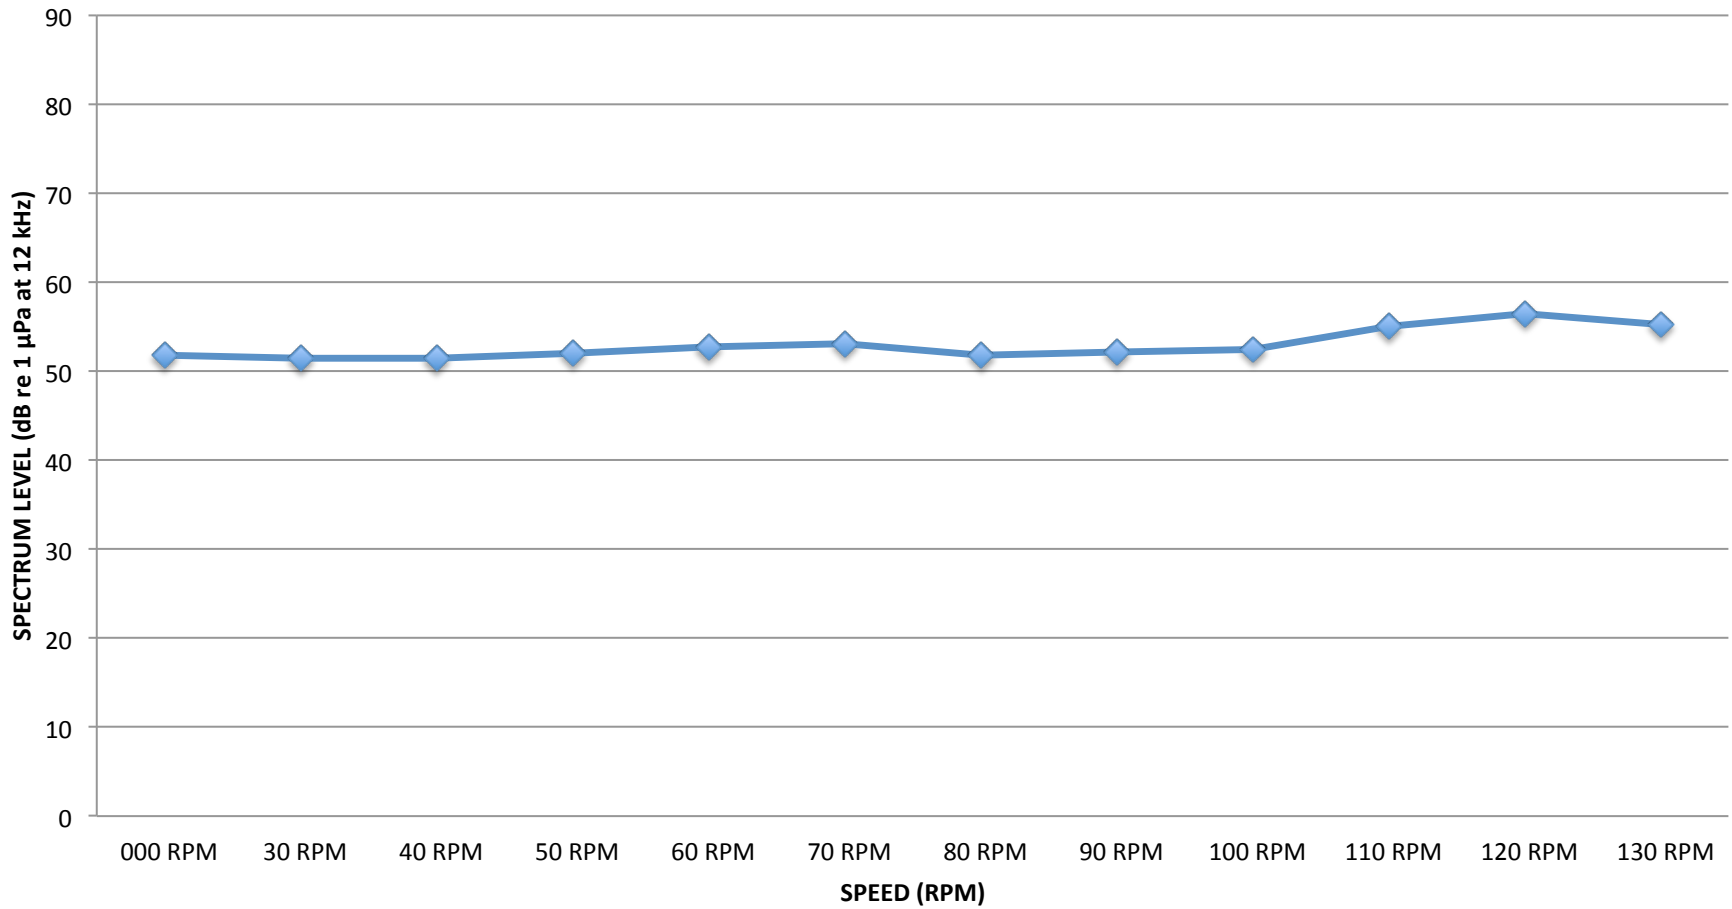
FIGURE 1

As part of the acoustic test, data was acquired from the Built In Self Test (BIST) RX NOISE LEVEL routine of the EM 122 bathymetric sonar. The data was collected during all tested run conditions. An average of 20 samples was used to make the averages, which will be presented in this report. Figure 1 presents an overall average of all sonar elements at each speed in level versus speed format. The data contained in this figure starts out relatively high with levels over 50 dB and gradually rises as vessel speed increases. These levels are considered unacceptable and the majority of the at-sea test was spent attempting to determine the cause of this situation. Figure 2 compares this data with that obtained during several earlier acoustic tests. It is clear that data acquired in 2010 and 2012 is significantly quieter than any data obtained in 2015. The level increases were noted by University of Hawaii personnel during the April 2015 at-sea measurements. It was discovered that newly configured diesel engine mounts were improperly installed and that problem was corrected prior to additional measurements

**R/V KILO MOANA
EM 122 RX NOISE LEVEL
SPEED VERSUS 12 kHz LEVEL
9 AUGUST 2015**

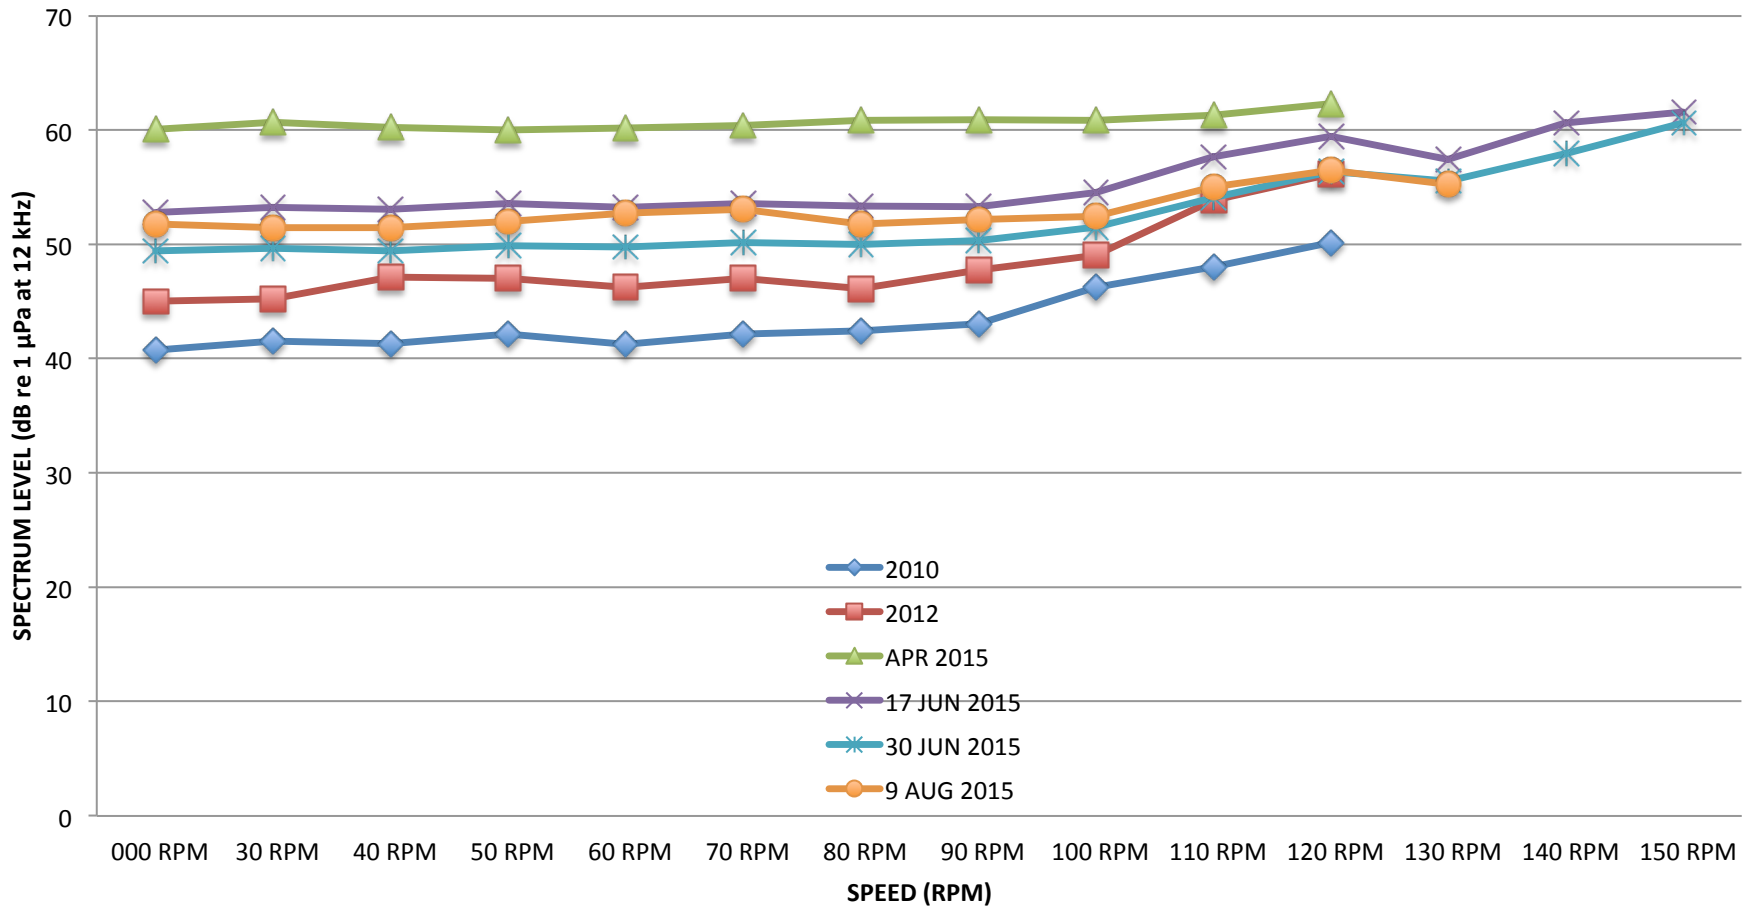
FIGURE 2

made in June 2015. The June and August data are similar and it was decided to immediately enter into diagnostic test conditions to troubleshoot the cause of this problem.

**R/V KILO MOANA
EM 122 RX NOISE LEVEL
SPEED VERSUS 12 kHz LEVEL
30 JUNE 2015**

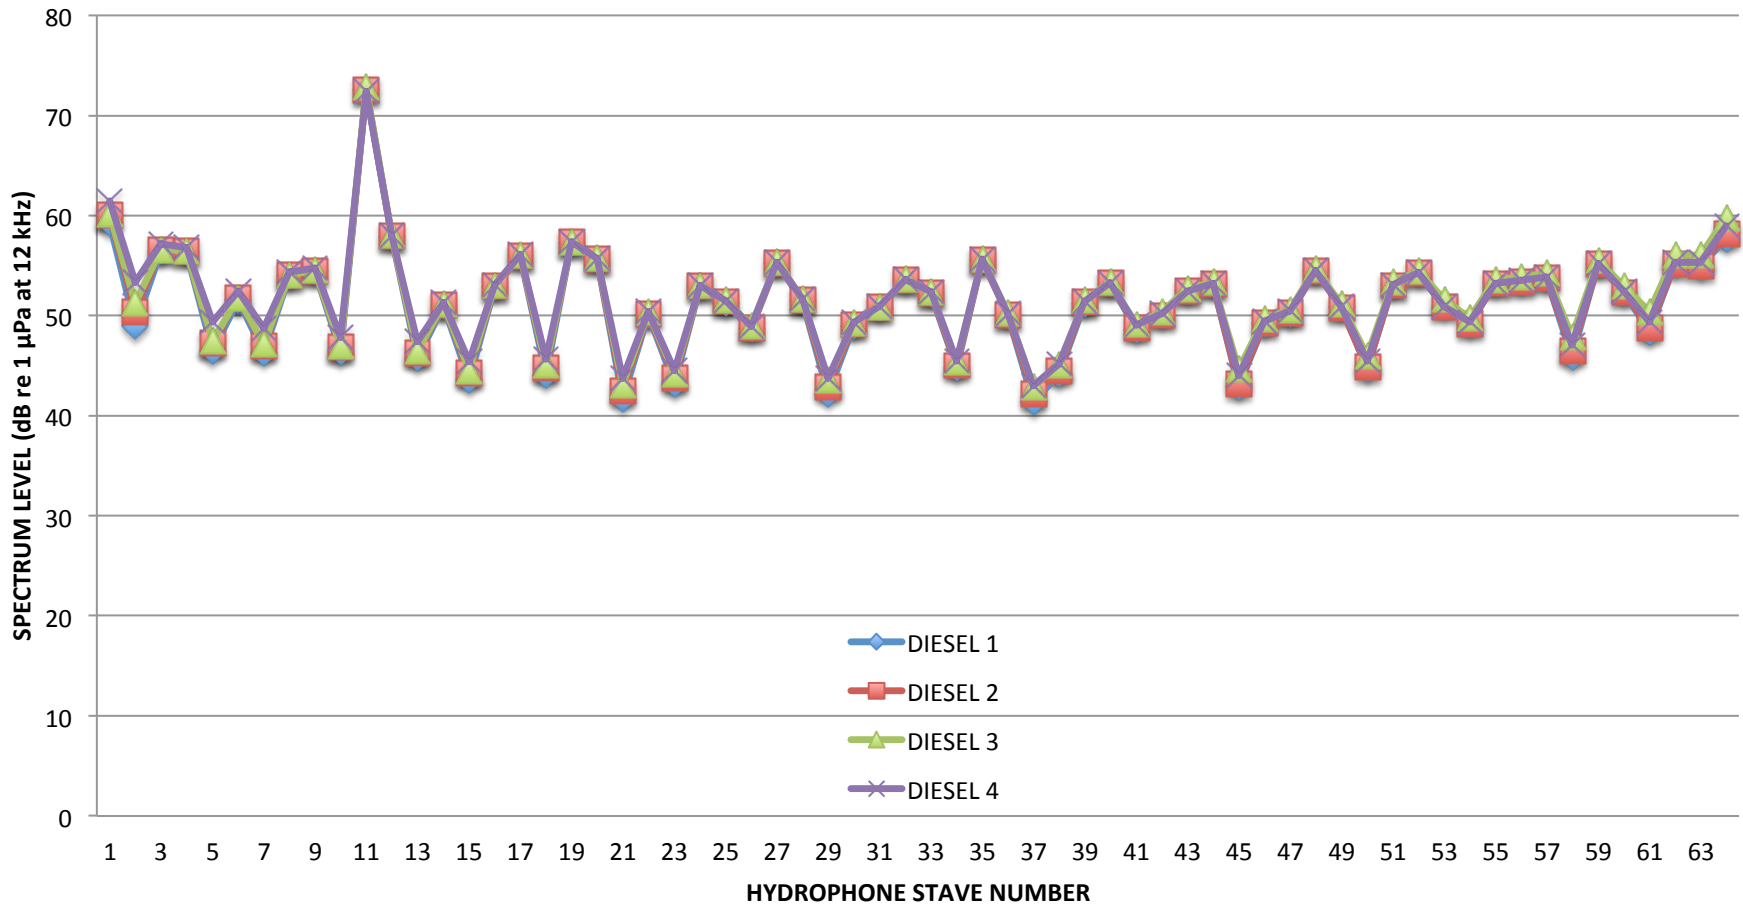
FIGURE 3

The initial diagnostics were focused on diesel engine noise. Figure 3 presents EM 122 RX NOISE LEVEL BIST data acquired during single engine operation while KILO MOANA was drifting with no propulsion. This figure reveals there are no level differences in sonar data associated with any particular engine line up. Since levels from the port engines (2 and 4) have historically produced significantly higher sonar levels due to their proximity to the sonar receive array, it was immediately suspected the cause of the EM 122 noise was not associated with diesel engine issues. Confirmation of this was obtained by shutting down all of the main diesel engines and powering the ship with the Emergency Diesel Generator (EDG). Figure 4 presents EDG data compared to a typical main engine and this comparison indicates the acoustic issue is still present. A final diagnostic test was conducted by taking KILO MOANA to a "Black Ship" condition, where all vessel machinery was secured and sonar data was acquired using UPS battery power. The Black Ship data is presented in Figure 5 and indicates the noise problem on KILO MOANA is not associated with any shipboard machinery system. This clearly points to the sonar itself as the cause and source of the high noise levels and dictated a different diagnostic path.

**R/V KILO MOANA
EM 122 RX NOISE LEVEL
DIESEL COMPARISON
9 AUGUST 2015**

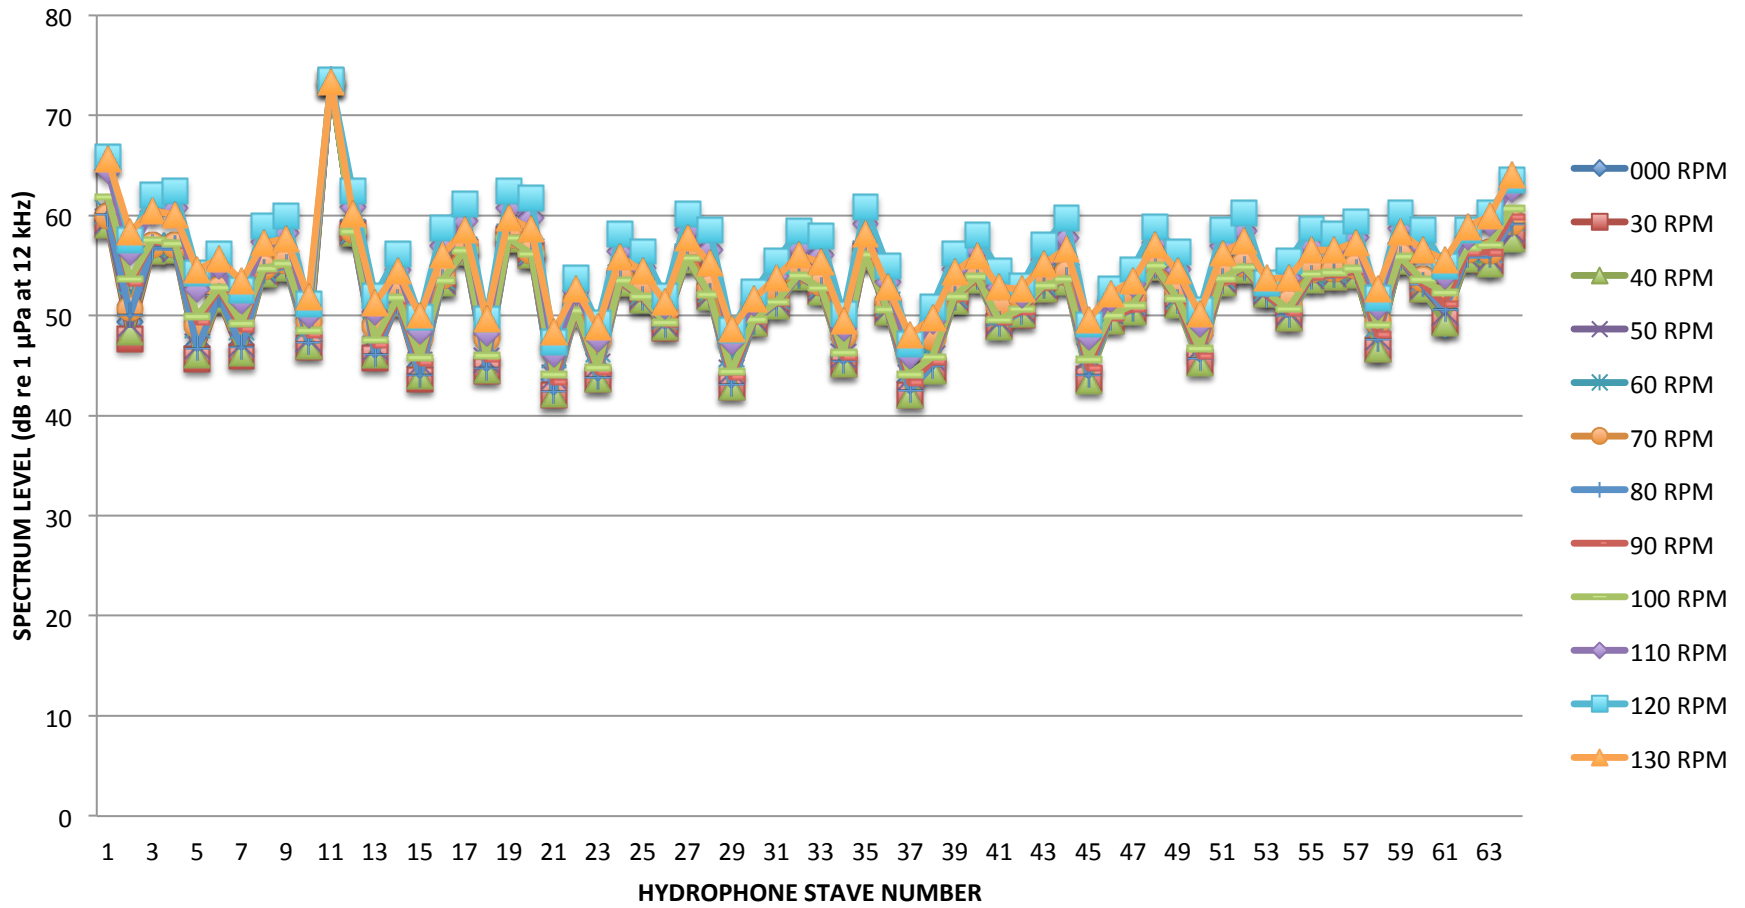
FIGURE 6

Figure 6 presents profiles from the EM 122 RX NOISE LEVEL BIST routine at all speeds tested. This figure indicates there is little speed dependence in sonar data and it also shows a very high noise spike contained in channel 11 of the sonar array. Figure 7 presents the current data with that collected in 2012 at a vessel speed of 0 knots. The large spike is not present in channel 11 of the 2012 data, but another spike is revealed at a different location. At this point, many sonar boards were swapped and different electronic conditions were evaluated. It was discovered the 2 spikes contained in this figure were actually the same channel on their respective boards and it is believed, with a high degree of confidence, the boards had previously been swapped and were actually the same problem. During the swapping of boards, data was acquired and it was discovered that when the board with the problem was not installed, significant changes occurred to all of the sonar data. Figure 8 presents EM 122 data collected with the "problem" preamplifier board removed. It is readily seen from this figure that, not only is the spike gone, but the acoustic levels from sonar hydrophones being processed through other preamplifier board were reduced and smoothed. Figure 9 demonstrates this conclusion more clearly by comparing the two data sets with the board installed and removed. Figure 10 confirms when the preamplifier board is installed in slot 2, the spike shifts to a different location, exactly in the same place as it was in 2012.

**R/V KILO MOANA
EM 122 RX NOISE LEVEL
SPEED SERIES
9 AUGUST 2015**

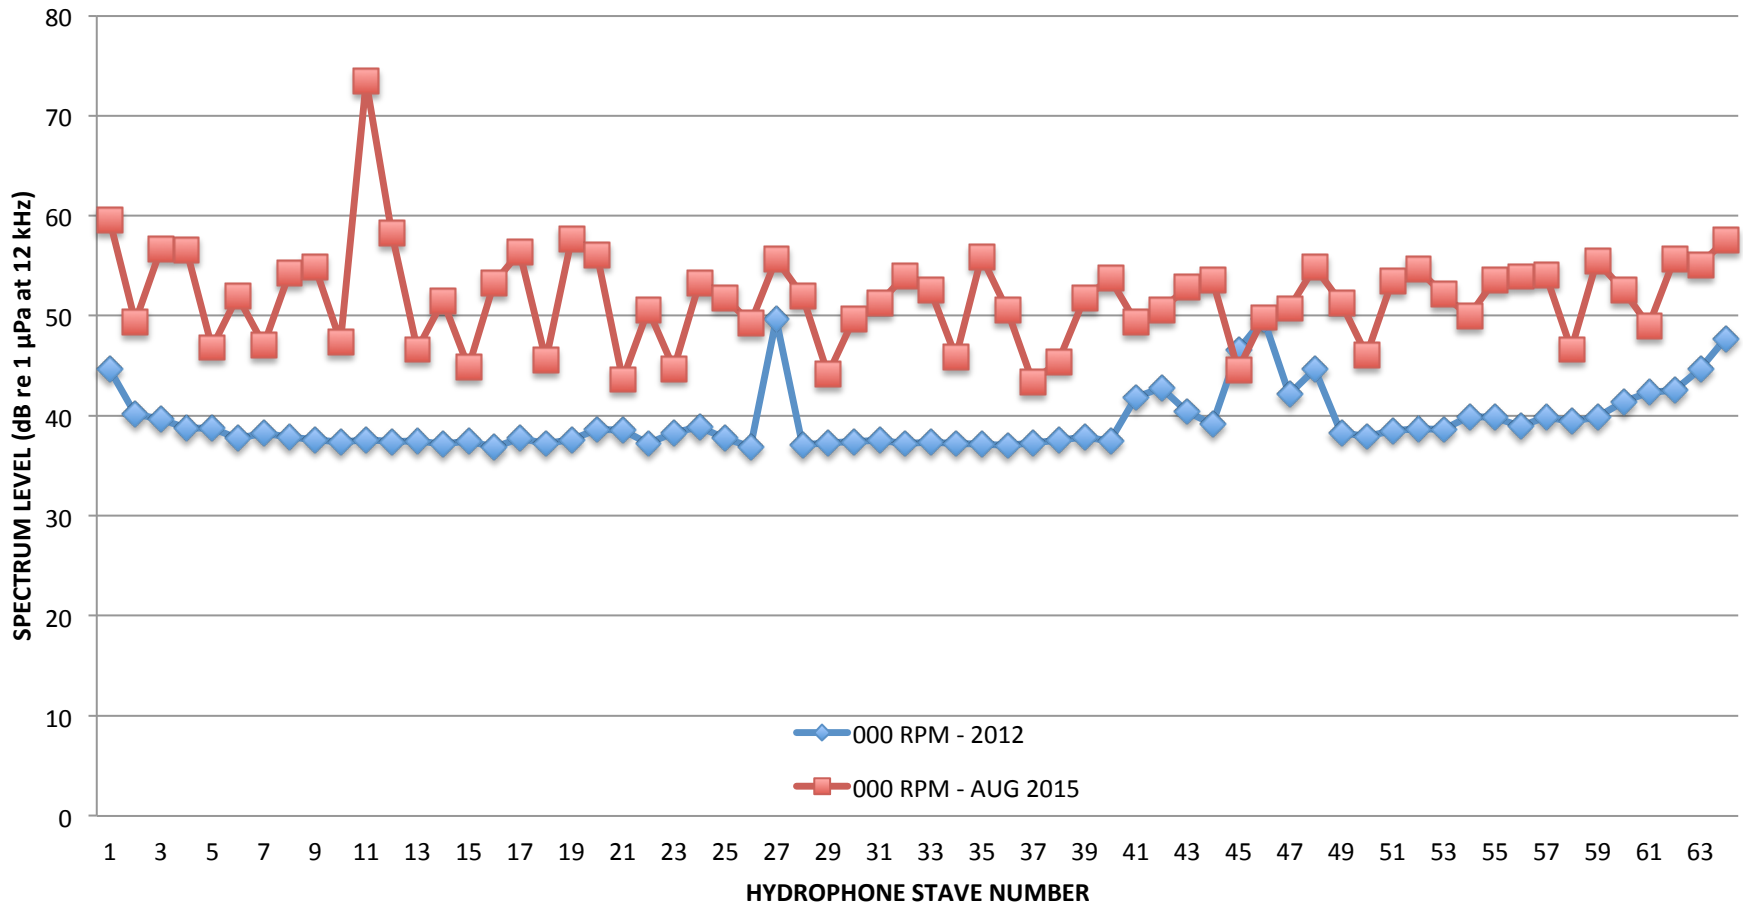
FIGURE 7

**R/V KILO MOANA
EM 122 RX NOISE LEVEL
000 RPM - 0 KTS
JUNE 2012 VS AUGUST 2015**

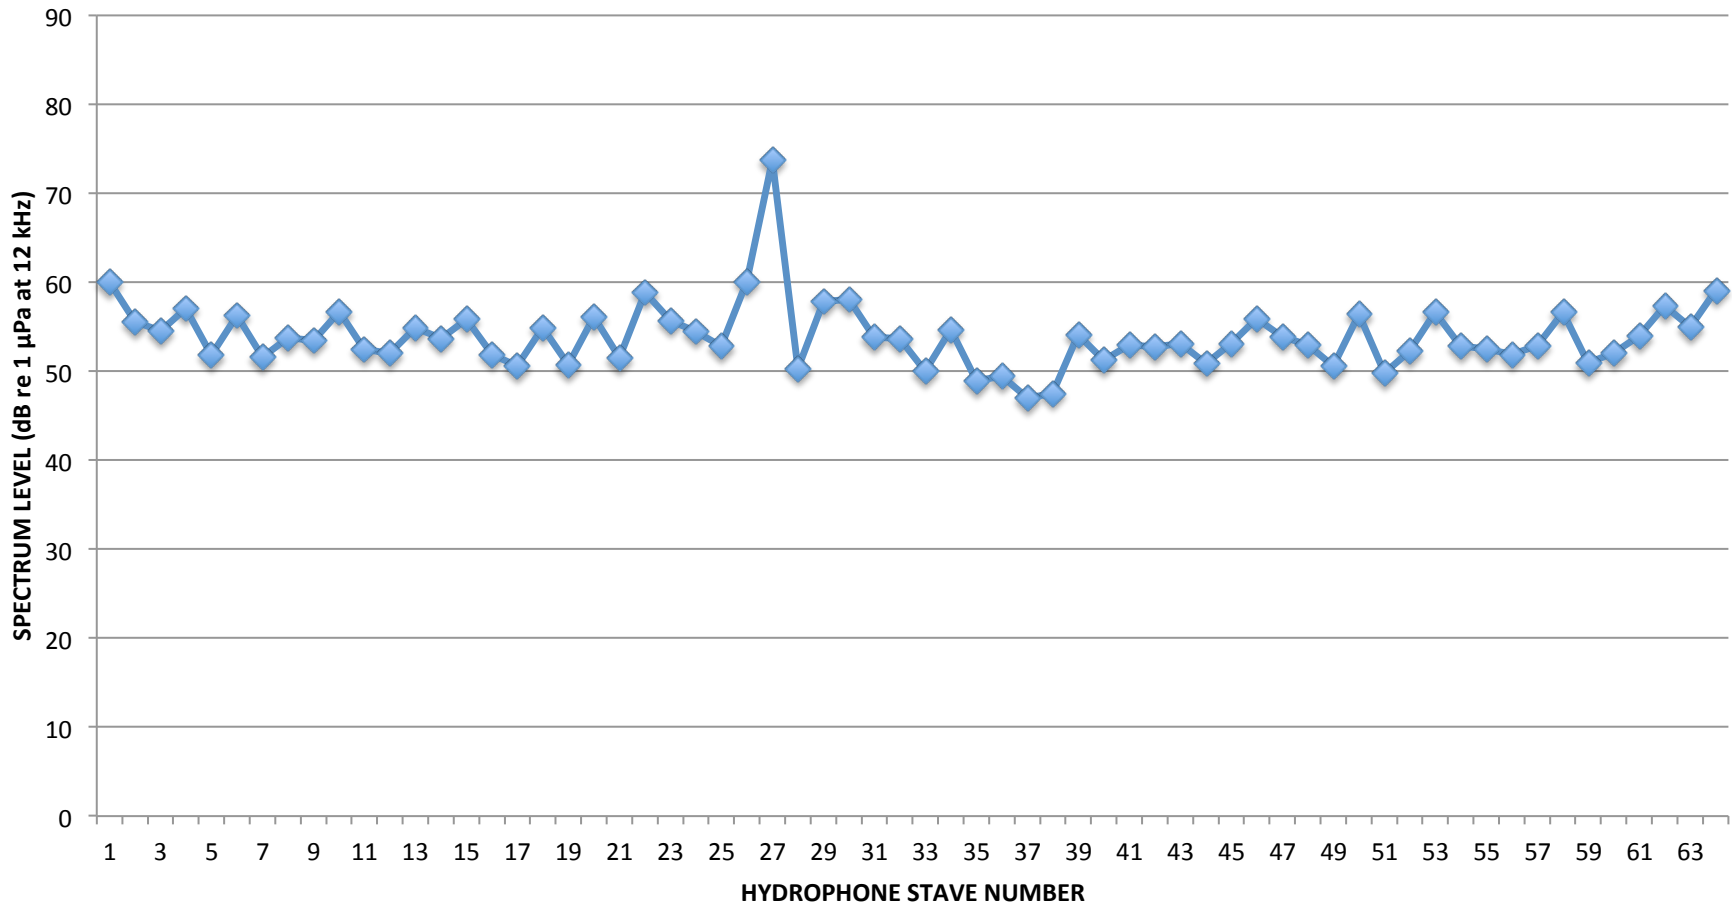
FIGURE 10

**R/V KILO MOANA
EM122 RX NOISE LEVEL
PREAMP BOARD 1 AND 2 SWAPPED - 000 RPM - 0 KTS
9 AUGUST 2015**

1. Replace bad sonar preamplifier board.
2. Ensure all sonar modules are in phase with each other.
3. DOCUMENT all temporary fixes to the sonar so future operations issues are easier to diagnose.
4. Correct rattle in sewage room.
5. Install a permanent acoustic monitoring system to allow for shipboard personnel to listen to reference hydrophone data and to acquire and analyze this data during real time operations.

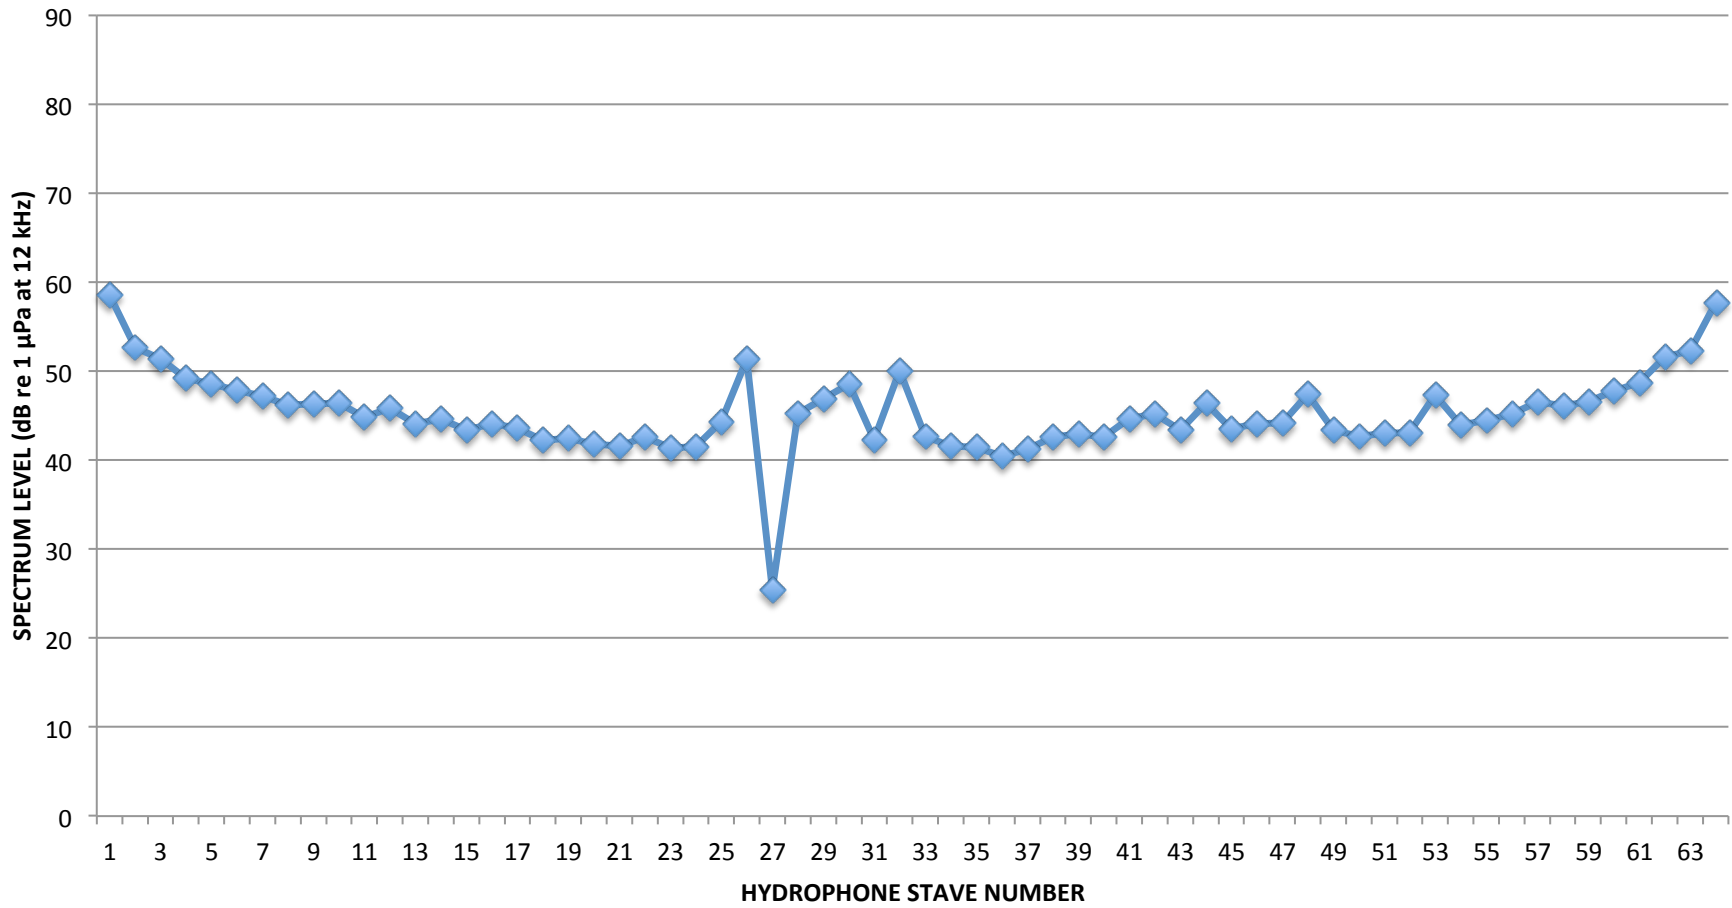
FIGURE 11

There were no spare preamplifier boards available on KILO MOANA, so in an attempt to provide a working solution, University of Hawaii personnel modified the board to effectively eliminate the one bad channel. (This is not a recommended procedure). Figure 11 presents data with the intentional dead channel and demonstrates the data is significantly better across the entire receive array. With this modification in place, a full speed test was conducted as quickly as possible to maximize remaining ship time and that data is presented in a speed versus level format in Figure 12. The data in this figure is significantly lower than that obtained at the beginning of the at-sea test as

**R/V KILO MOANA
EM122 RX NOISE LEVEL
STBD ENGINES - DIW - 000 RPM - 0 KTS
12 AUGUST 2015**

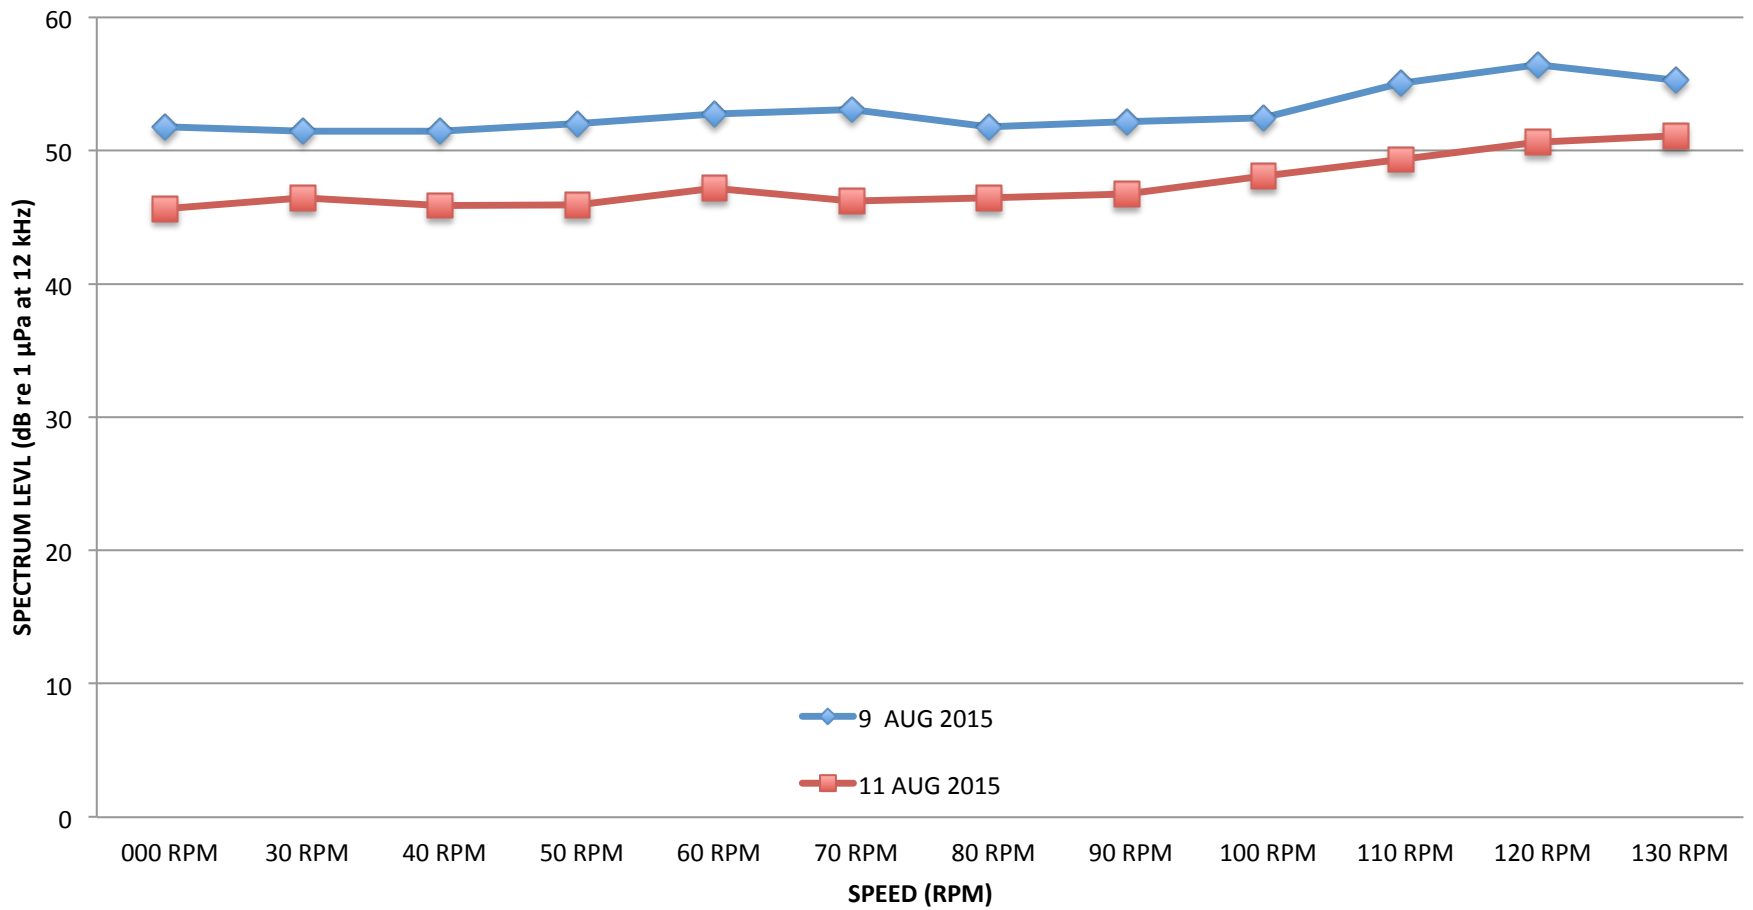
FIGURE 13

shown in Figure 13. Consistent 6 dB level improvements were realized for this test. A final comparison was made with the current configuration to historically good data and that comparison is presented in Figure 14 against 2010 and 2012 data. While the current data is not as good as the 2010 levels, it is as good or better than that measured in 2012.

**R/V KILO MOANA
EM 122 RX NOISE LEVEL
SPEED VERSUS 12 kHz LEVEL
11 AUGUST 2015**

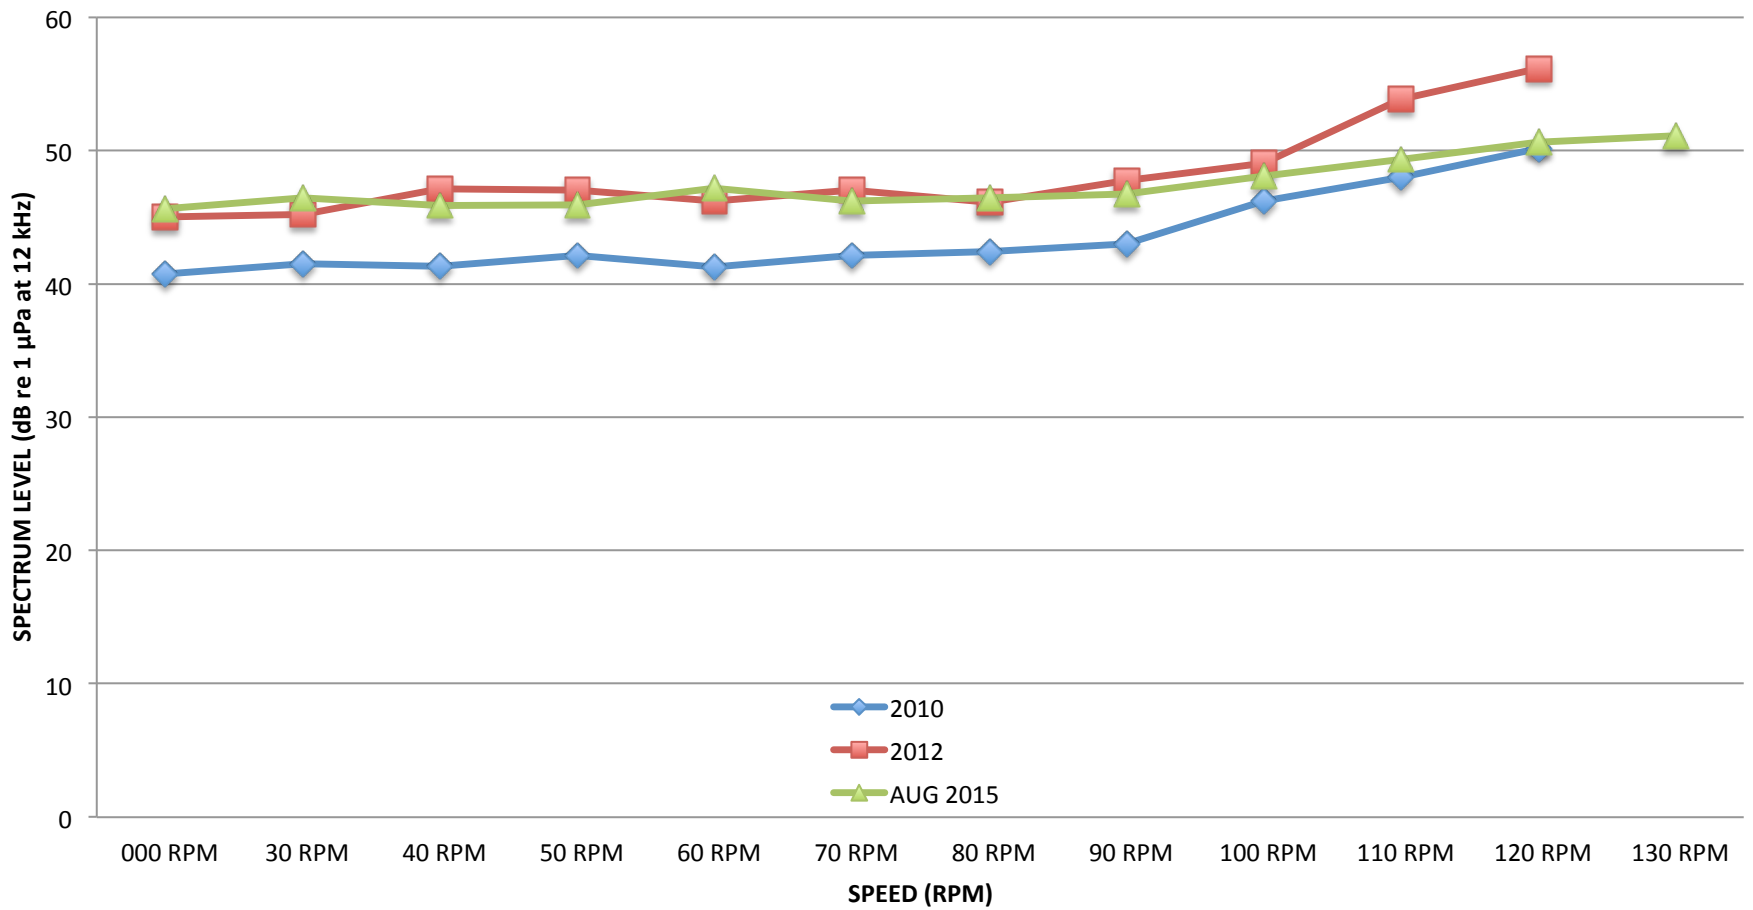
FIGURE 14

**R/V KILO MOANA
EM 122 RX NOISE LEVEL
SPEED VERSUS 12 kHz LEVEL
11 AUGUST 2015**

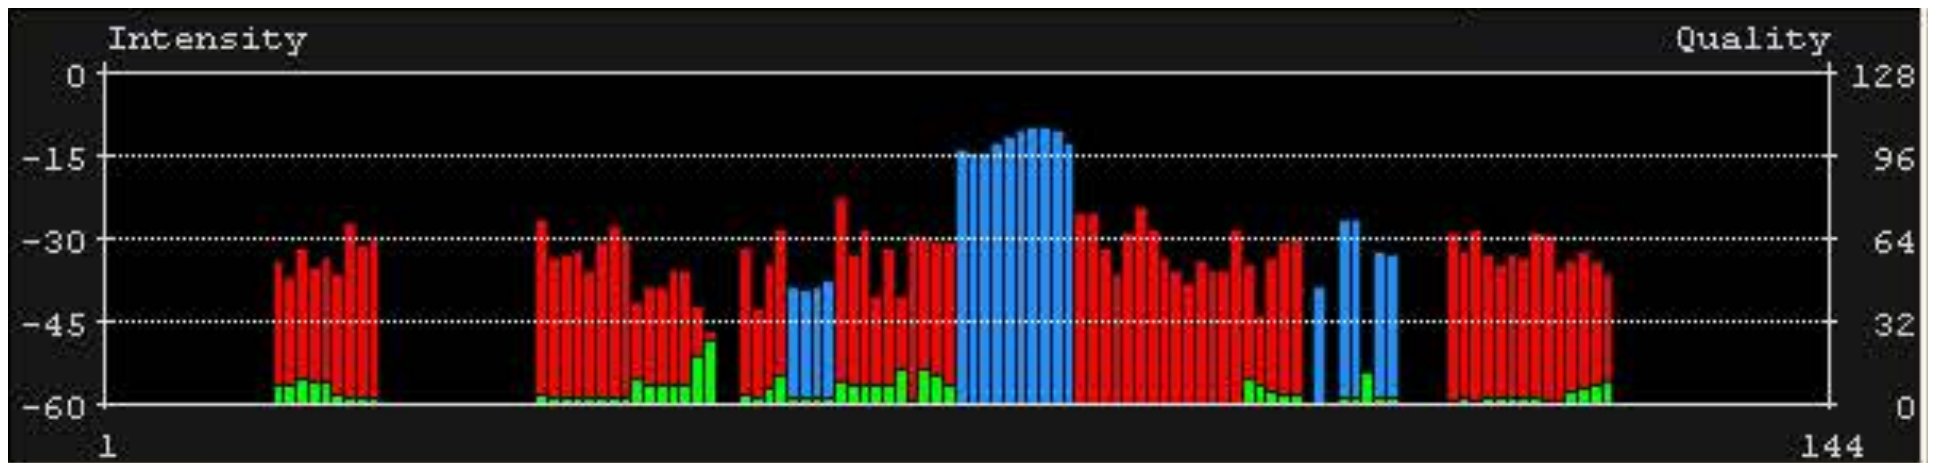
FIGURE 15

An assessment of EM 122 operation was performed by Paul Johnson and Vicki Ferrini from the MAC committee to determine if the reduced noise levels improved operational sonar performance. It was quickly determined the data quality was still very poor and not considered acceptable for future science requirements. While their report will fully document the investigation and findings, it is appropriate to provide a quick snapshot of the diagnostics and results here. Figure 15 presents a screenshot of the Beam Intensity display from the EM 122 during mapping operations. This data was collected while KILO MOANA was drifting to eliminate all vessel noise associated with propulsion and motion. There are significant data drop outs noted in this data and these drop outs were determined to be associated with the reason the sonar was not working properly. Additional diagnostics were focused on these drop outs contained in the Beam Intensity display.

REPRESENTATIVE EXAMPLE OF DATA DROPOUTS

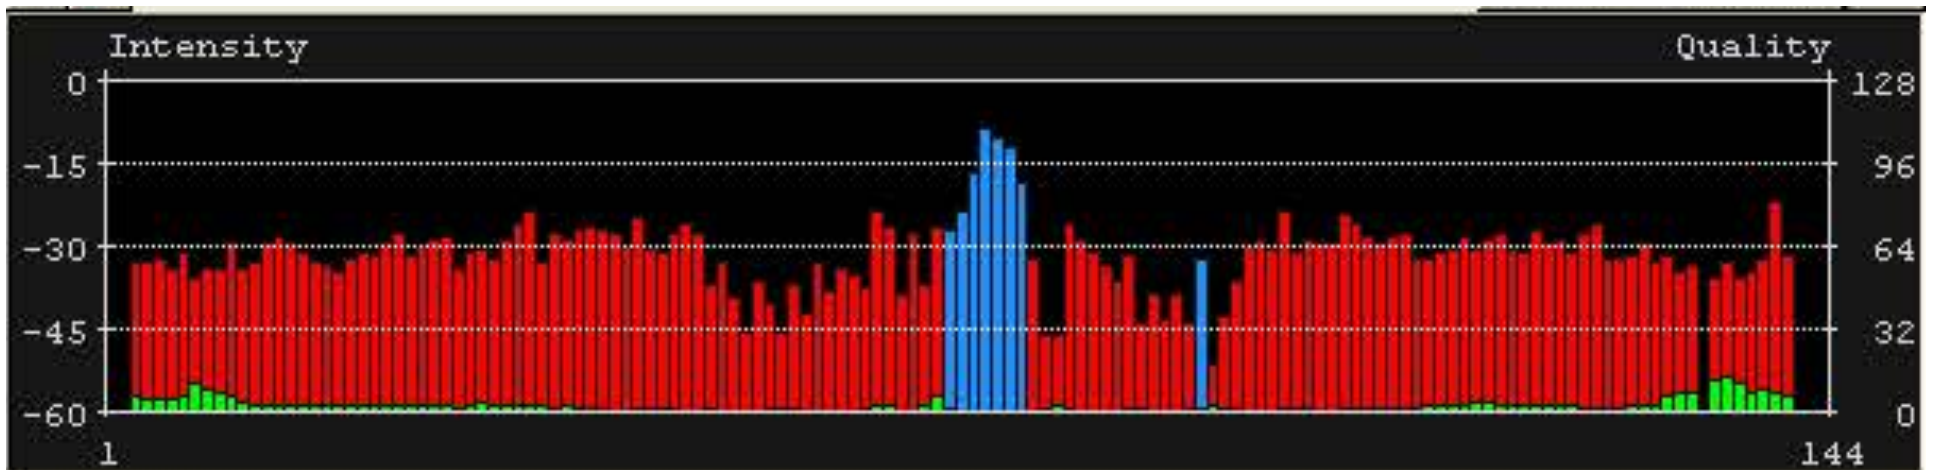
FIGURE 20

Knowing module 6 was causing the problems, an additional test was conducted. The phase reversal cable was attached to module 6 and data was then reassessed with the system in a 1 by 4 degree mode for modules 5, 6, 7 and 8. The Beam Intensity screen shot of this configuration is presented in Figure 20. It is quite clear the problem was removed by reversing the phase of module 6. A final test was conducted by reconfiguring the sonar back to a 1 by 2 degree system with all 8 hydrophone modules, and adding a phase reversal modification to module 6. The Beam Intensity screen shot of this test is presented in Figure 21. The system was completely fixed in this configuration and there was much rejoicing! (A final note regarding module 6: The authors have heard that module 6 was actually not phase reversed, but that 5 of the original modules of KILO MOANA were out of phase. When the initial modification was performed to get the

entire array in phase, it caused the entire array to be 180 degrees out of phase. When a “good” module was subsequently added to the array, it caused significant beam forming issues.).

EM 122 IN 1X4 DEGREE MODE USING MODULES 5, 6, 7 AND 8 WITH MODULE 6 CORRECTED

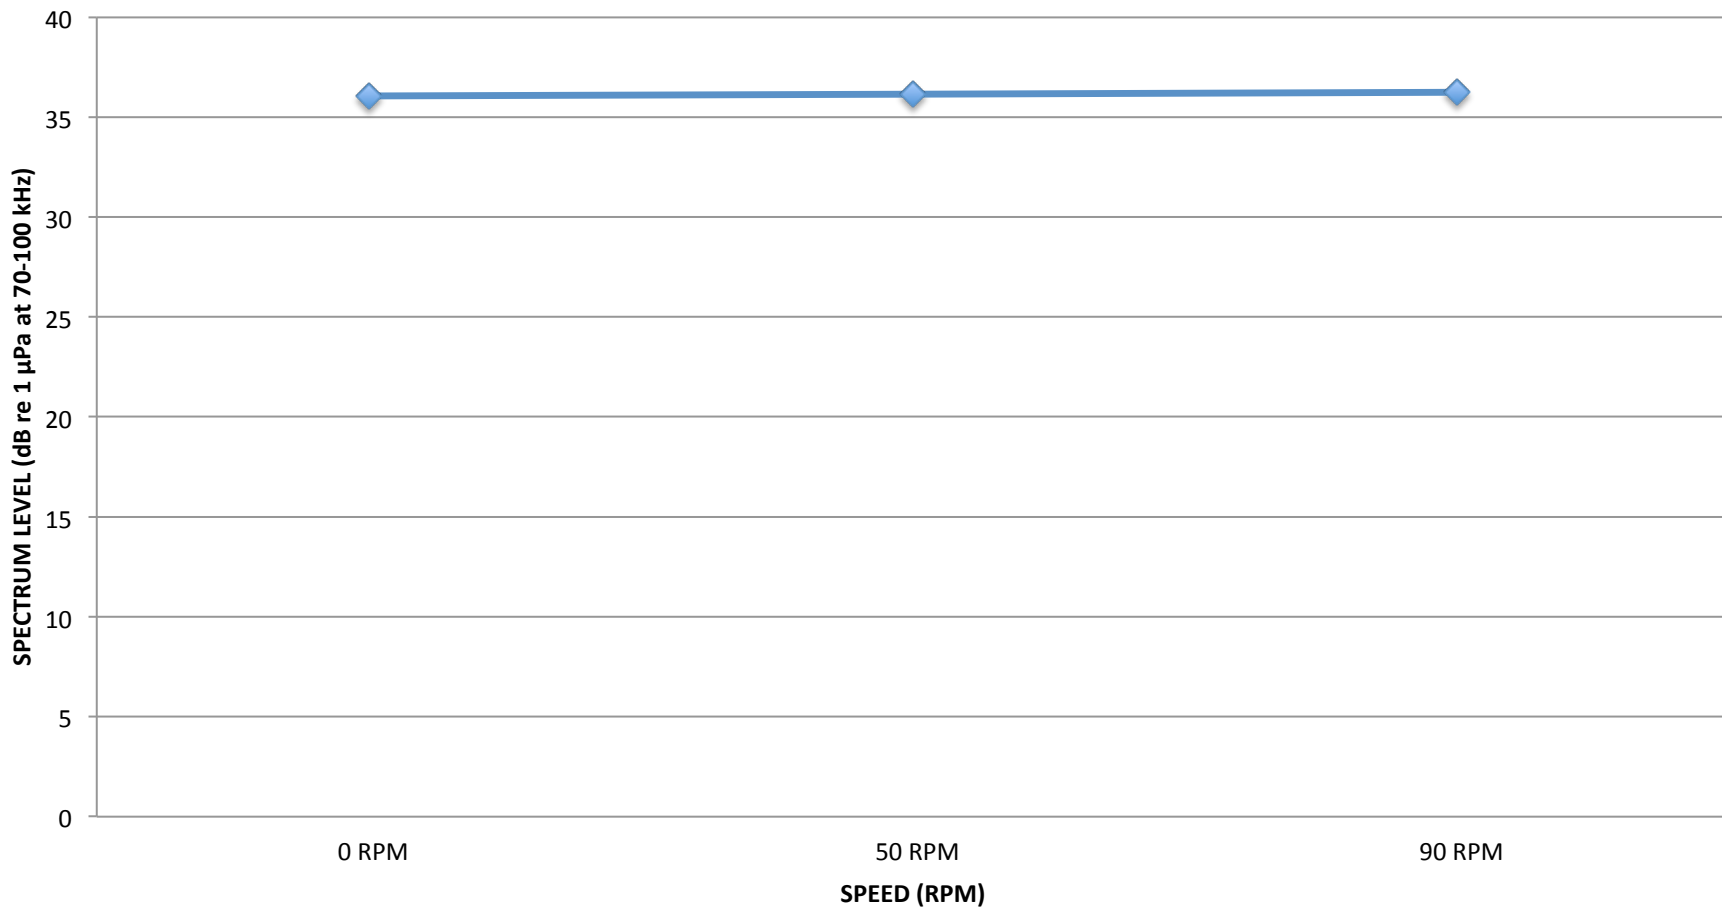
FIGURE 22

During the acoustic test on KILO MOANA, data was also acquired from the internal RX NOISE LEVEL BIST routines of the EM 710 sonar. Due to time constraints, a very limited data set was obtained. Figure 22 presents a speed versus level of this data. As seen on the figure, the levels do not change with increasing vessel speed. Figure 23 presents a speed series format of the acoustic profile across the receive array for this sonar at the three tested speeds. With a few exceptions caused by typical electronic noise, the profile is relatively flat across the EM 710 receive array and no vessel noise impacts were noted. The acoustic levels of the EM 710 are completely controlled by the electronic noise floor of the system components. This is typical of this system and was expected from evaluations on other research vessels. Based on these measurements, it is expected the EM 710 sonar will realize full performance during all KILO MOANA operational conditions. Figures 24 and 25 compare current EM 710 data to that obtained in 2012 to document that no changes or degradations have occurred with this system.

**R/V KILO MOANA
EM 710 RX NOISE LEVEL
SPEED VERSUS 70-100 kHz LEVEL
11 AUGUST 2015**

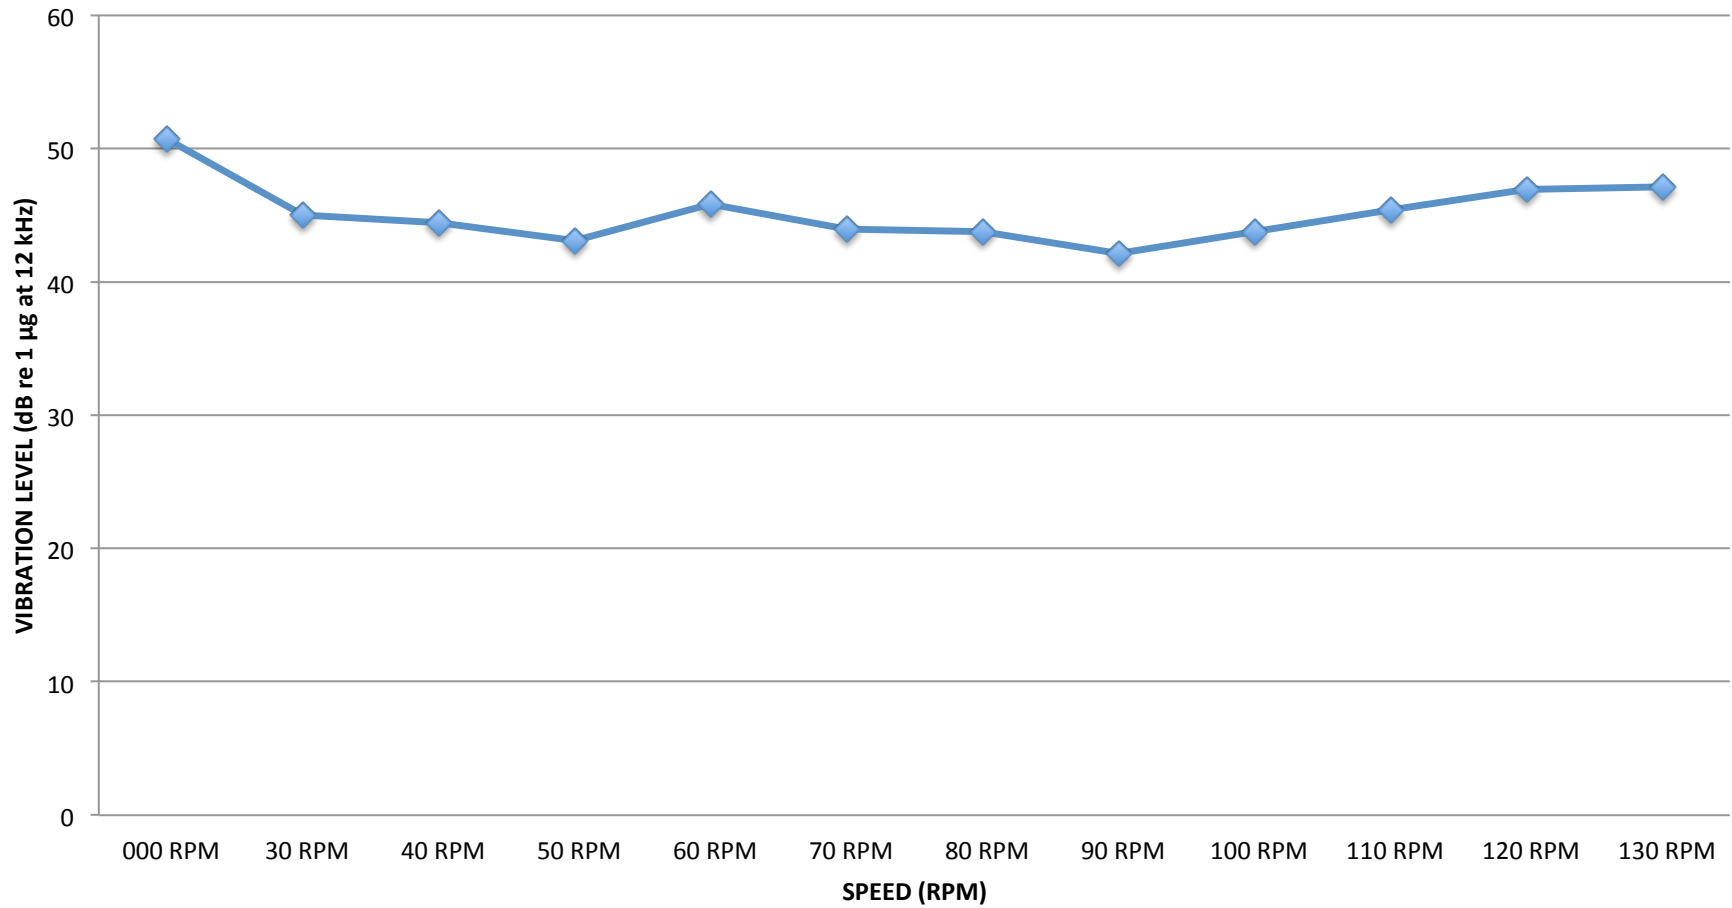
FIGURE 28

Cavitation measurements were made on the propellers of KILO MOANA. The measurements were made using an accelerometer that was mounted on the hull plating located near each propeller. Cavitation performance was evaluated by monitoring the high frequency band levels of this sensor as speed was slowly increased in one-knot increments during straight-line course conditions. Cavitation was determined to incept between ship speeds of 90 and 100 rpm. This is considered good for this ship and is very similar to results obtained on these propellers during acoustic testing at delivery and during 2010 testing. Figures 26 and 27 document propeller vibration levels for the port and starboard propellers, respectively. Figures 28 and 29 present this data in a speed versus level format for a frequency of 12 kHz.

**R/V KILO MOANA
PORT PROPELLER
SPEED VERSUS 12 kHz LEVEL
11 AUGUST 2015**
