R/V KILO MOANA (AGOR 26)

ACOUSTIC TRIAL RESULTS

Tim Gates – tim@gatesacoustics.com
Marisa Yeara – marisa@gatesacoustics.com
AUGUST 2015

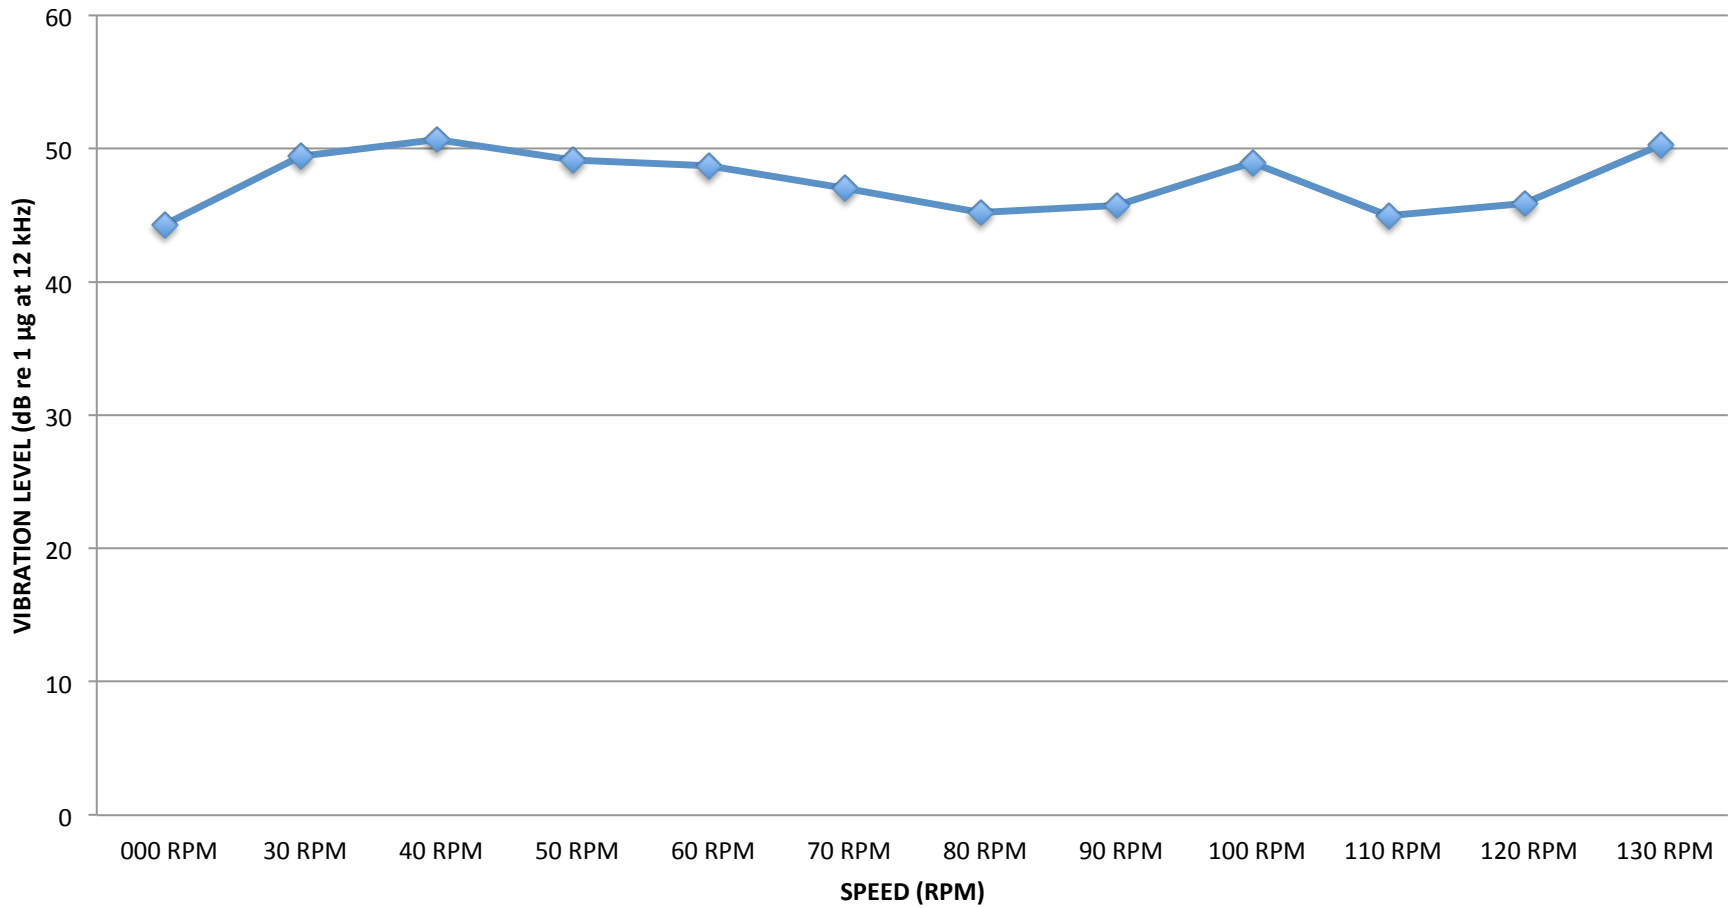
FIGURE 29

Cavitation measurements were made on the propellers of KILO MOANA. The measurements were made using an accelerometer that was mounted on the hull plating located near each propeller. Cavitation performance was evaluated by monitoring the high frequency band levels of this sensor as speed was slowly increased in one-knot increments during straight-line course conditions. Cavitation was determined to incept between ship speeds of 90 and 100 rpm. This is considered good for this ship and is very similar to results obtained on these propellers during acoustic testing at delivery and during 2010 testing. Figures 26 and 27 document propeller vibration levels for the port and starboard propellers, respectively. Figures 28 and 29 present this data in a speed versus level format for a frequency of 12 kHz.

**R/V KILO MOANA
STARBOARD PROPELLER
SPEED VERSUS 12 kHz LEVEL
11 AUGUST 2015**

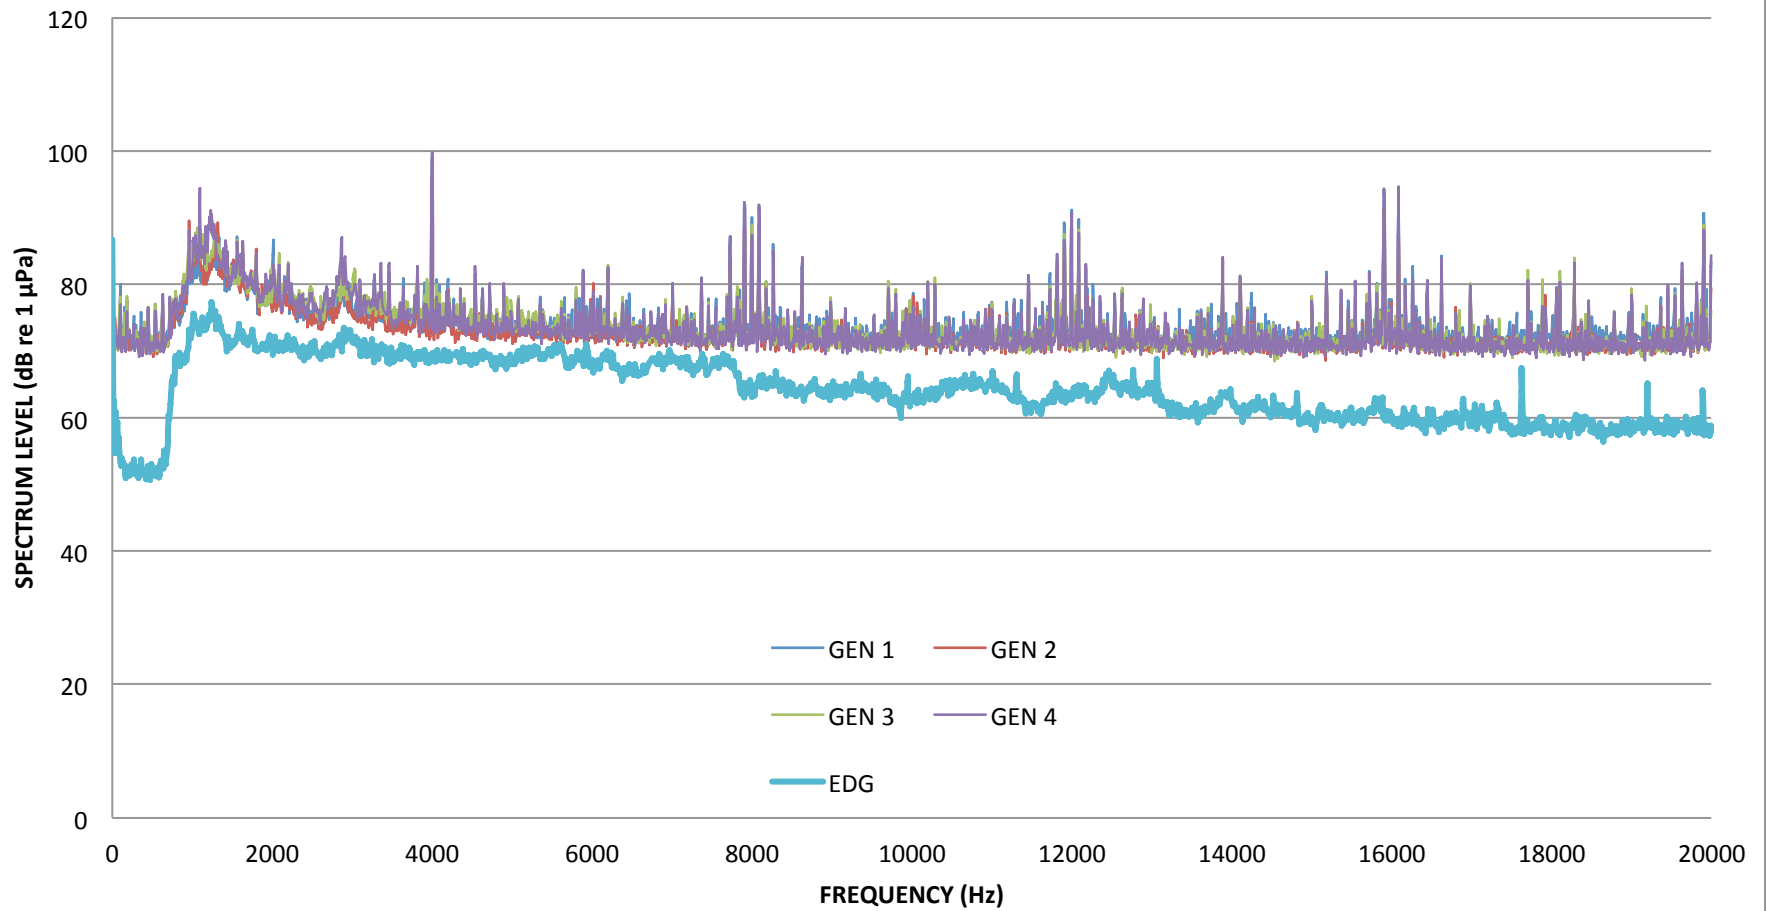
FIGURE 30

Figures 30, 31 and 32 present data from the reference hydrophones for each diesel engine operating independently. Additionally, data from the Emergency Diesel Generator is included on these figures. The data from the EM 710 hydrophone is completely controlled by electrical noise and harmonics from air handler #4 and is not relevant for diesel engine comparisons. There are still some air handling contributions on

**R/V KILO MOANA
EM 710 REFERENCE HYDROPHONE
DIESEL GENERATOR COMPARISON
9 AUGUST 2015**

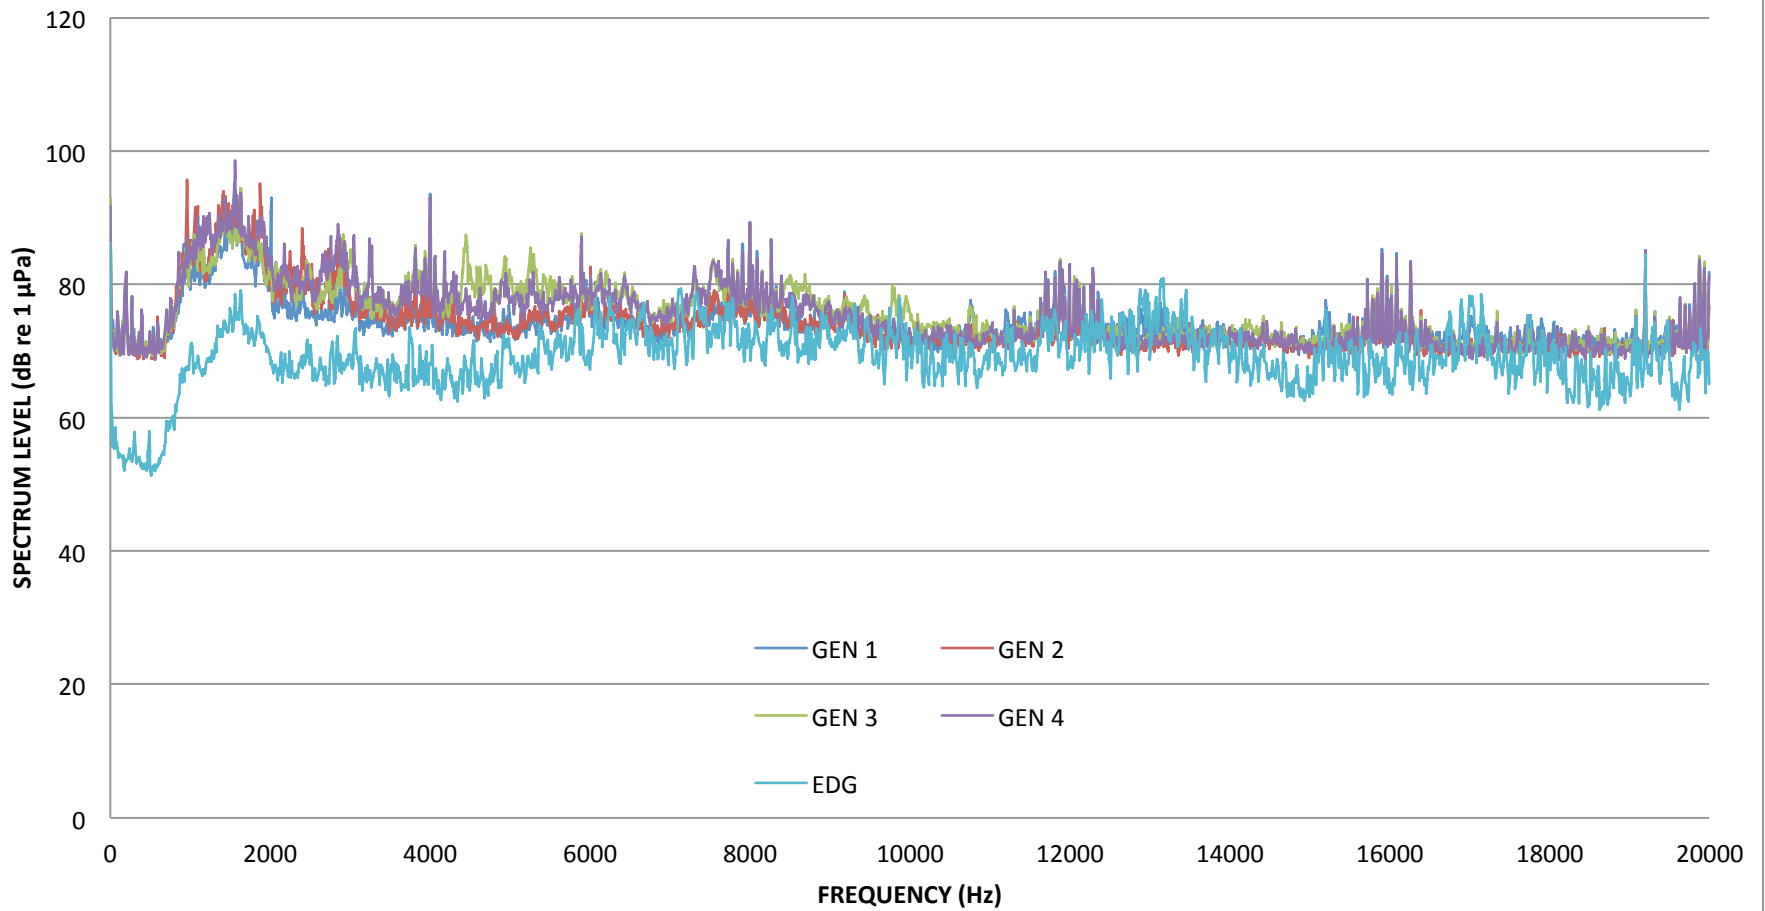
FIGURE 31

the port and starboard hydrophone figures as well. These figures are included to document the quiet conditions observed when the EDG is the only significant machinery item operating.

**R/V KILO MOANA
EM 122 PORT REFERENCE HYDROPHONE
DIESEL GENERATOR COMPARISON
9 AUGUST 2015**

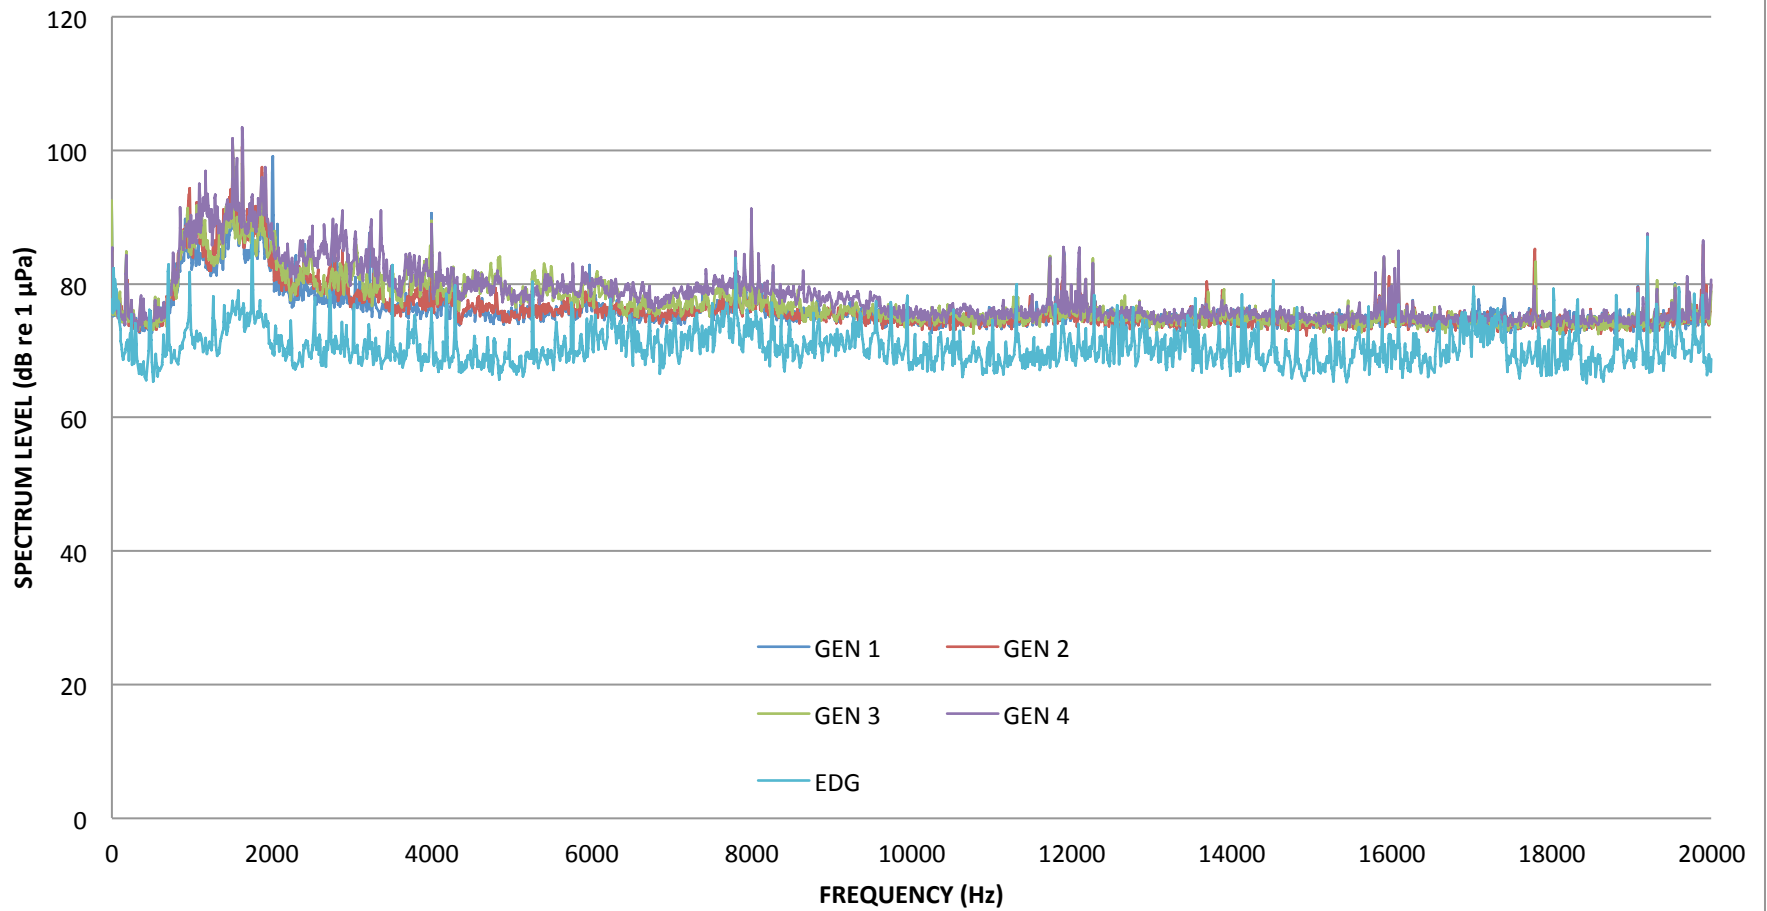
FIGURE 32

**R/V KILO MOANA
EM 122 STARBOARD REFERENCE HYDROPHONE
DIESEL GENERATOR COMPARISON
9 AUGUST 2015**
