R/V Roger Revelle

EM712 & EM124

Calibration Report

RR2301

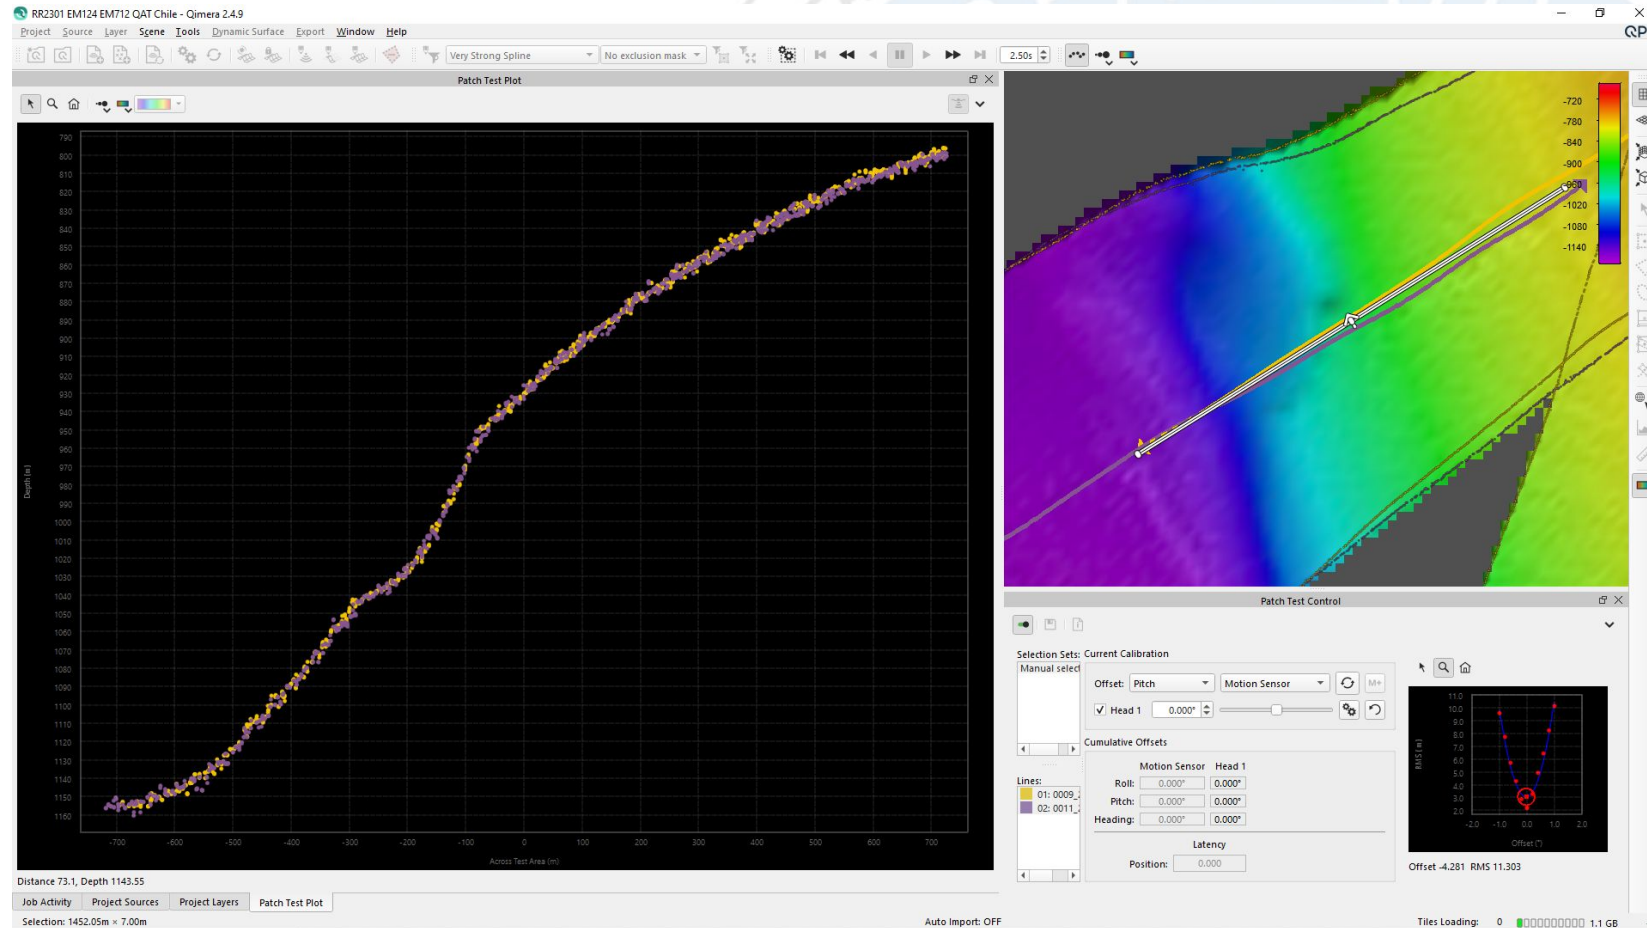
EM124 Calibration (Cape Town) Results: **Pitch (Seapath)**

Pitch calibration lines shown at left in the Qimera Patch Test Tool

1. Attitude 1 initial setting: 0.00°
2. Calibration adjustment: $+0.05^\circ$
3. **Final pitch offset: $+0.05^\circ$ in SIS**

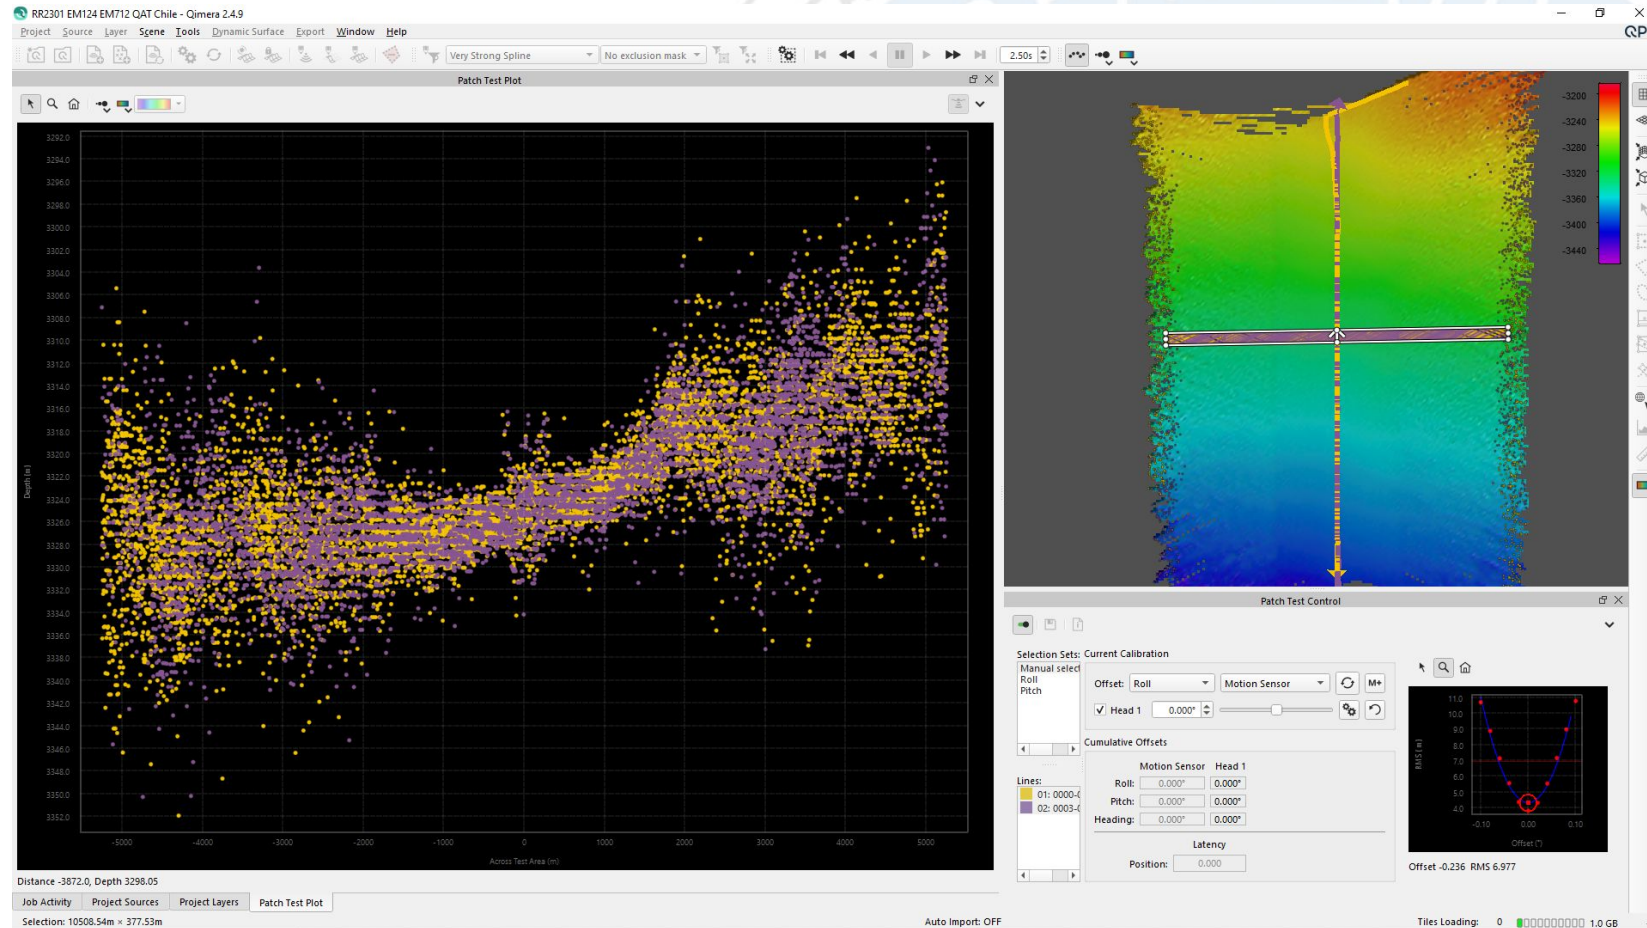
Results: **Roll (Seapath)**

Roll calibration lines shown at left in the Qimera Patch Test Tool

1. Attitude 1 initial setting: $+0.15^\circ$
2. Calibration adjustment: 0.00°
3. **Final roll offset: $+0.15^\circ$ in SIS**

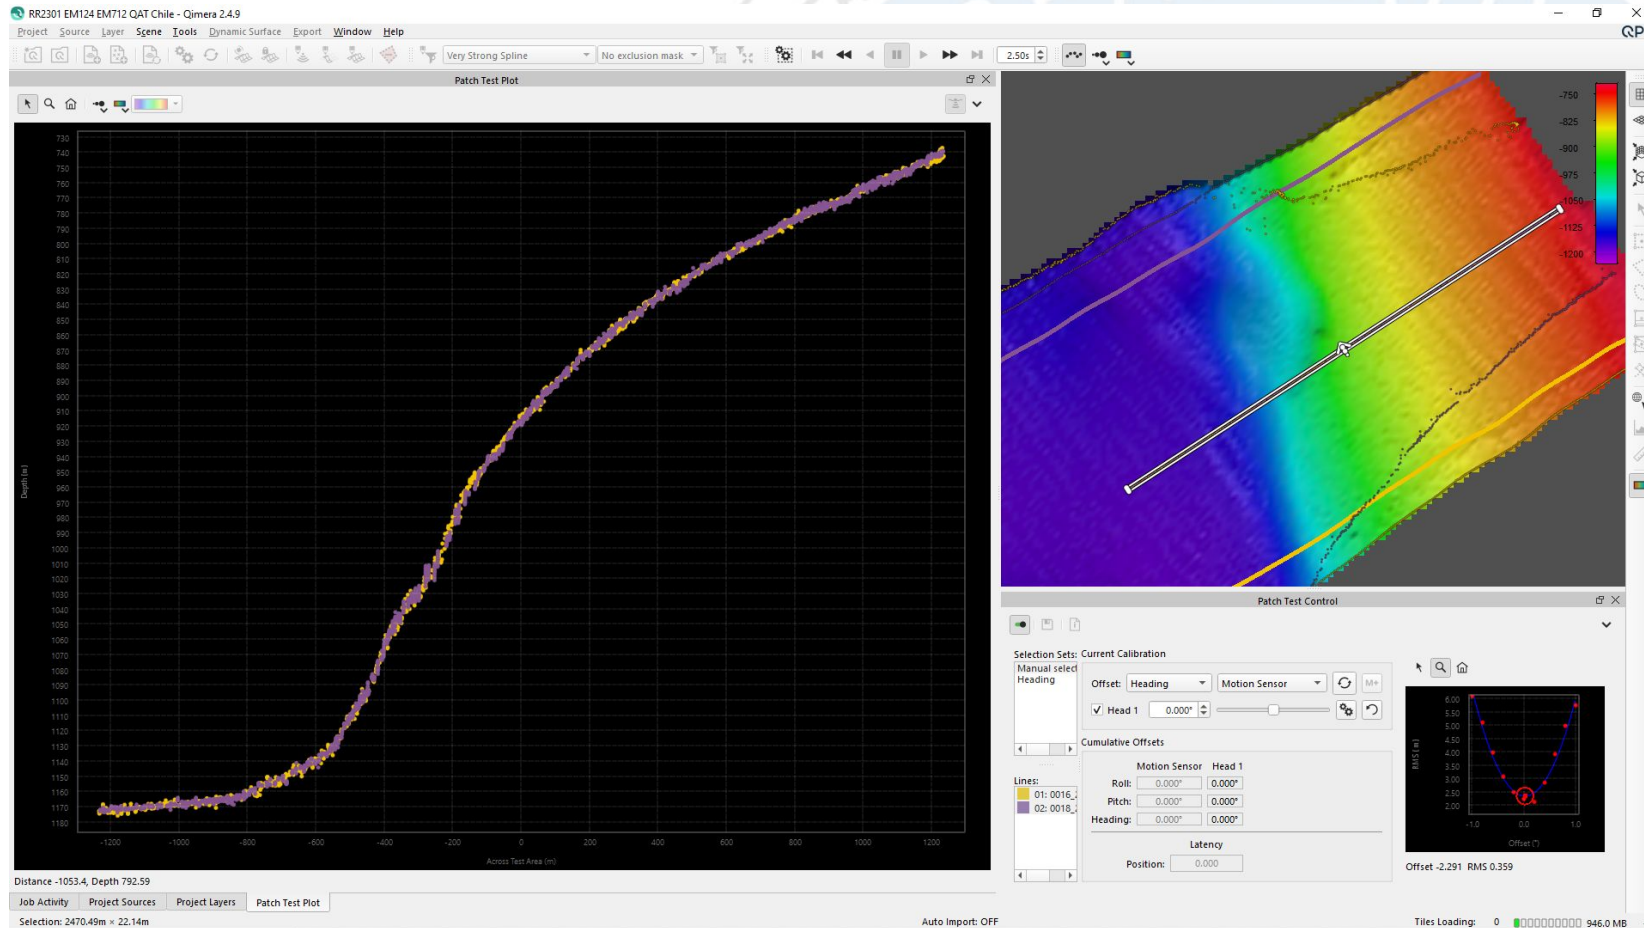
Results: Heading (Seapath)

Heading calibration lines shown at left in the Qimera Patch Test Tool

1. Attitude 1 initial setting: $+0.05^\circ$
2. Calibration adjustment: $+0.10^\circ$
3. **Final hdg. offset: $+0.15^\circ$ in SIS**

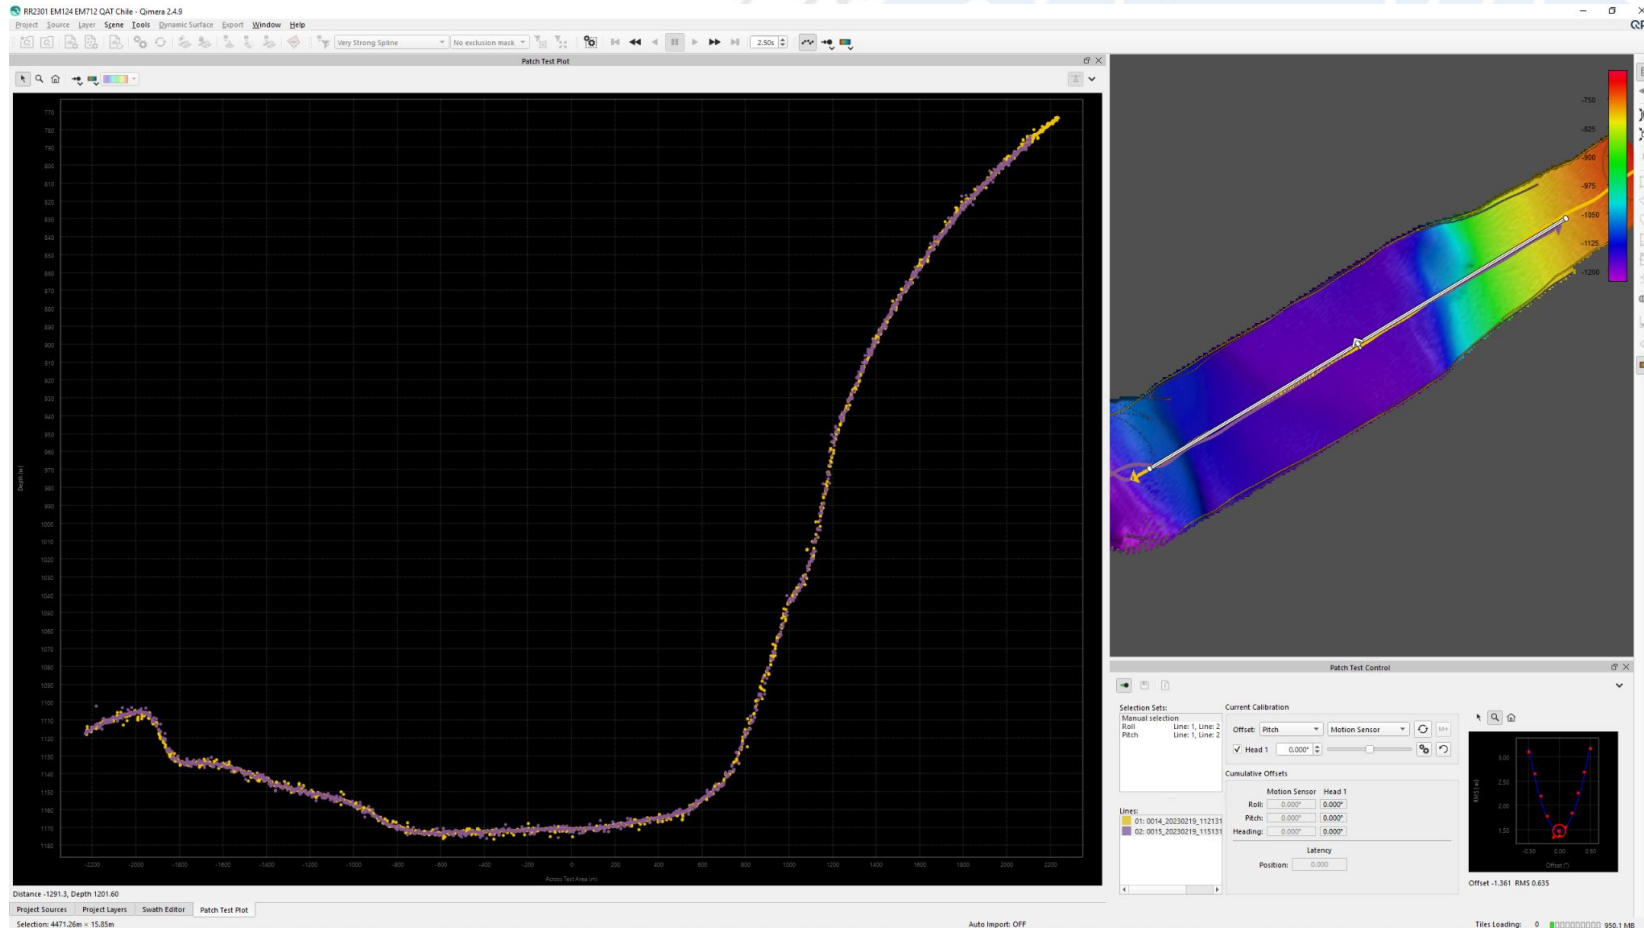
Results: Pitch (Seapath)

Pitch calibration lines shown at left in the Qimera Patch Test Tool

1. Attitude 1 initial setting: 0.00°
2. Calibration adjustment: $+0.01^\circ$
3. **Final pitch offset: $+0.01^\circ$ in SIS**

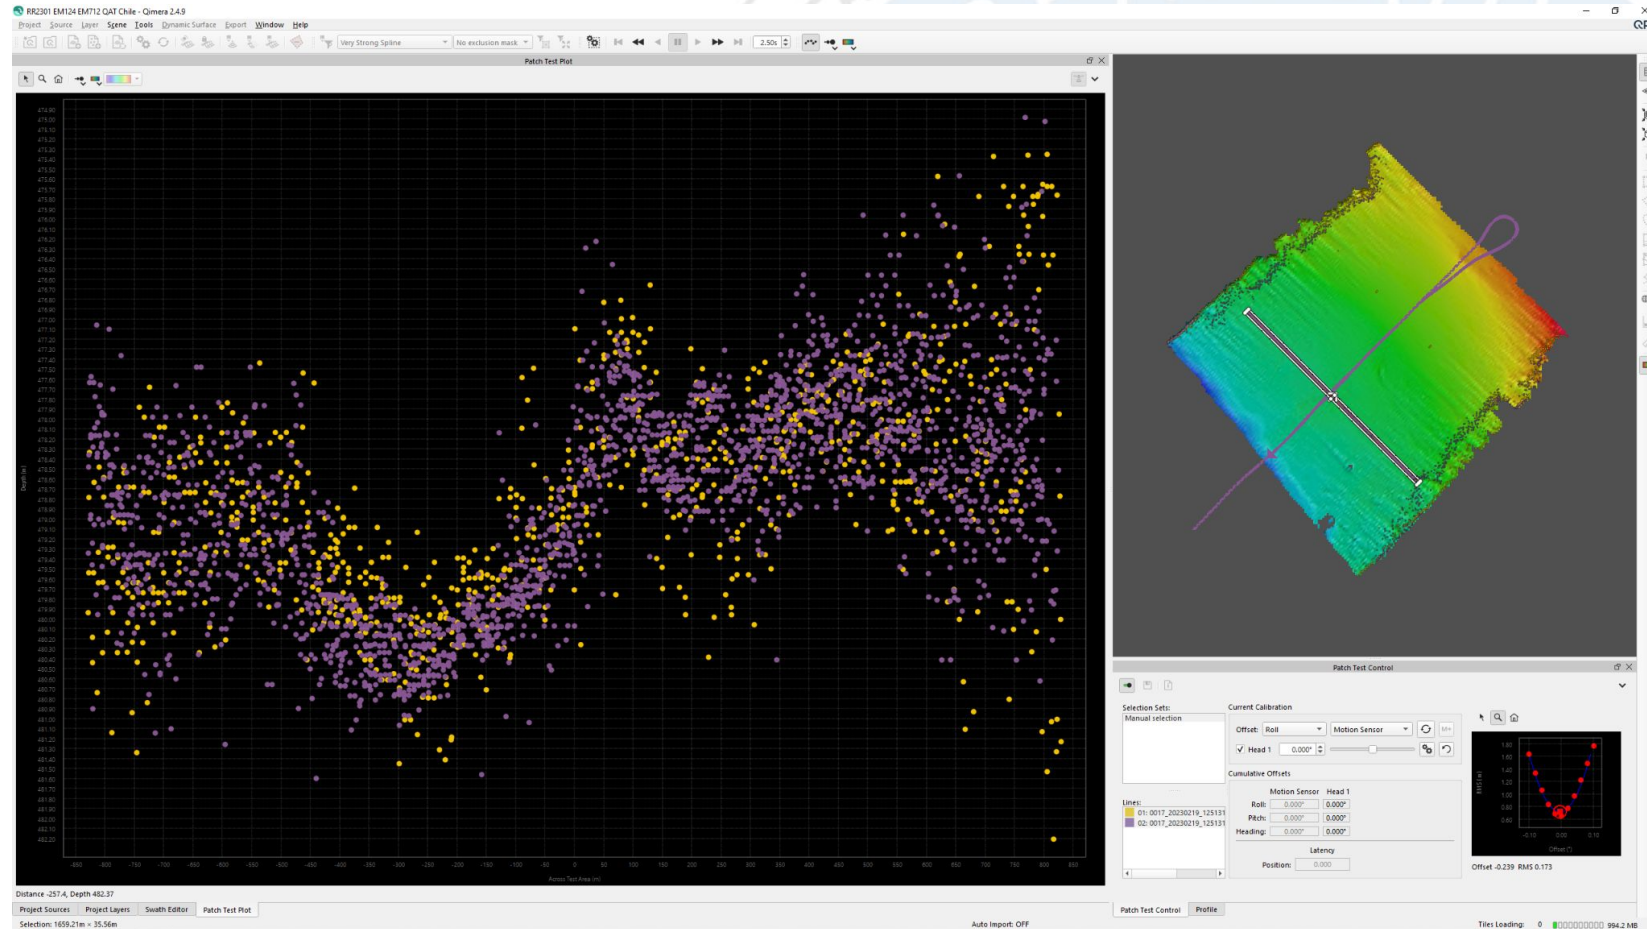
Results: **Roll (Seapath)**

Roll calibration lines shown at left in the Qimera Patch Test Tool

1. Attitude 1 initial setting: $+0.15^\circ$
2. Calibration adjustment: $+0.02^\circ$
3. **Final roll offset: $+0.17^\circ$ in SIS**

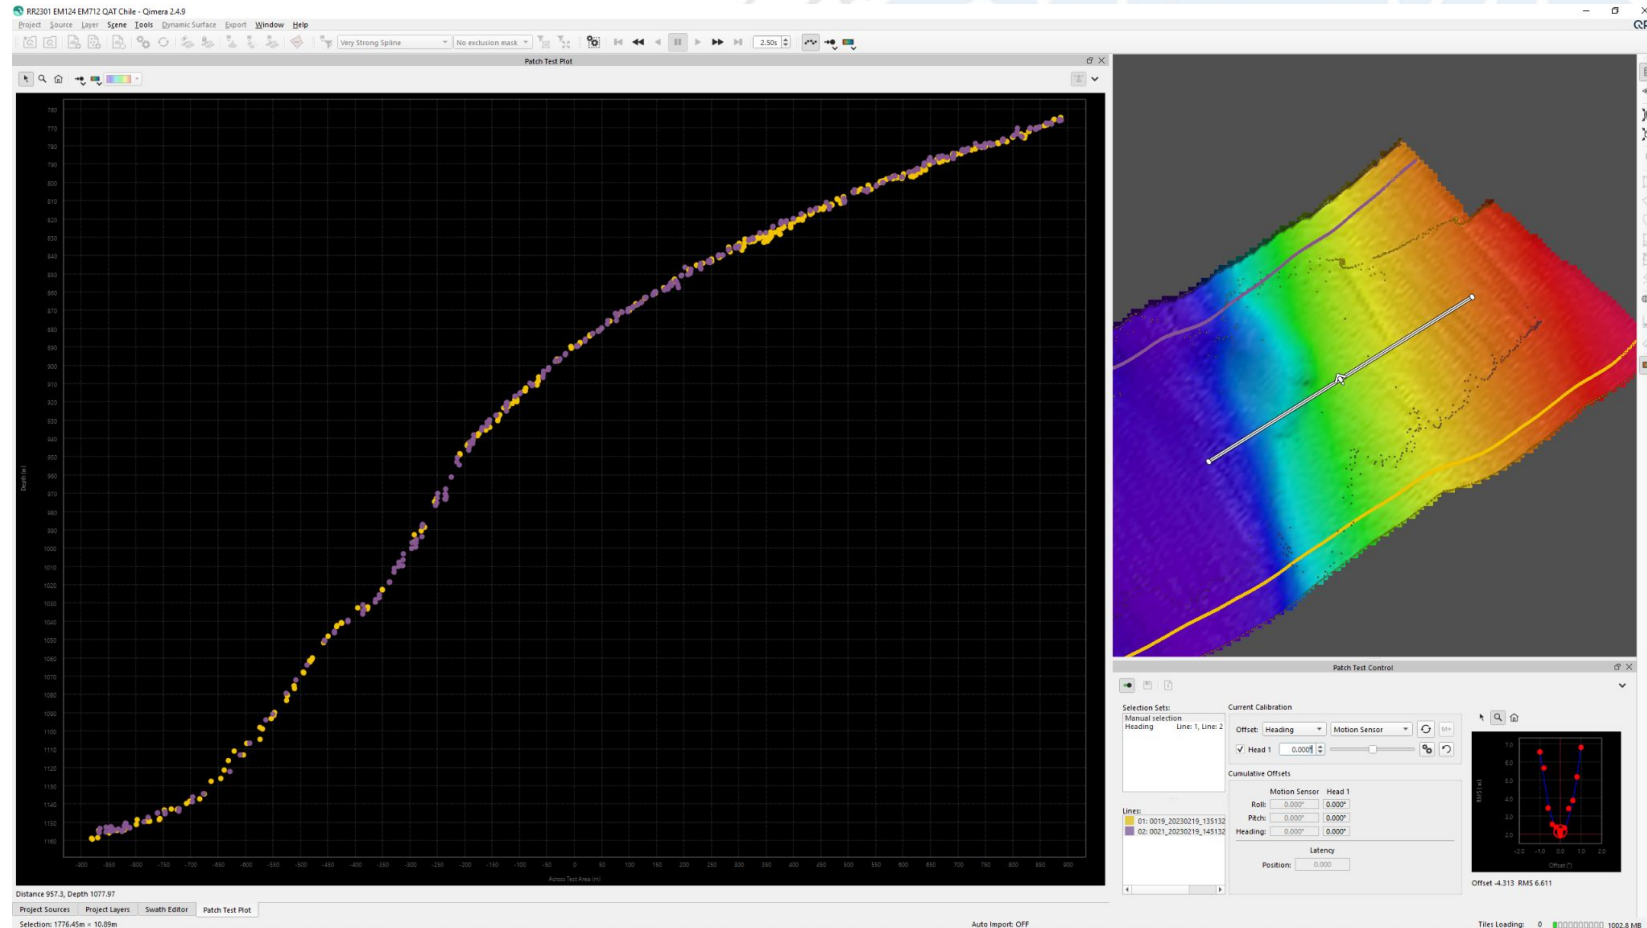
Results: **Heading (Seapath)**

Heading calibration lines shown at left in the Qimera Patch Test Tool

1. Attitude 1 initial setting: -0.35°
2. Calibration adjustment: -0.05°
3. **Final hdg. offset: -0.40° in SIS**
