R/V *Sikuliaq*

EM302 / EM710

Calibration Report

SKQ201907T

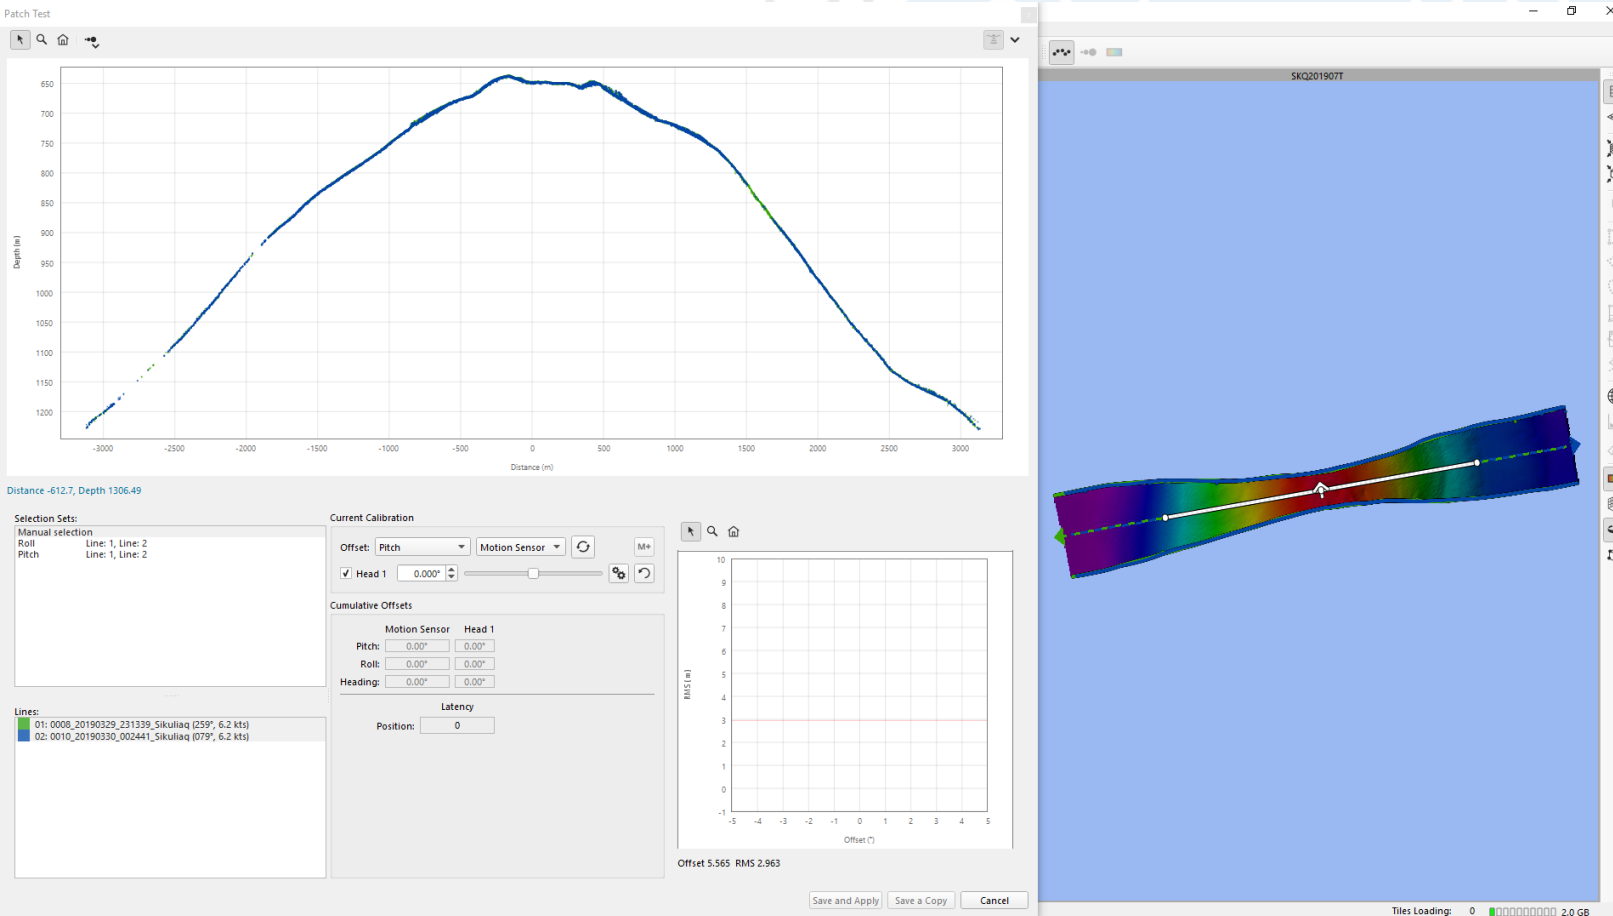
Results: Pitch

Pitch calibration lines shown at left in the Qimera Patch Test Tool

1. Attitude 1 initial setting: -0.10°
2. Calibration adjustment: $+0.02^\circ$
3. No pitch verification performed
4. **Final pitch offset: -0.08° in SIS**

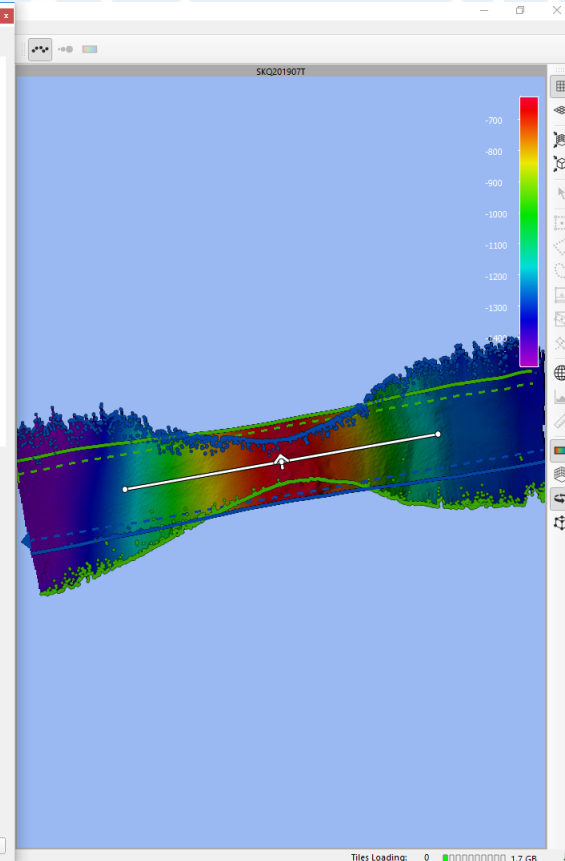
Heading calibration lines shown at left in the Qimera Patch Test Tool

1. Attitude 1 initial setting: -0.11°
2. Calibration adjustment: $+0.06^\circ$
3. **Final hdg. offset: -0.05° in SIS**

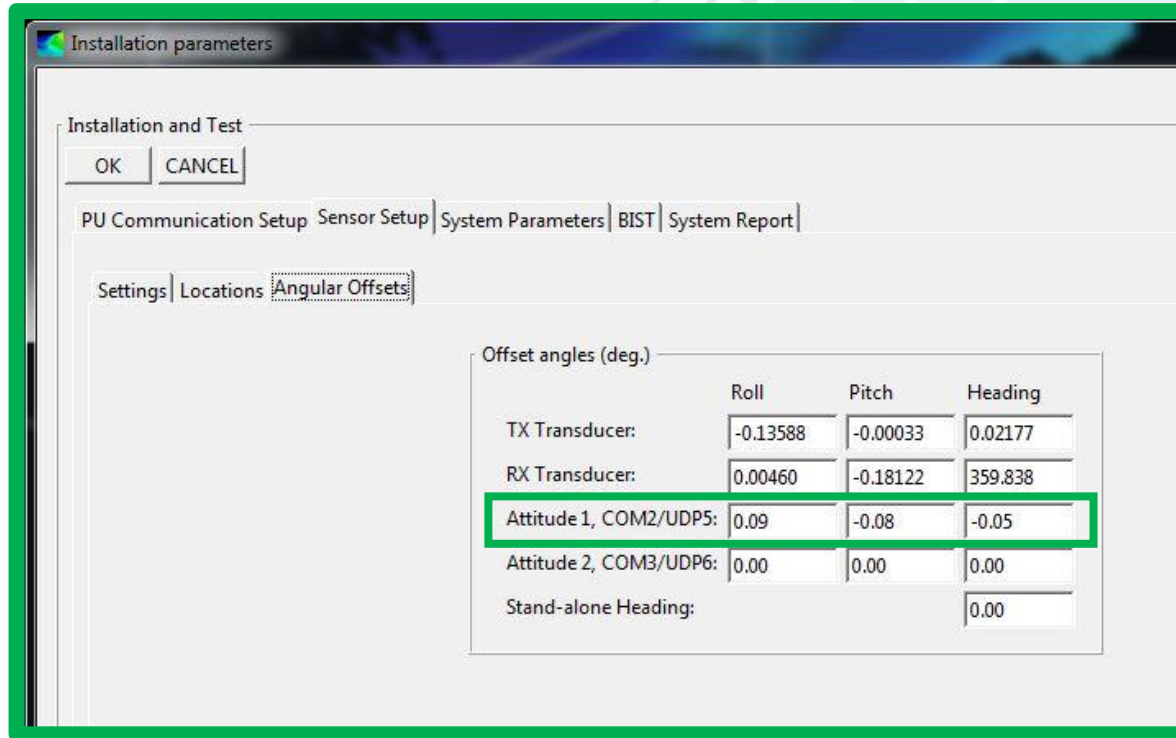
POST-CALIBRATION (EM302)

1. While larger than the 2018 results, the relatively small *Attitude 1* adjustments made during the 2019 EM302 calibration confirm a high-quality vessel offset survey, consistent integration, and no significant changes across the Seapath and EM302 sensor layouts since the last QAT in 2018
2. The *Installation Parameters: Angular Offsets* shown at left should be maintained until any modification is made to the Seapath 320 or EM302 arrays, or another calibration becomes necessary for other reasons

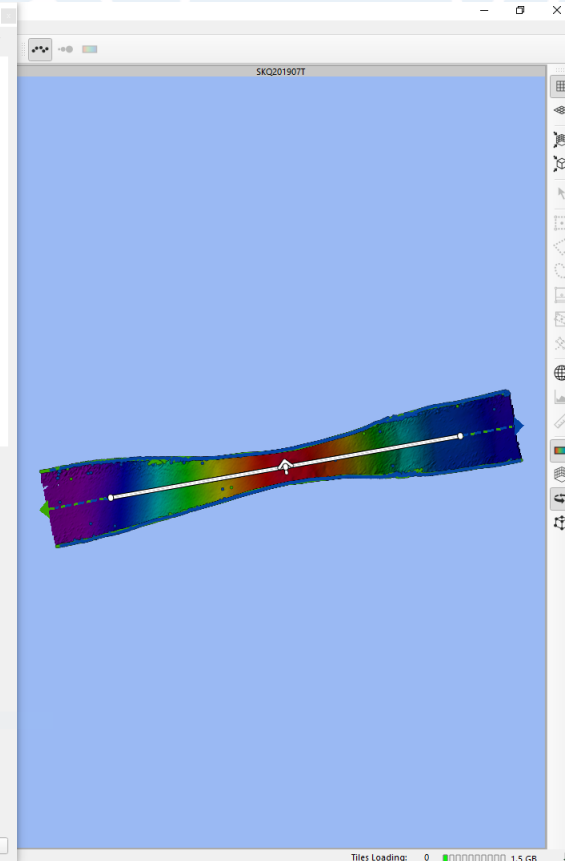
Pitch calibration lines shown at left in the Qimera Patch Test Tool

1. Attitude 1 initial setting: -0.05°
2. Calibration adjustment: 0.01°
3. **Final pitch offset: -0.04° in SIS**

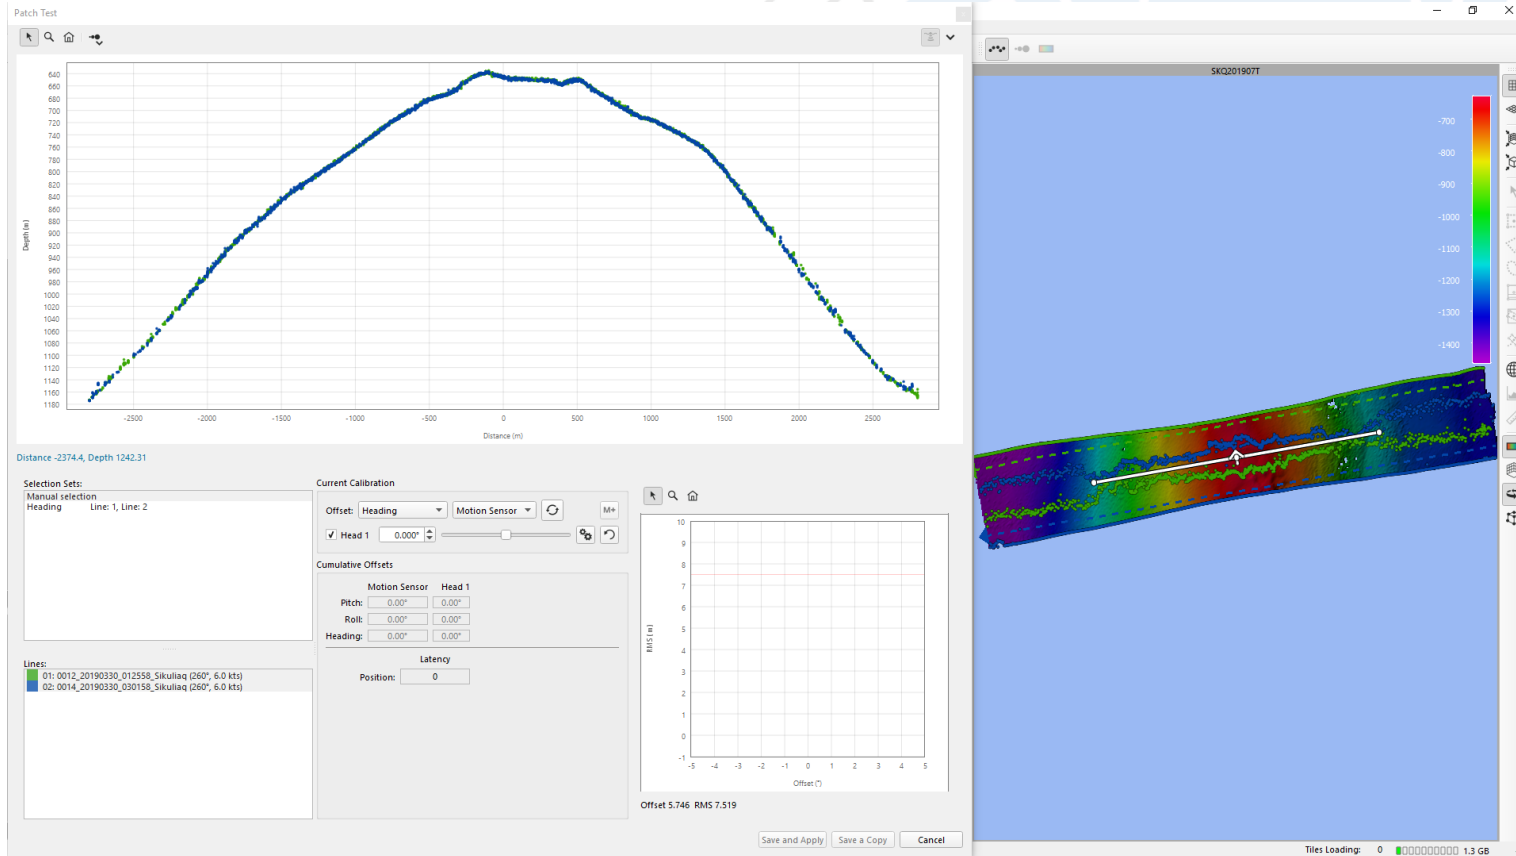
Results: **Heading**

Heading verification lines shown at left in the Qimera Patch Test Tool

1. Attitude 1 initial setting: -0.08°
2. Calibration adjustment: 0.11°
3. **Final hdg. offset: $+0.03^\circ$ in SIS**
