USCGC *Healy* EM122
Multibeam Echosounder System Review
May 16-20, 2017

Report prepared by:

Paul D. Johnson¹, Vicki L. Ferrini^{1,2}, and Kevin W. Jerram¹

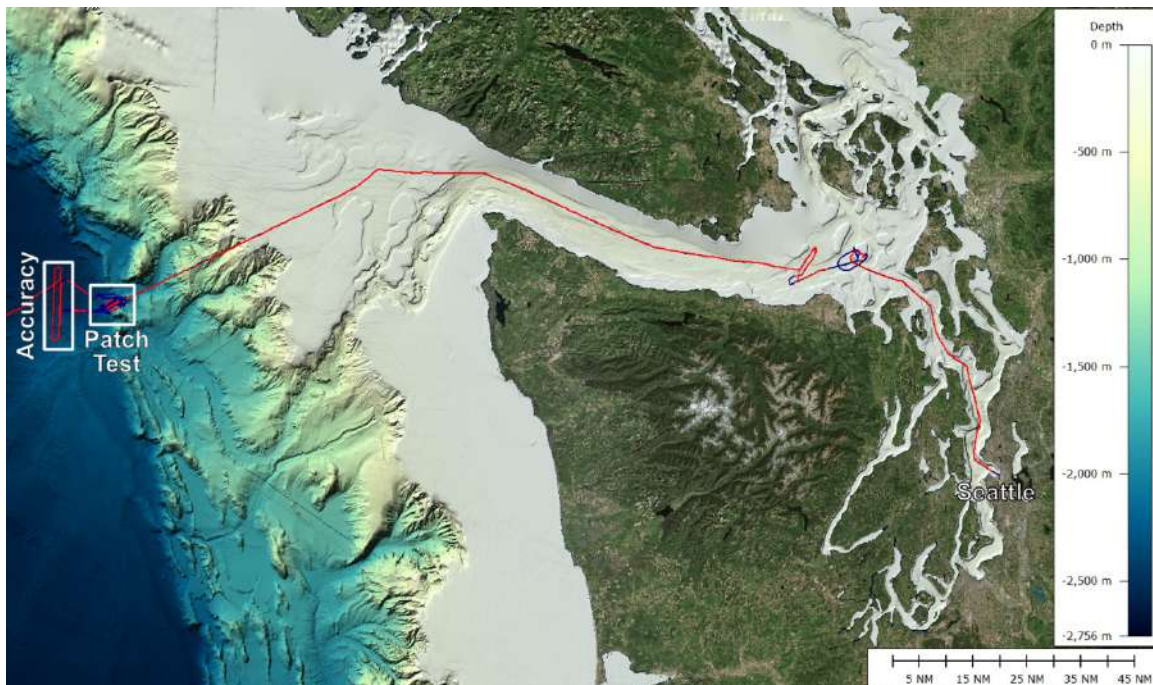
Figure 1. Calibration and accuracy testing sites in the Strait of Juan de Fuca and off the coast of Washington during HE17TA. These sites were selected based on availability of suitable seafloor features in the intended operational depth range for the EM122 multibeam echosounder. Swath coverage (acoustic extinction) data were collected up and down the slope in addition to over these test sites (red ship track).

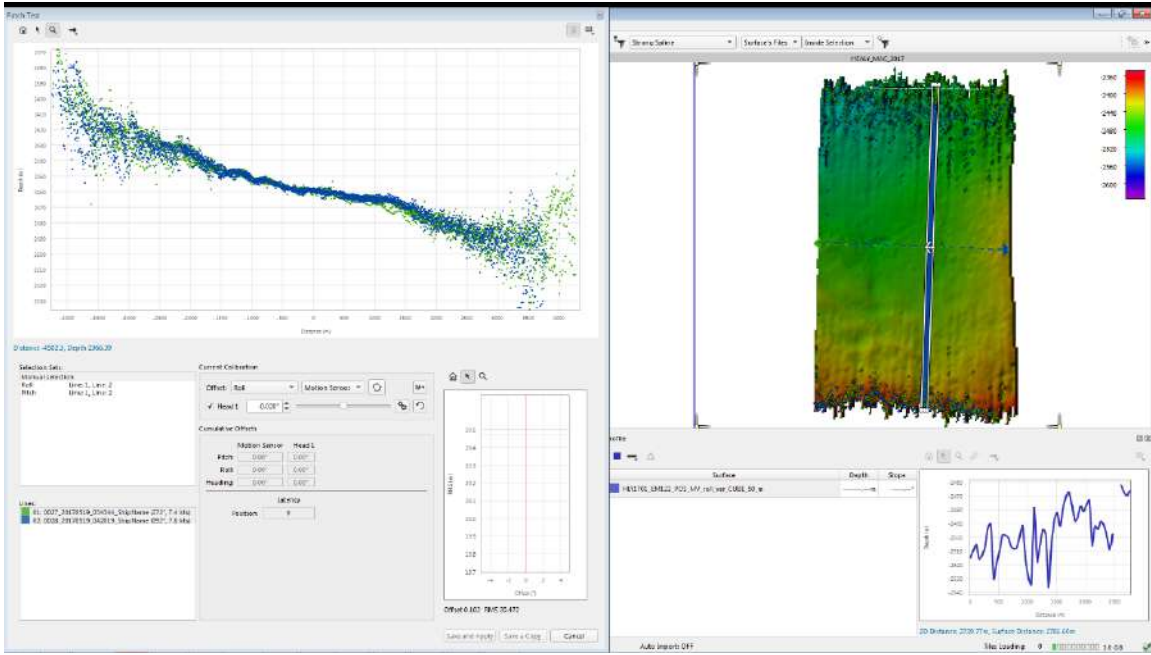
Figure 10. EM122 / POS MV roll verification in Qimera, applying an adjustment of -0.02° to the initial value of -0.20° for a final offset of -0.22° in SIS.

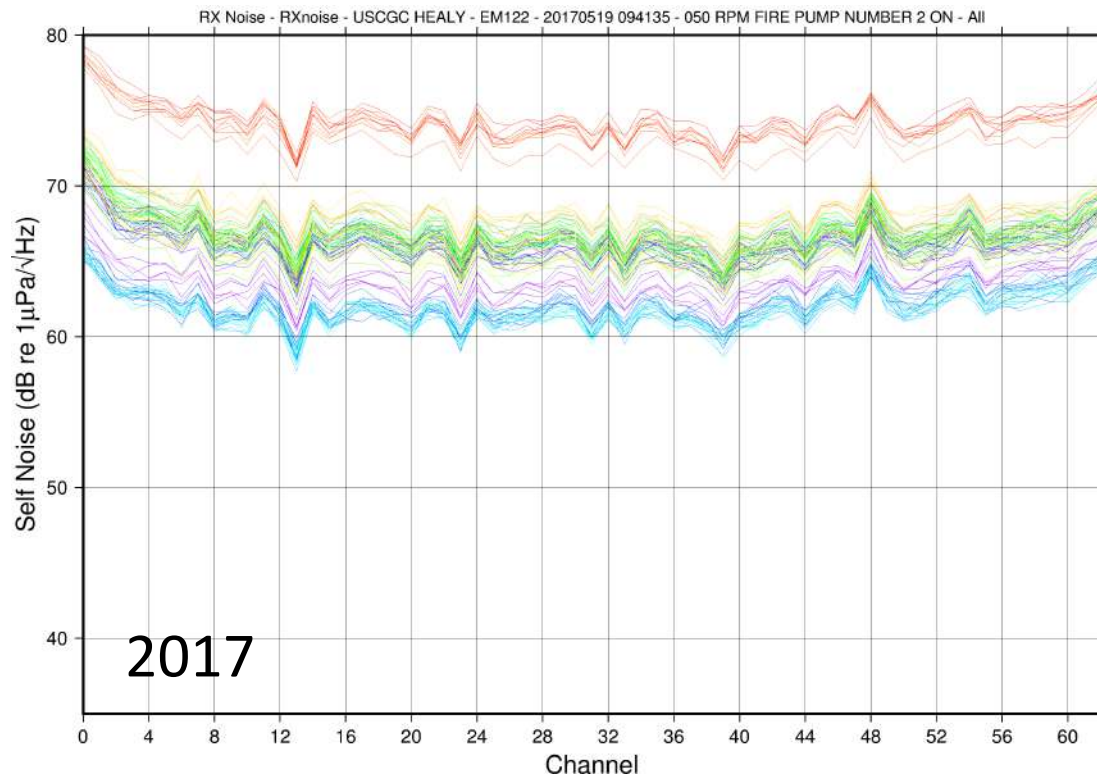
In general, the results show a relatively narrow distribution of noise levels as was seen in 2014 under most of the test configurations, though all levels are high relative to the noise levels observed on other mapping vessels. One notable machinery noise result from HE17TA is Fire Pump #2, which showed significantly elevated noise levels under operation. This is not considered to be a concern for routine mapping operations, given the emergency purpose and infrequent use of the pump.

Figure 13. Noise levels perceived by the EM122 receiver under different machinery configurations. Individual test results are presented in Appendix 4.

7. Vessel noise levels are higher than seen aboard other EM122-equipped ships, which likely contributes to reduced swath width and increased standard deviation of soundings. Any reduction in vessel noise (perceived by the EM122 receiver) would have multiple positive impacts on the multibeam data and mapping operations. That said, there are no significant changes in the noise characteristics of the ship from those observed in 2014 by Gates Acoustics.

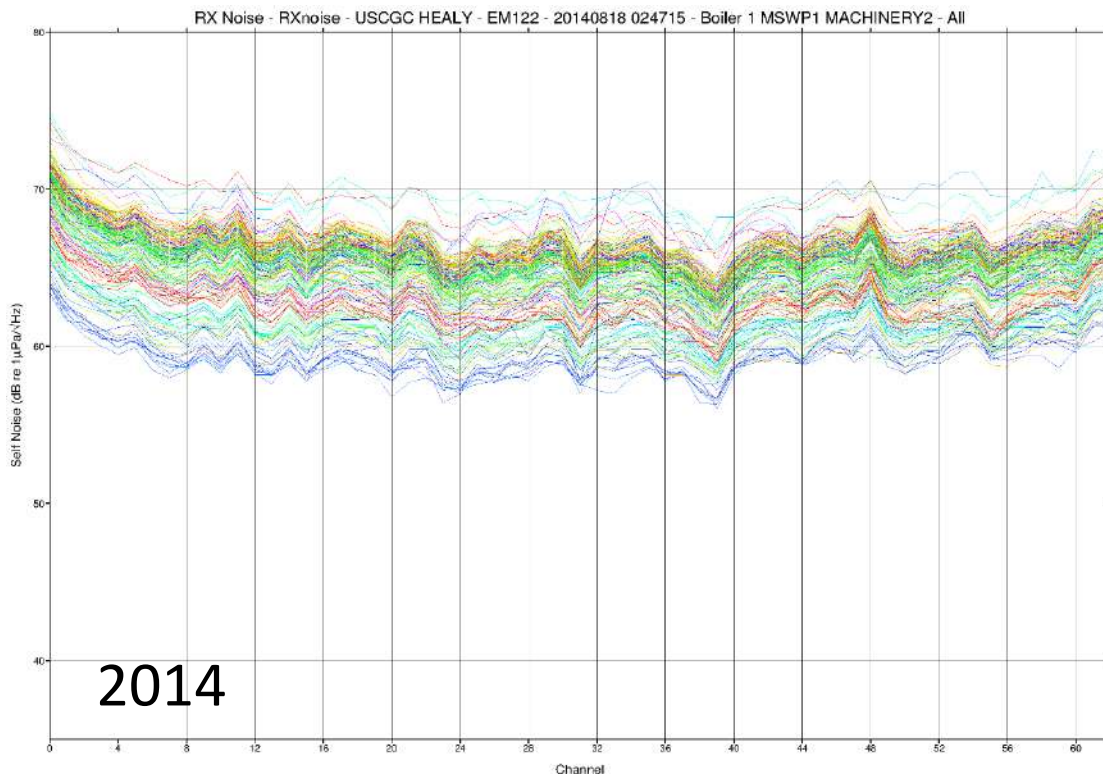
Figure 14. Noise levels perceived by the EM122 receiver under different machinery configurations. This data was collected in 2014 by Gates Acoustic. Individual test results are presented in Appendix 4.

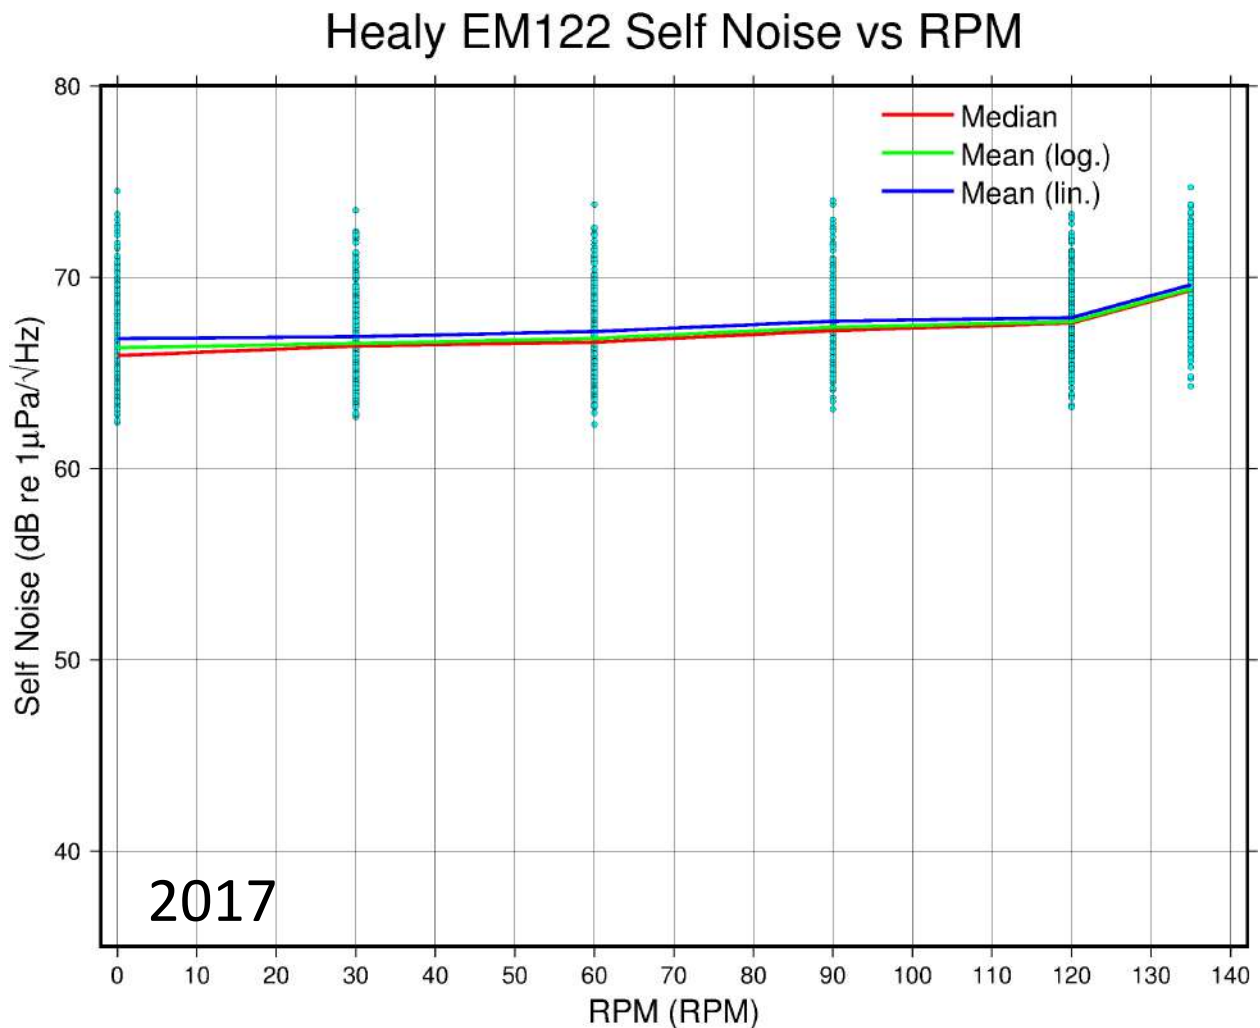
A series of RX Noise and RX Spectrum BISTs were collected with the vessel operating at different speeds in order to characterize the combined effects of machinery (primarily main engine) and flow noise on the EM122 receiver noise environment. Figure 15 shows the trends in noise versus shaft speed; notably, the slope of the plot is relatively flat until 120 RPM, indicating the dominance of machinery noise over flow noise over most of the speed range. Figure 16 shows the results of the 2014 testing, which exhibits a comparable range of noise values at similar RPM. These data are also presented versus RX module in Figure 17 and 18. As noted during previous evaluations with Gates Acoustic Services, the *Healy* exhibits a higher noise profile in the frequency bands of interest for the EM122 compared to other vessels with similar systems, possibly negatively affecting swath coverage and accuracy performance.

Figure 15. Mean and median EM122 RX Noise BIST results collected at multiple shaft speeds during HE177A.

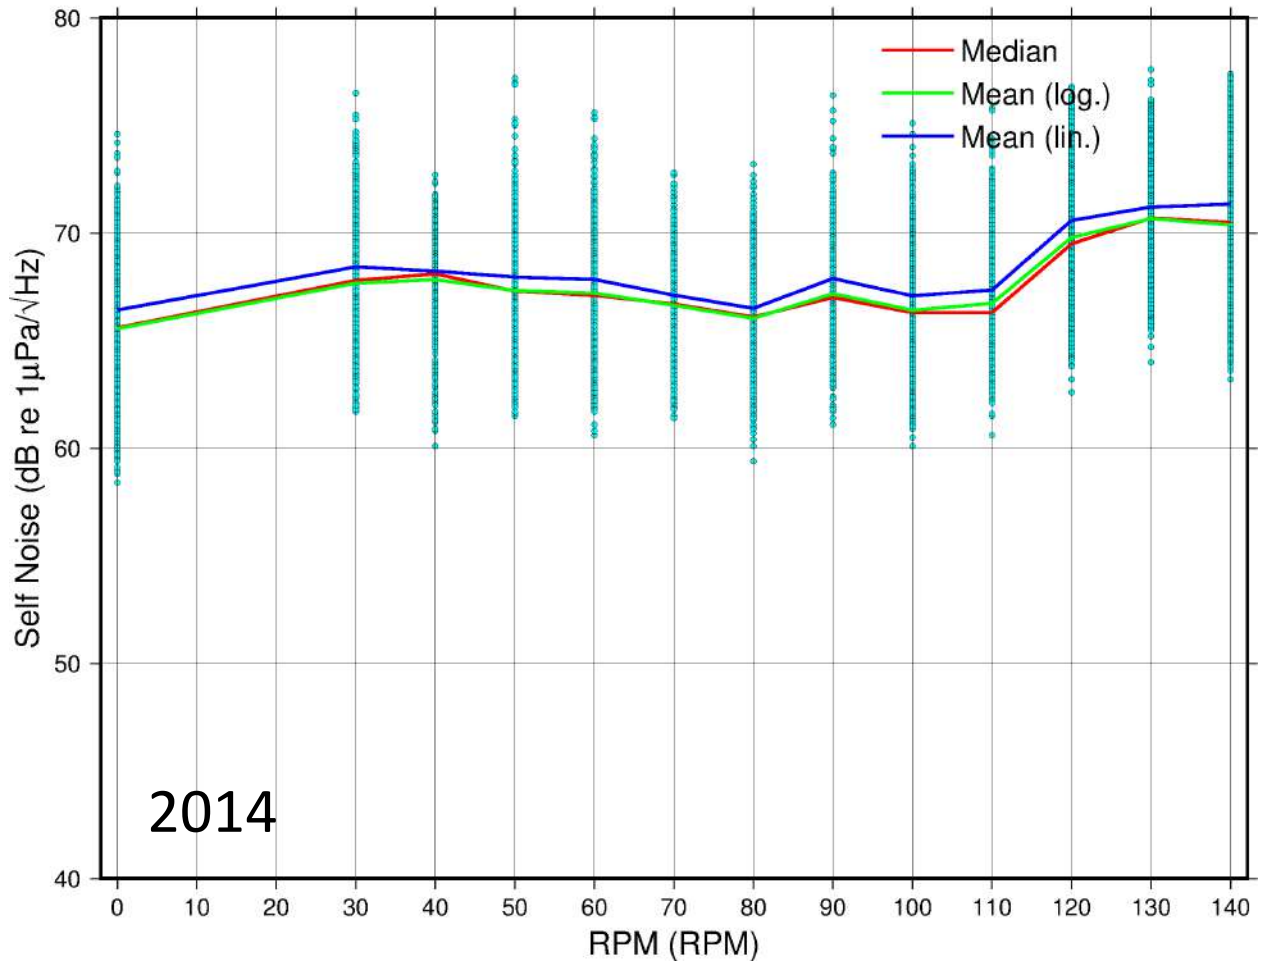
Figure 16. Mean and median EM122 RX Noise BIST results collected at multiple shaft speeds by Gates Acoustics in 2014.

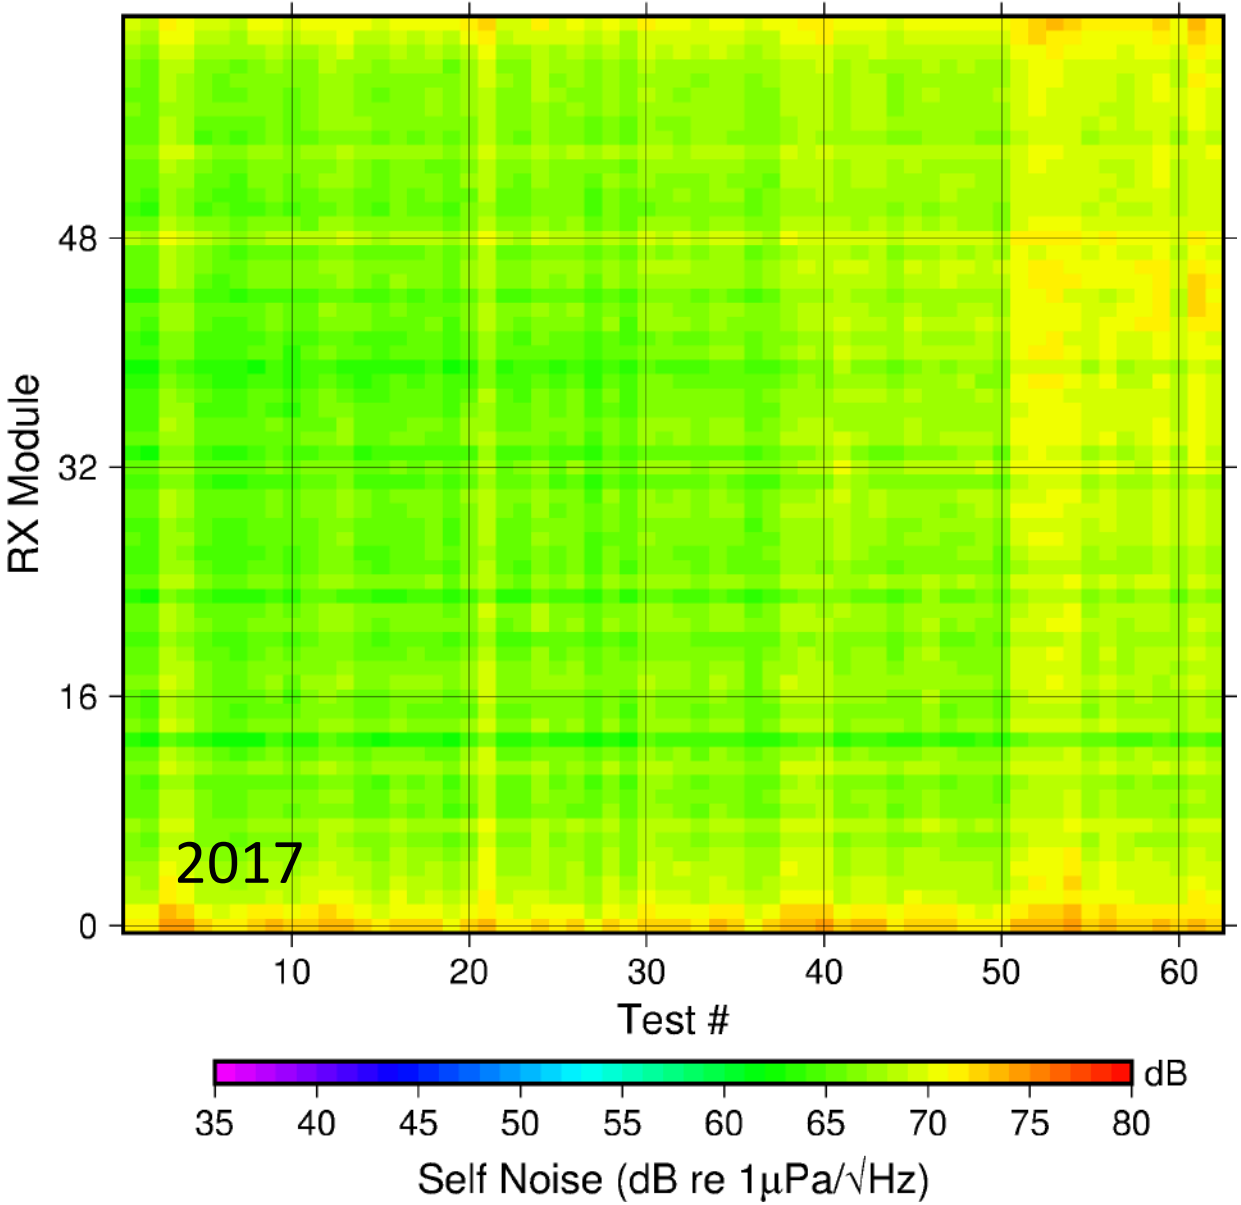
Figure 17. EM122 RX Noise results plotted versus RX module for each shaft speed test during HE17TA.

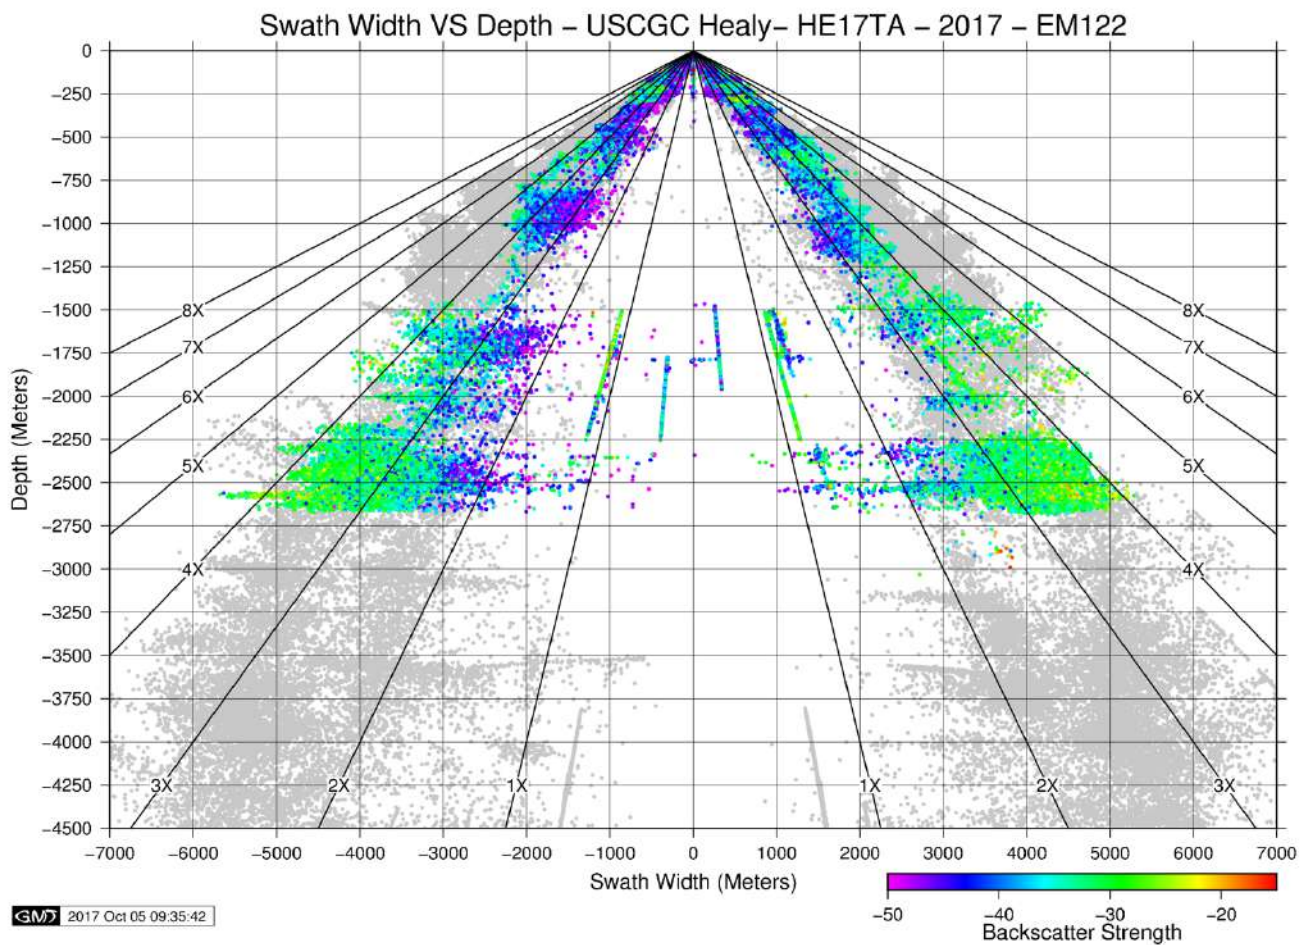
The EM122 swath coverage over the depth ranges surveyed during HE17TA (Figure 23) shows less than expected performance, maintaining swath width of roughly five times water depth (5 x w.d.) to ~750 m and reducing to 4 times water depths at depths of ~2600 m. Interestingly, the 2012 data consistently shows wider swath widths for data collected shallower than 1500 m (grey points). While some of this may be attributed to difference in bottom type, sea conditions, and other environmental factors, between the 2012 and 2017 data collections sites, it is concerning that there is such a significant difference between the two years' swath performance. Additional data has been collected by the *Healy* in deeper waters and this report will be amended when that data has been analyzed.

Figure 23. EM122 swath coverage performance during HE17TA (colored by backscatter strength, dB) as compared to data collected in 2012 during the system's initial shipboard acceptance testing (grey points).
