# *R/V Sally Ride*

*EM124 SAT & EM712 QAT*

*Quality Assurance Testing*

*SR2307*

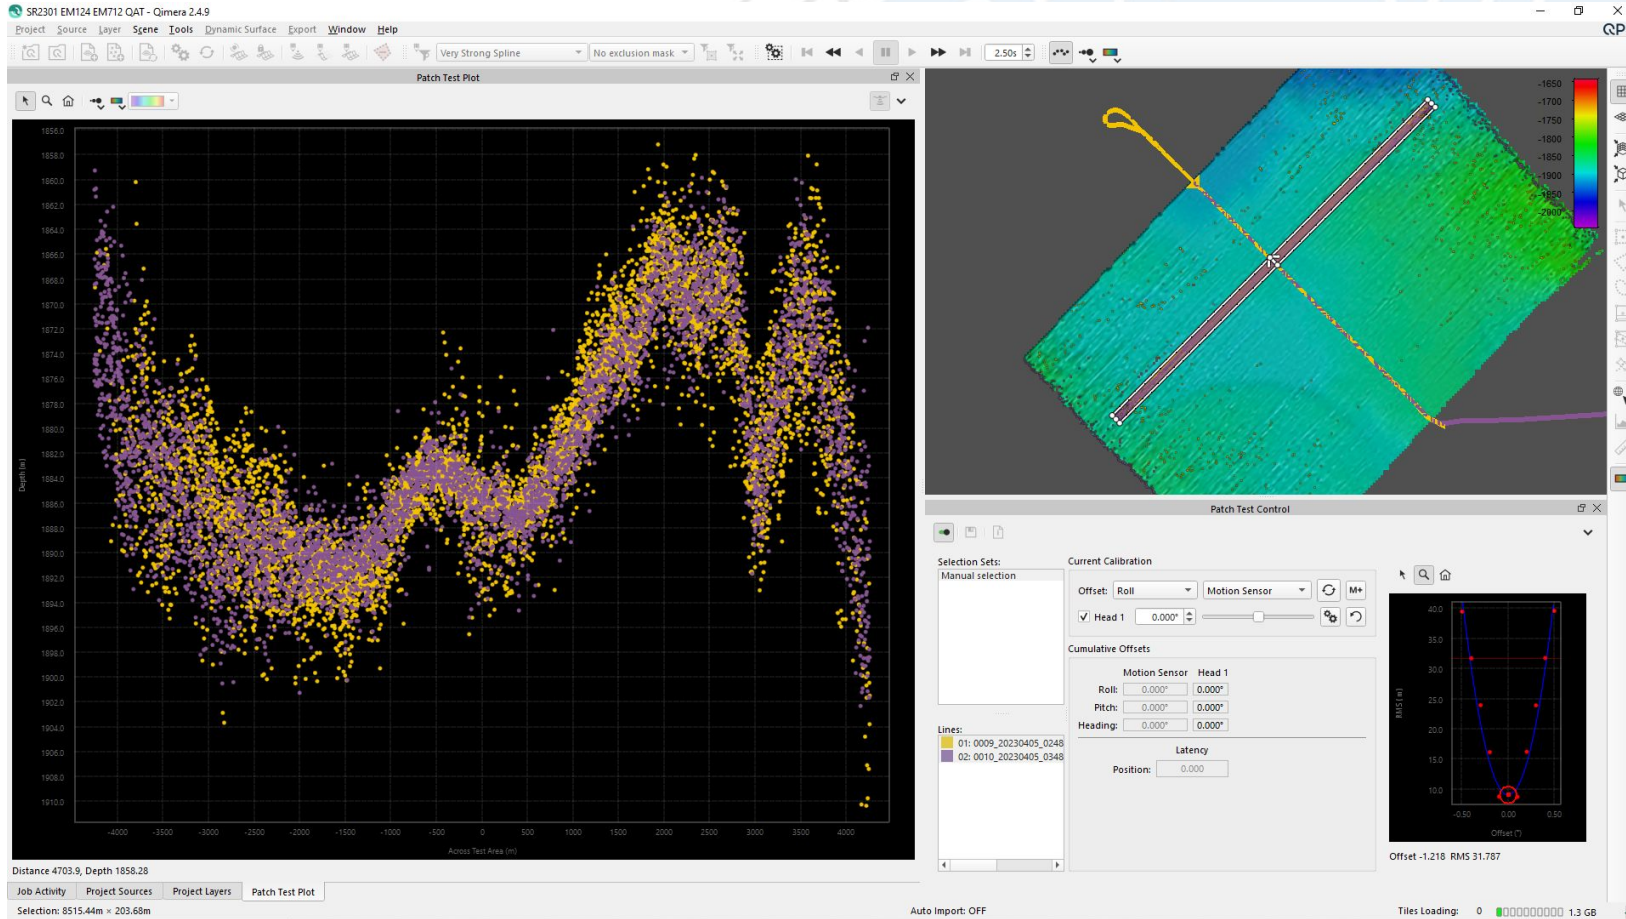
Files: 9-10

Roll verification lines shown at left in the Qimera Patch Test Tool

1. Attitude 1 initial setting:  $-0.175^\circ$
2. Calibration adjustment  $0.00^\circ$
3. **Final roll offset:  $-0.175^\circ$  in SIS**

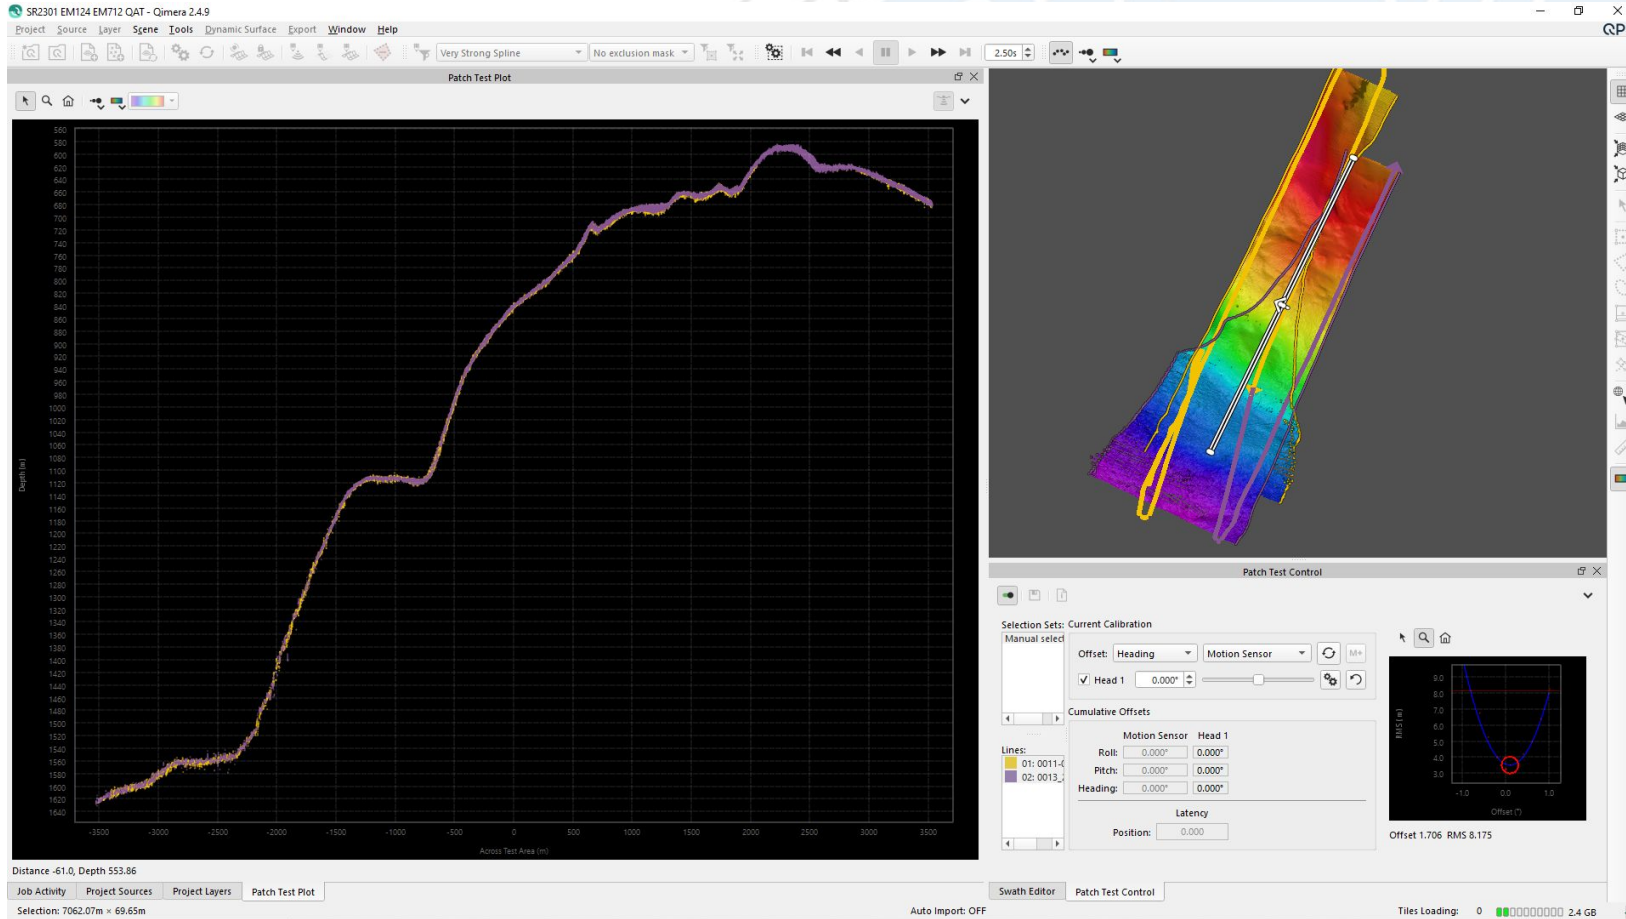
Files: 58-59, 62-63

Heading calibration lines shown at left in the Qimera Patch Test Tool

1. Attitude 1 initial setting:  $-0.05^\circ$
2. Calibration adjustment:  $+0.05^\circ$
3. **Final hdg. offset:  $0.00^\circ$  in SIS**

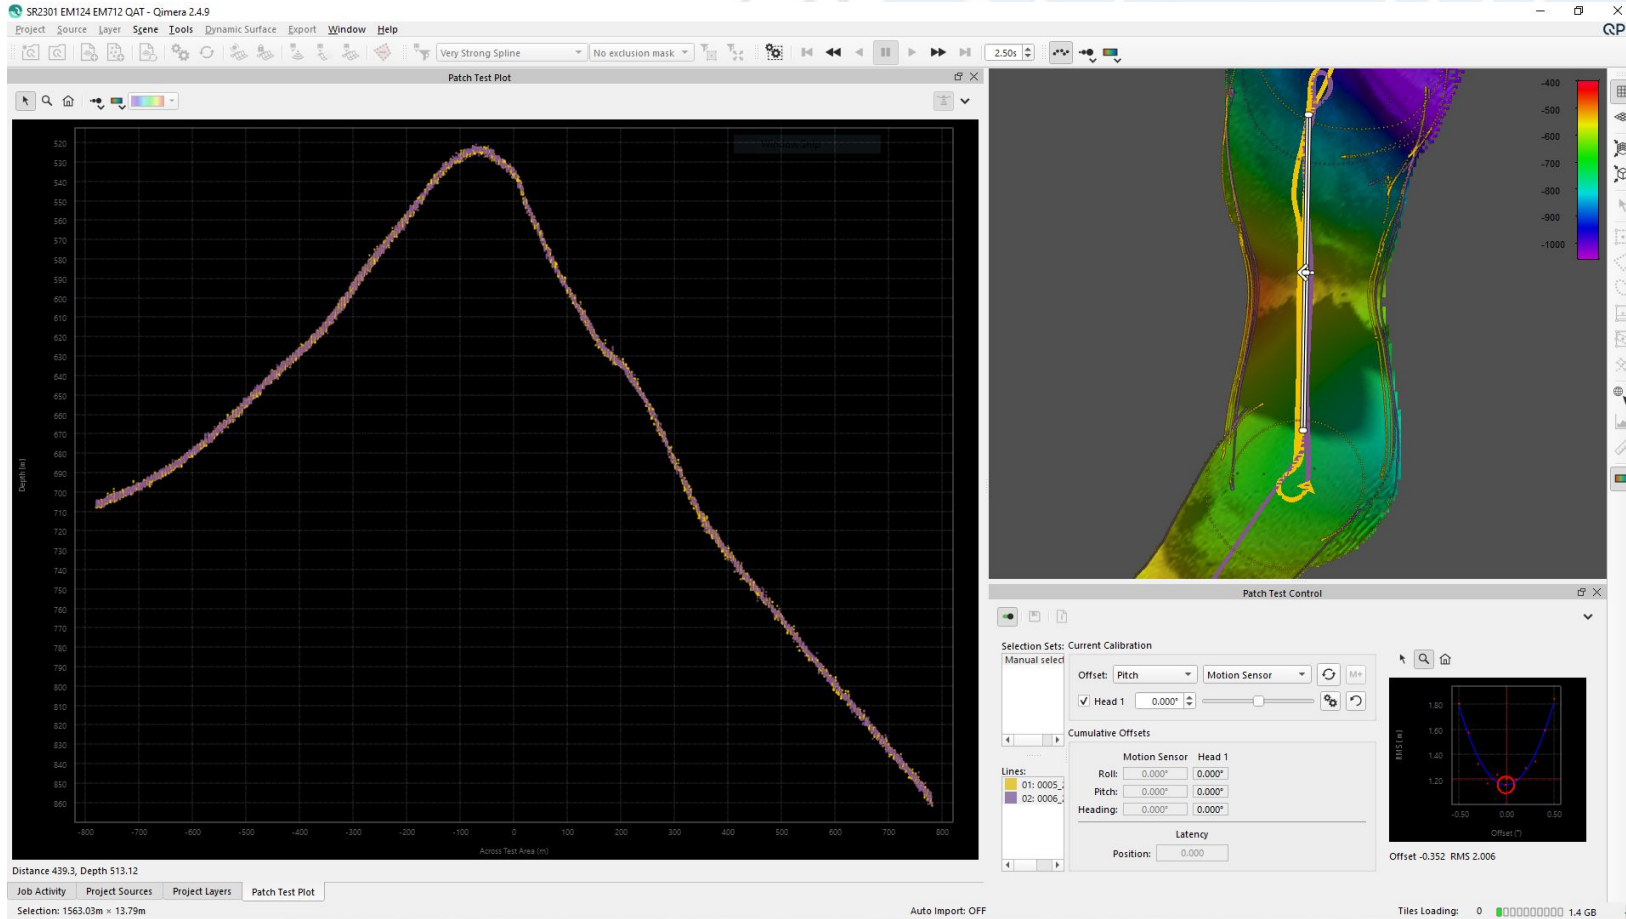
Files: 5-6

Pitch calibration lines shown at left in the Qimera Patch Test Tool

1. Attitude 1 initial setting:  $-0.32^\circ$
2. Calibration adjustment:  $0.00^\circ$
3. **Final pitch offset:  $-0.32^\circ$  in SIS**

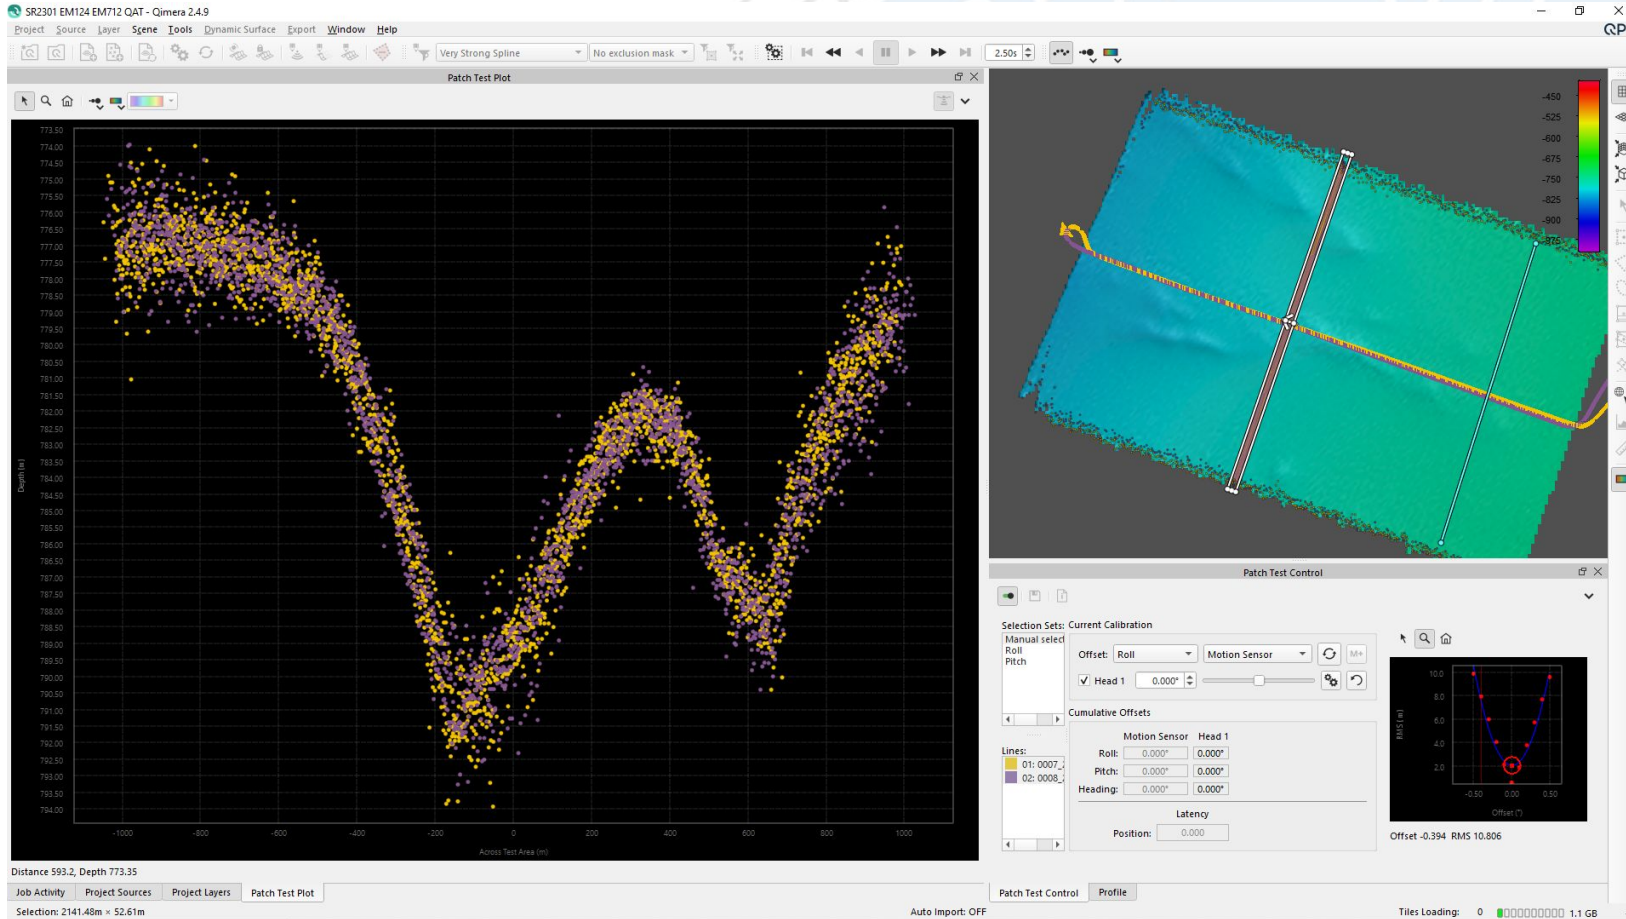
Files: 7-8

Roll verification lines shown at left in the Qimera Patch Test Tool

1. Attitude 1 initial setting:  $-0.11^\circ$
2. Calibration adjustment:  $0.00^\circ$
3. **Final roll offset:  $-0.11^\circ$  in SIS**

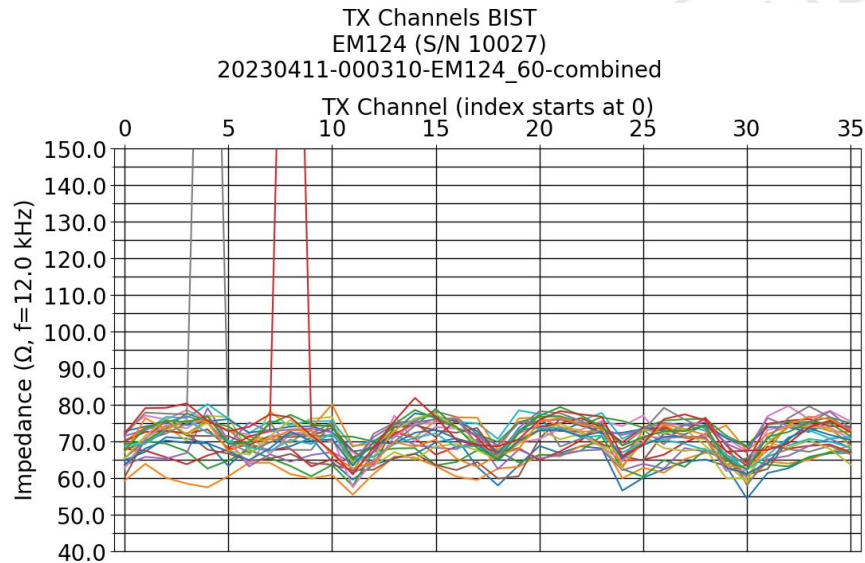
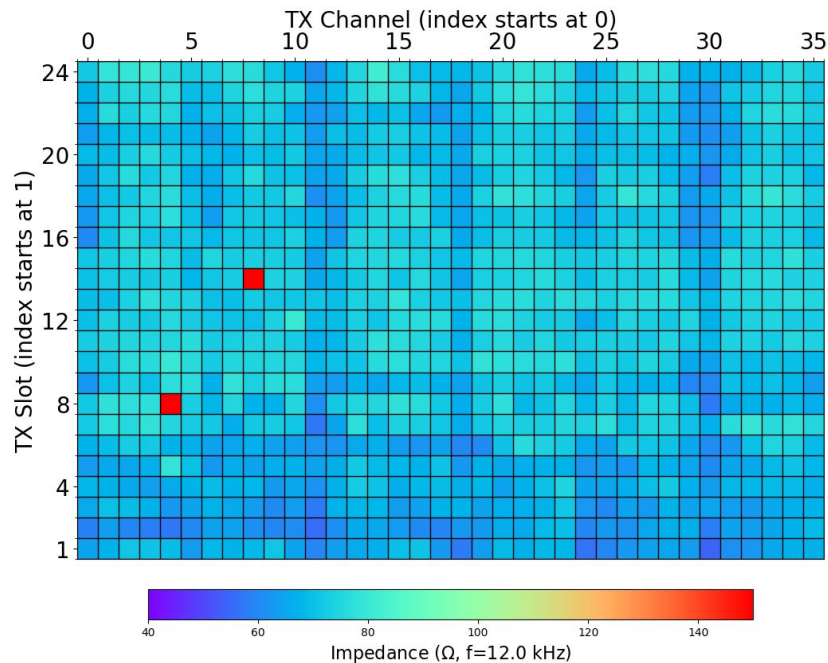
RX Channels BIST  
EM124 (S/N 10027)  
2023/04/11 00:02:40.000  
Frequency: 12 kHz

7. EM124 TX Channels BISTs indicated two channel failures since August 2022; while this remains a very low failure rate (out of 864 channels), routine BISTs should be conducted to monitor for additional failures

- EM124 Built-In Self-Tests (BISTs) have been collected routinely since the HAT and SAT portions of SR2104, including TX and RX Channels data that are useful as proxies for hardware health
- The color scale on each plot is based on the acceptable impedance range to pass a BIST, as defined by Kongsberg
- All but two EM124 TX elements appear to be within factory limits; the BIST history indicates these failures began appearing intermittently on 2022/08/27 and 2023/01/11
- While these are not a replacement for direct impedance tests, TX and RX Channels BISTs should be performed routinely (e.g., before and after each mapping mission) to monitor for channel failures and general shifts over time

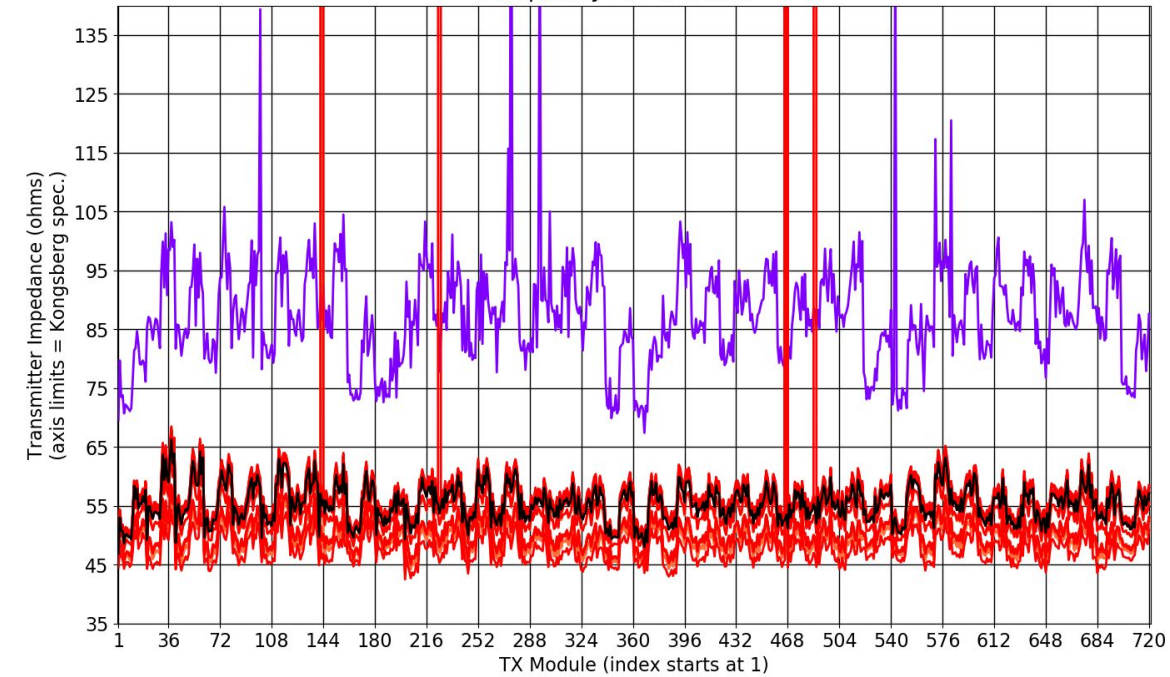
TX Channels BIST  
EM712 (S/N 10003)  
Years: 2016-2023 (28 BISTs)  
Frequency: 40-100 kHz

The cause of the general downward shift and flattening of TX Channels results between 2016 and 2022+ is not known; no BISTs from 2017-2021 were included, though the 2022-23 results appear stable and within spec.

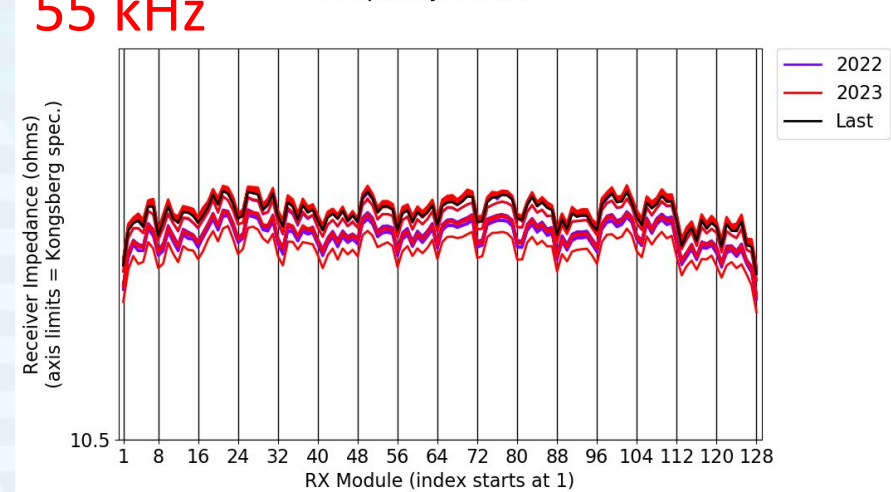
RX Channels BIST  
EM712 (S/N 10044)  
Years: 2022-2023 (32 BISTs)  
Frequency: 55 kHz

A few RX Channels BISTs from 2016 onward was included, but did not parse correctly in the BIST Plotter; all recent RX Channels data appear within spec.

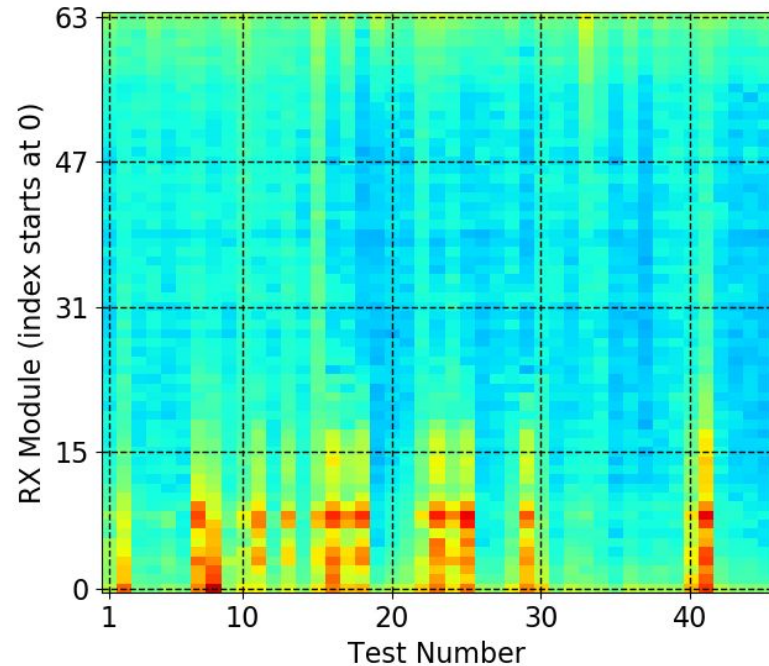
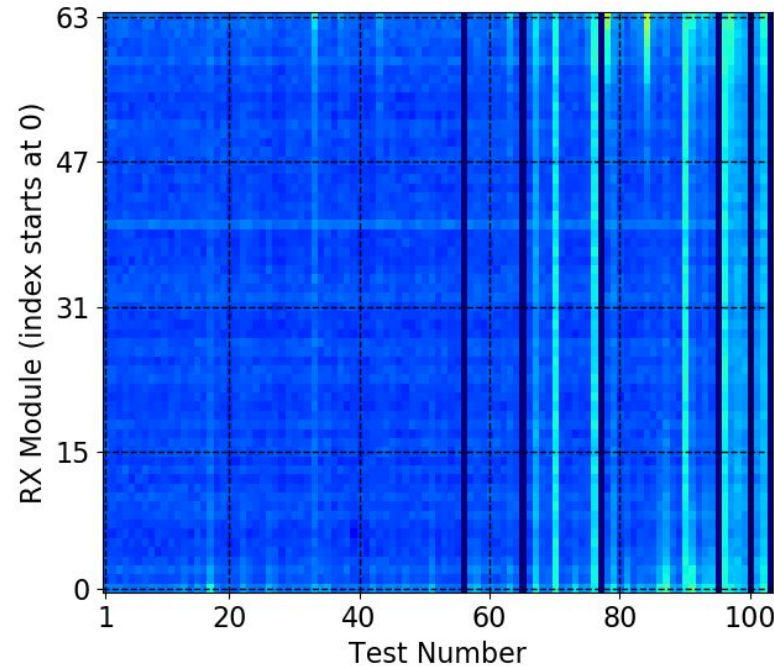
RX Noise vs. Speed  
EM124 (S/N 10027)  
Date: 2023-04-05  
Freq: 10-14 kHz

8. RX noise vs. speed testing revealed a significant increase in EM124 noise levels since SR2104, presenting a risk of swath coverage and accuracy degradation; because the speed range was limited to 6-9.5 kts in the test data, it is not clear whether the increase is due primarily to higher machinery noise levels that are present at all speeds or other speed- and flow-related impacts (e.g., from biofouling) that may be reduced at low speeds

Comparison to 2021 (SR2104)  
EM124 RX Noise testing shows a significant increase in noise levels at speeds of 6-9.5 kts; it is unknown whether this trend continues at lower speeds

Common causes include biofouling on the hull and arrays, as well as machinery modifications between tests

The cause of these higher noise levels should be investigated and addressed, as they will negatively impact swath coverage and accuracy (and may worsen over time)
