R/V Kilo Moana

*2025-26 EM122 / EM710
Multibeam Echosounder
Quality Assurance Testing*

*Multibeam Advisory Committee
July 12-25, 2025
Dec 6, 2025
Jan 8, 2026*

*Report prepared by:
Kevin Jerram
Paul D. Johnson
Vicki Ferrini*

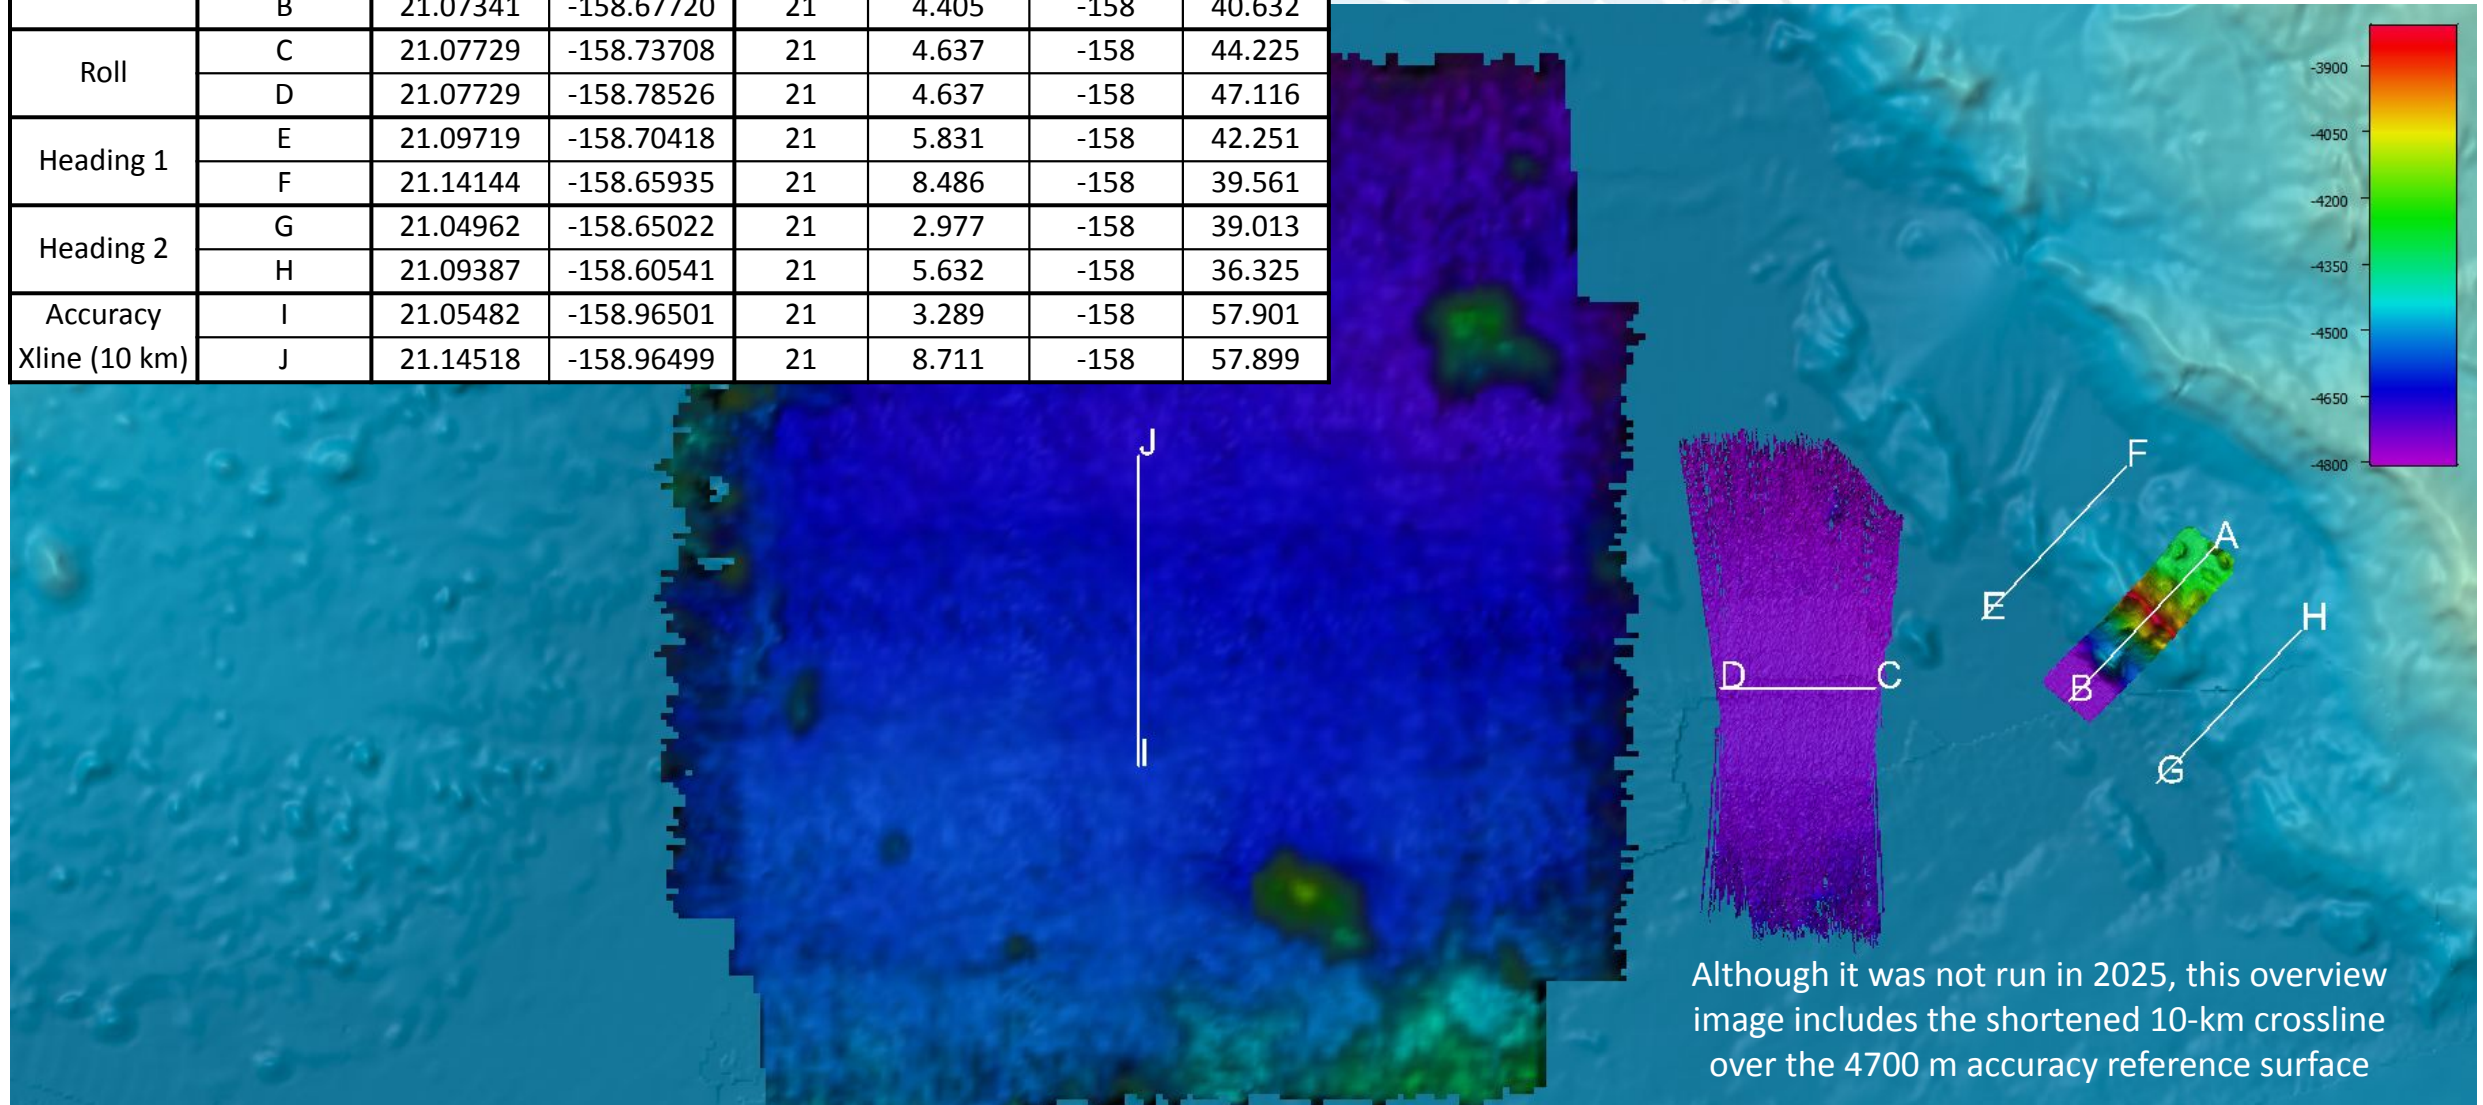
Although it was not run in 2025, this overview image includes the shortened 10-km crossline over the 4700 m accuracy reference surface

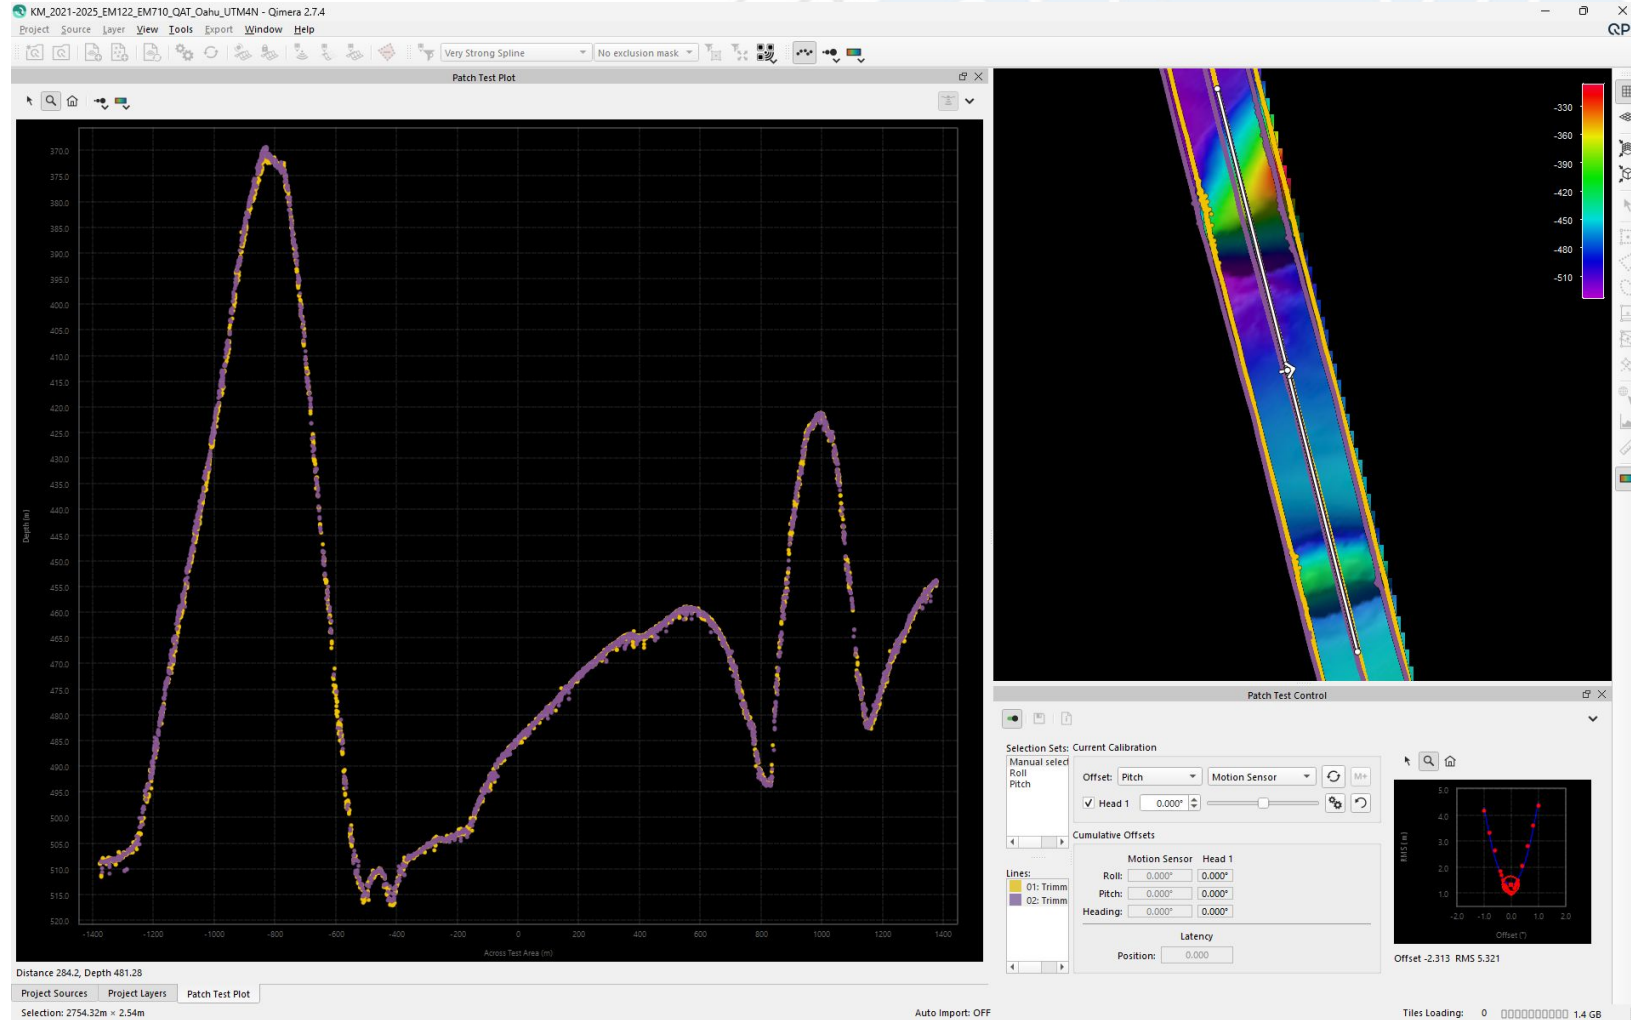
Results: Pitch

Pitch calibration lines are shown at left in the Qimera Patch Test Tool

1. Attitude 1 initial setting: $+0.01^\circ$
2. Calibration adjustment: -0.16°
3. **Final pitch offset: -0.15° in SIS**

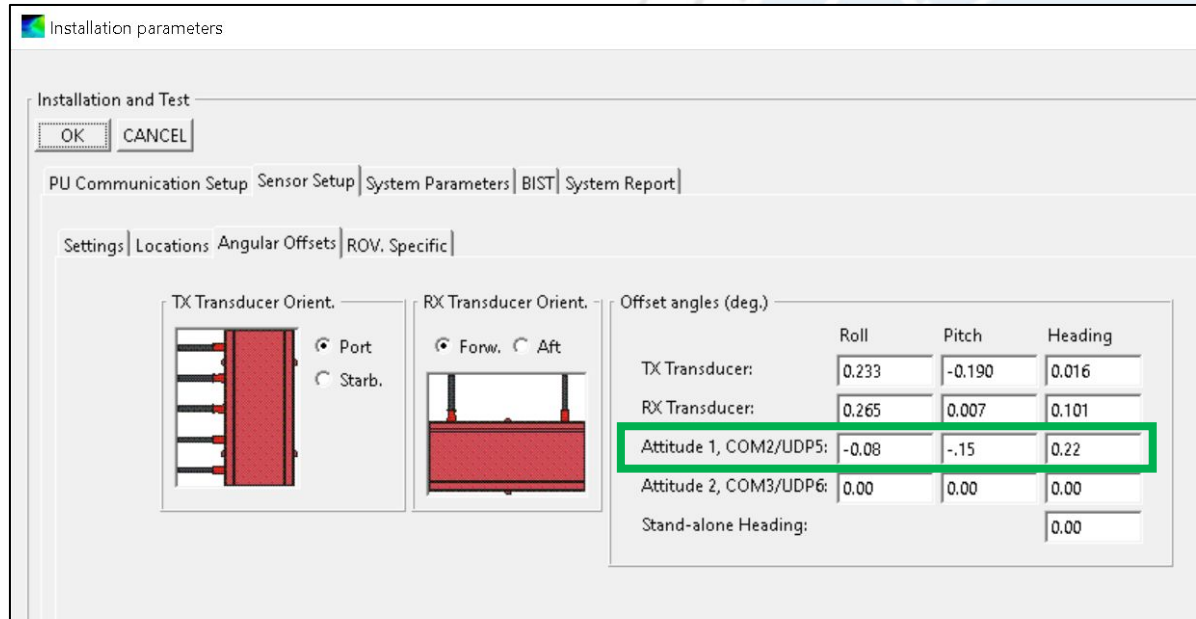
POST-CALIBRATION (EM710)

1. The EM710 *Attitude 1* adjustments in 2026 are on the upper end of typical ranges for year-to-year testing; however, they reflect a return toward the 'middle' of the range of historic results and appear reasonable given the interval since the last calibration (2022)
2. Taken together, these latest results generally confirm a high-quality vessel offset survey, consistent integration, and no significant changes across the POS MV and EM710 installations since 2017
3. The *Installation Parameters: Angular Offsets* shown at left should be maintained until any modification is made to the POS MV or EM710 arrays, or another calibration becomes necessary for other reasons

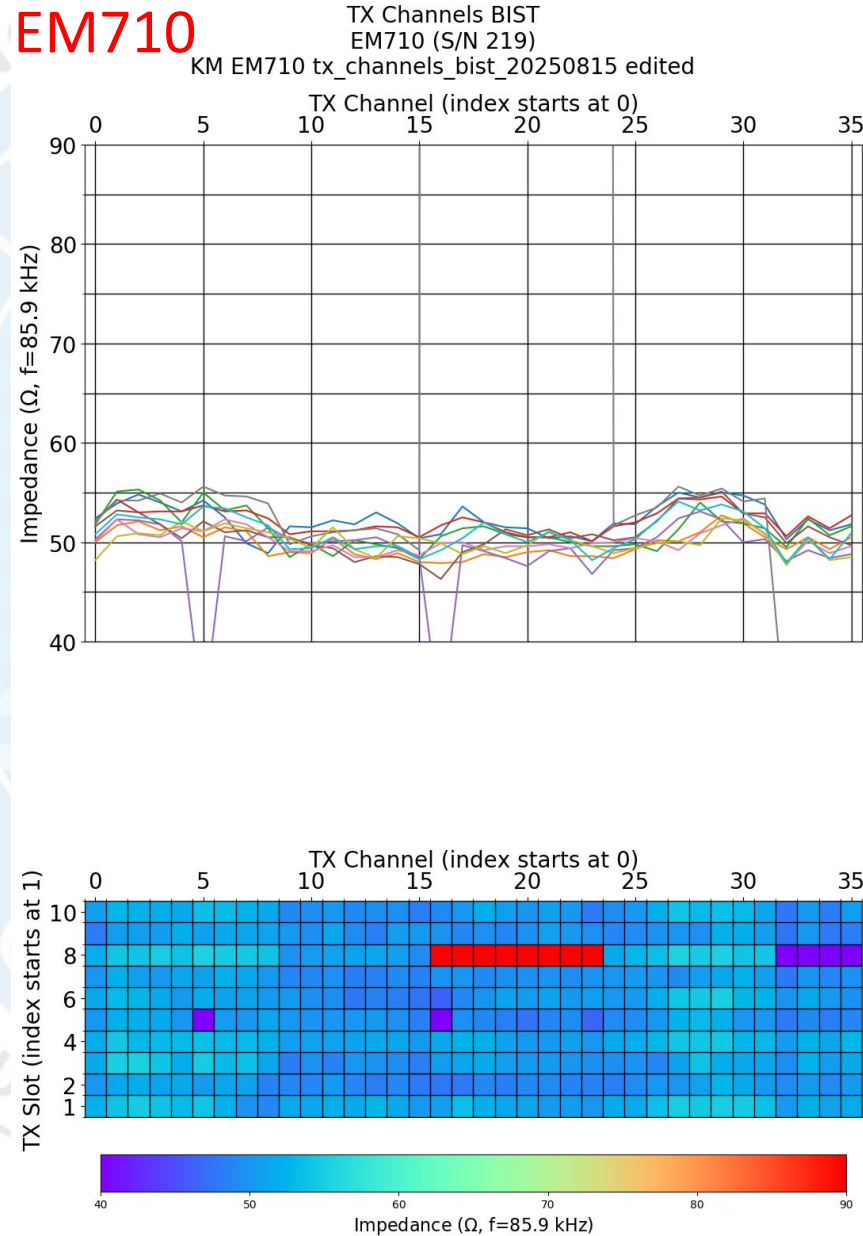
1. TX Channels BISTs were collected via telnet on July 12 and August 15, 2025
2. The color scales are based on Kongsberg specs included in the BIST files, with red (high Z, open) and purple (low Z, short) indicating element failure
3. EM710 TX slot #2 was missing in earlier BIST files (Jan 7, July 12); later BISTs included this slot as normal, as shown here (Aug 15, left) and included in the history plots (next slides)

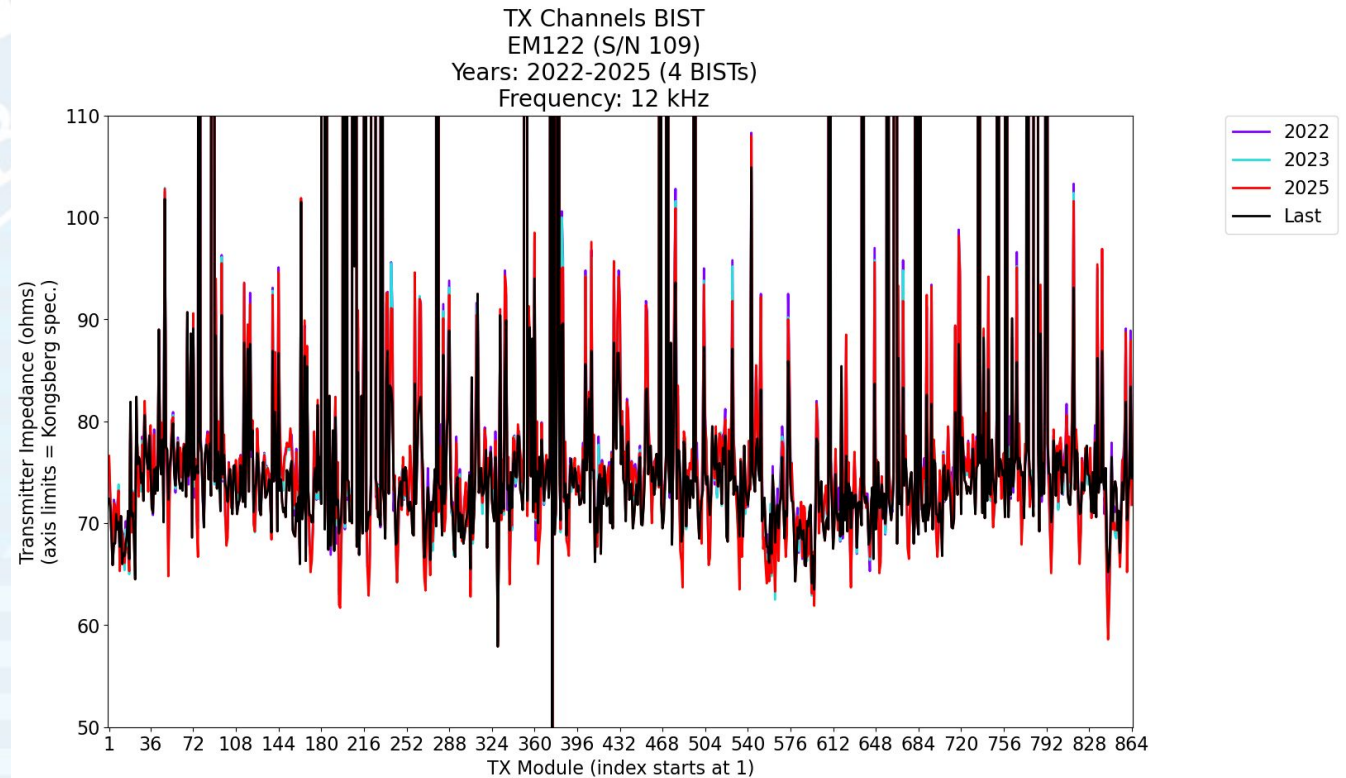
1. An EM122 TX Channels BIST was logged on 2025-07-12, showing 38 errors (37 High Z and 1 Low Voltage) out of 864 channels, or ~4%; this represents a small increase of two more failures since direct Z measurements were taken by Kongsberg in Feb 2023, as expected for hardware of this age
2. **EM122 replacement planning should be underway due to the potential for more rapid / unplanned hardware failure and the end of manufacturer support for this generation of multibeam systems**

4. Given the age of the EM122 and EM710, hardware health trends, and the end of maintenance support from Kongsberg (e.g., decreasing availability of spare parts), the MAC recommends planning the replacement/upgrade process for the *Kilo Moana's* multibeam mapping systems

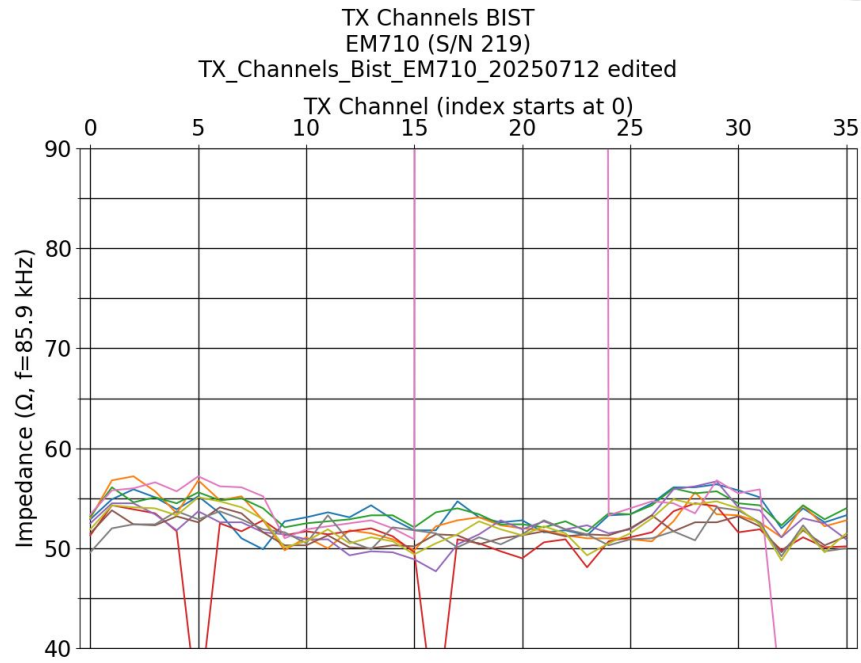
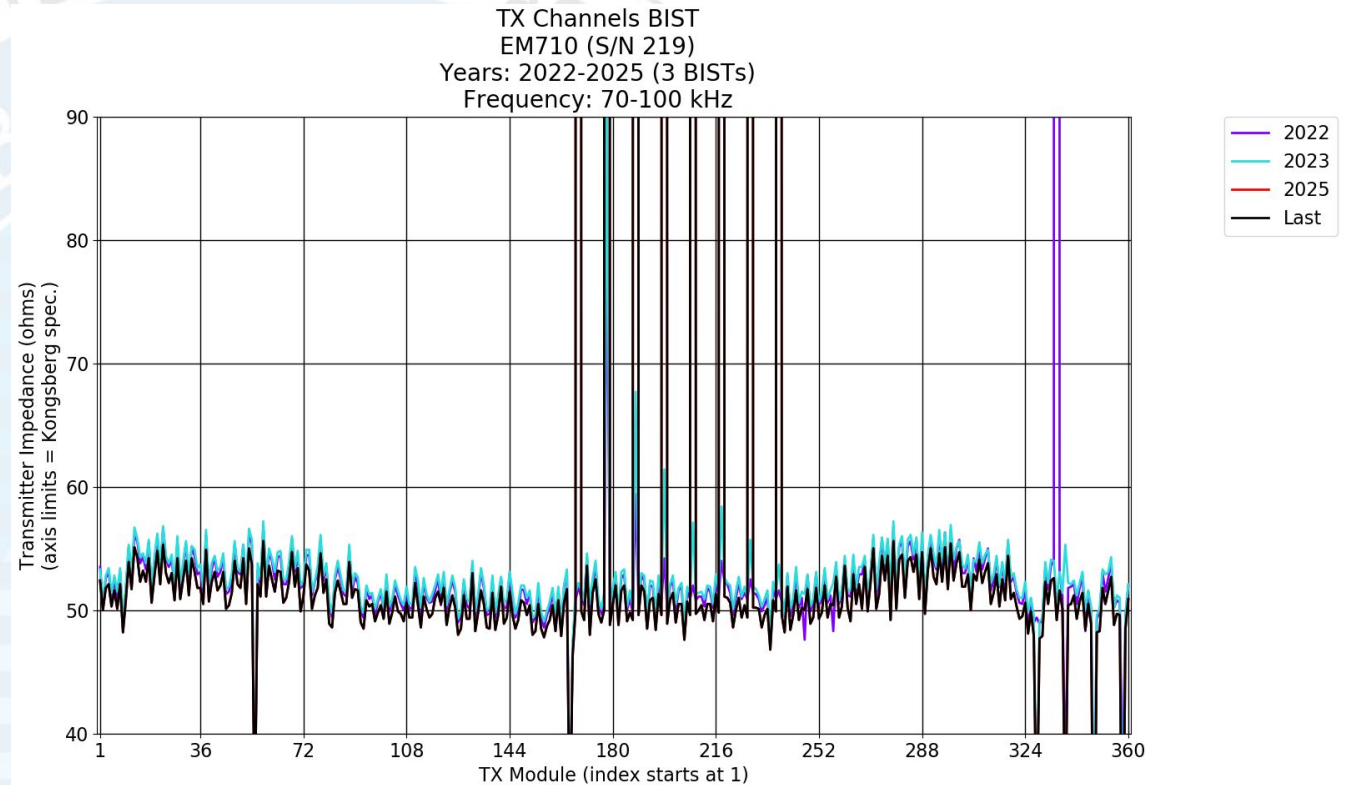
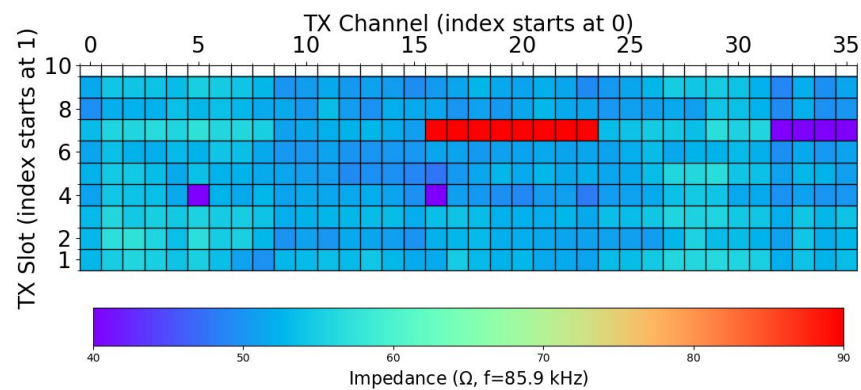
1. No TX Channels data are available prior to 2022
2. The 2025 results indicate an increase in the number of 'Open' and 'Low Z' channels; these occur in blocks of 4-8, possibly suggesting module-level failures that should be monitored with routine BISTs

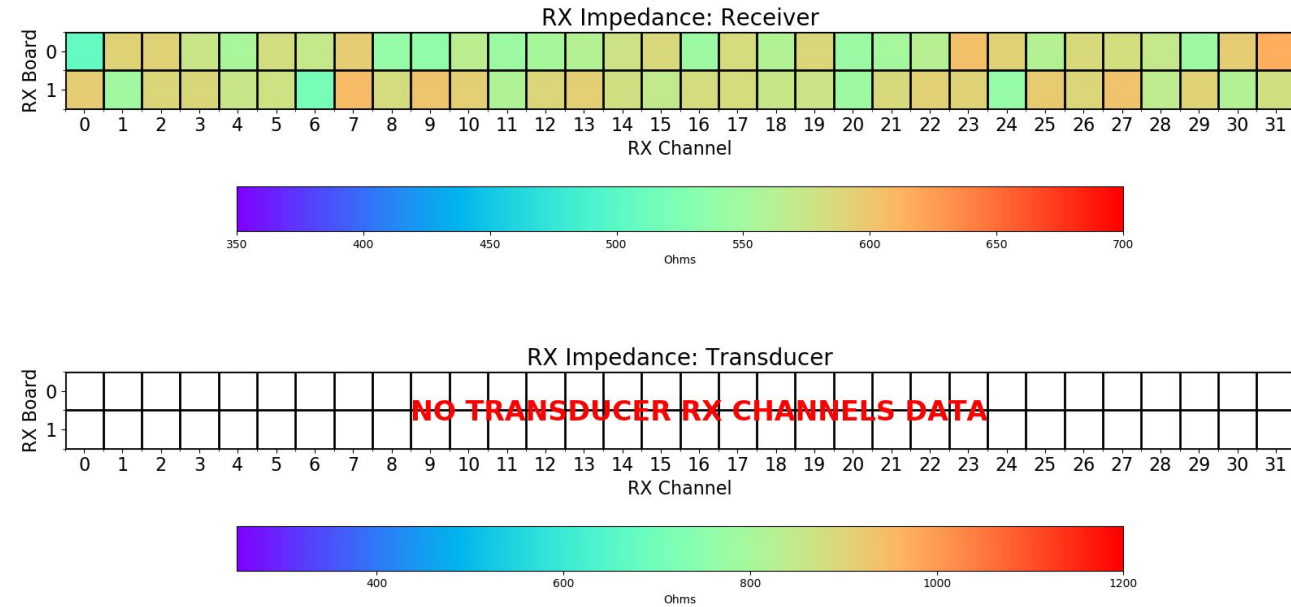
RX Channels BIST
EM122 (S/N 109)
2025/07/12 20:29:05.975
Frequency: 12 kHz

- EM122 RX channels data for the receiver (top) and transducer (bottom) were logged on 2025-07-12
- The color scale on each plot is based on the acceptable impedance range to pass a BIST, as defined by Kongsberg
- All receiver impedance values are well within spec
- For this EM122 BIST format, the text file does not include transducer element impedance data; this should be tested with direct measurements (e.g., Cypher tool) as the array elements may degrade without impacting receiver impedance results

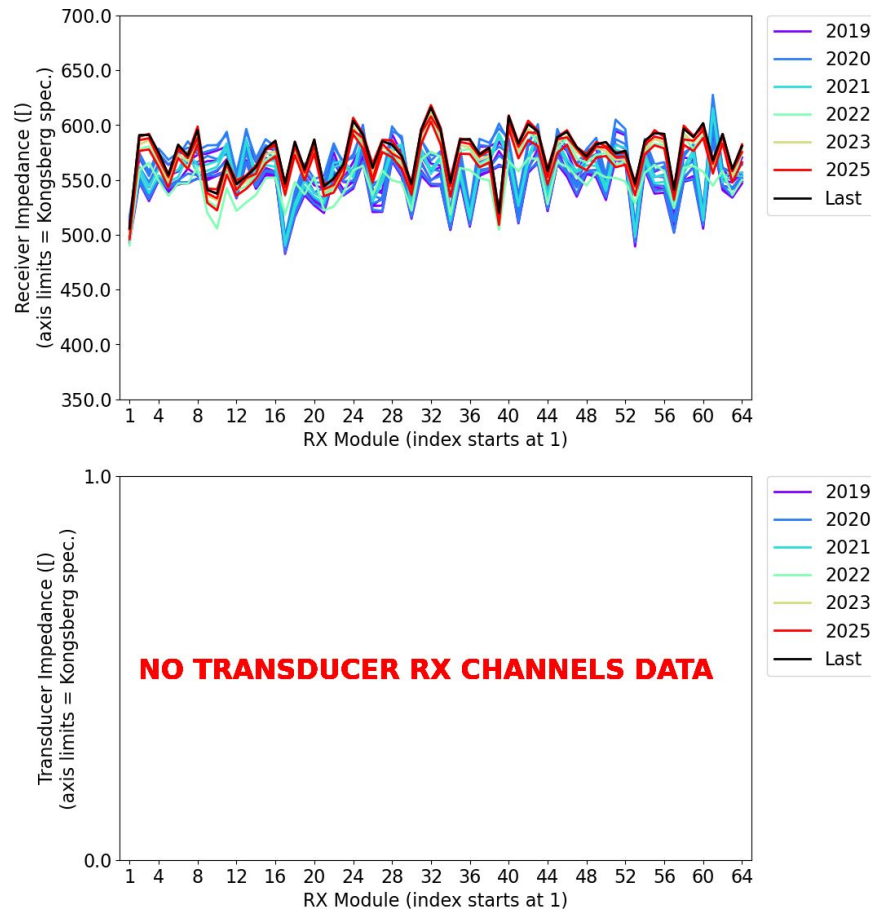
RX Channels BIST
EM122 (S/N 109)
Years: 2019-2025 (19 BISTs)
Frequency: 12 kHz

- EM122 RX channels impedance data for the receiver (top) and transducer (bottom) are shown for all available BISTs (2019-2025); the last BIST plotted (black) is from 2025-07-10
- These plots show consistent trends for each module and no significant changes in the 19 available files
- For this EM122 BIST format, the text file does not include transducer element impedance data

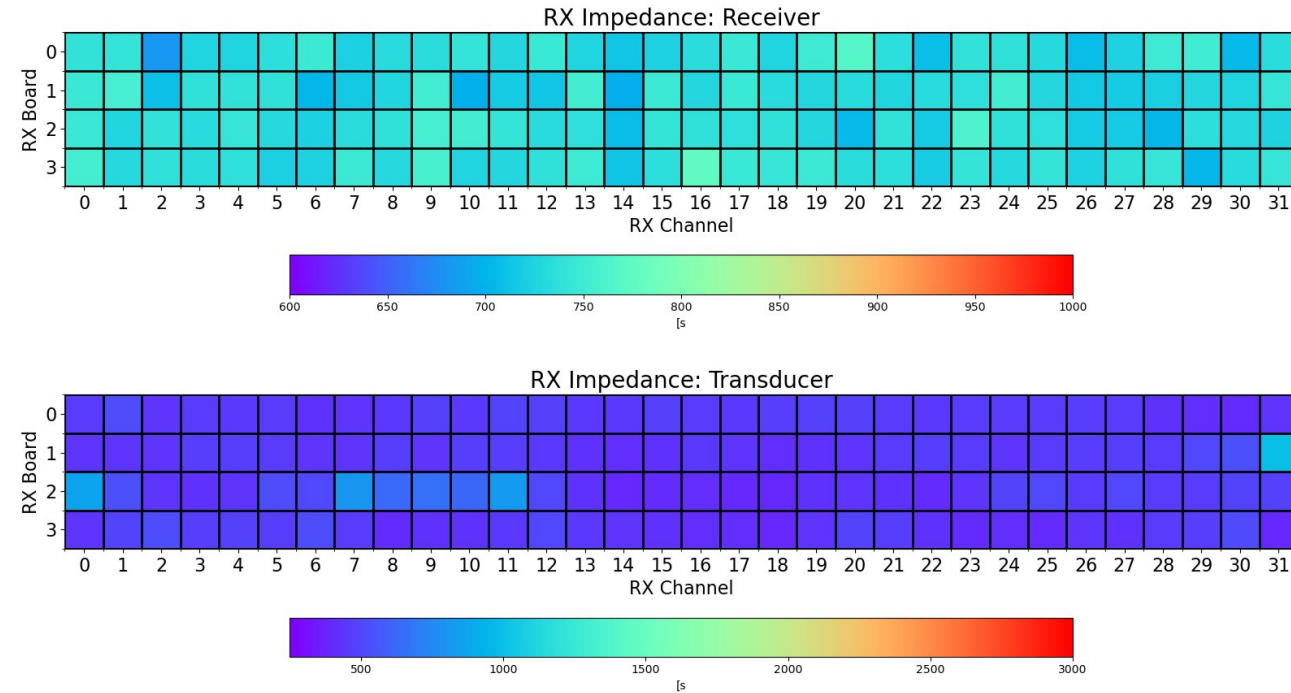
RX Channels BIST
EM710 (S/N 219)
2025/08/15 11:46:21.012
Frequency: 70-100 kHz

- EM710 RX channels data for the receiver (top) and transducer (bottom) were logged on 2025-08-15
- The color scale on each plot is based on the acceptable impedance range to pass a BIST, as defined by Kongsberg
- Aside from a few clustered high values (e.g., elements 7-11 on board 2), the receiver and transducer impedance values appear to remain well within specification for all elements

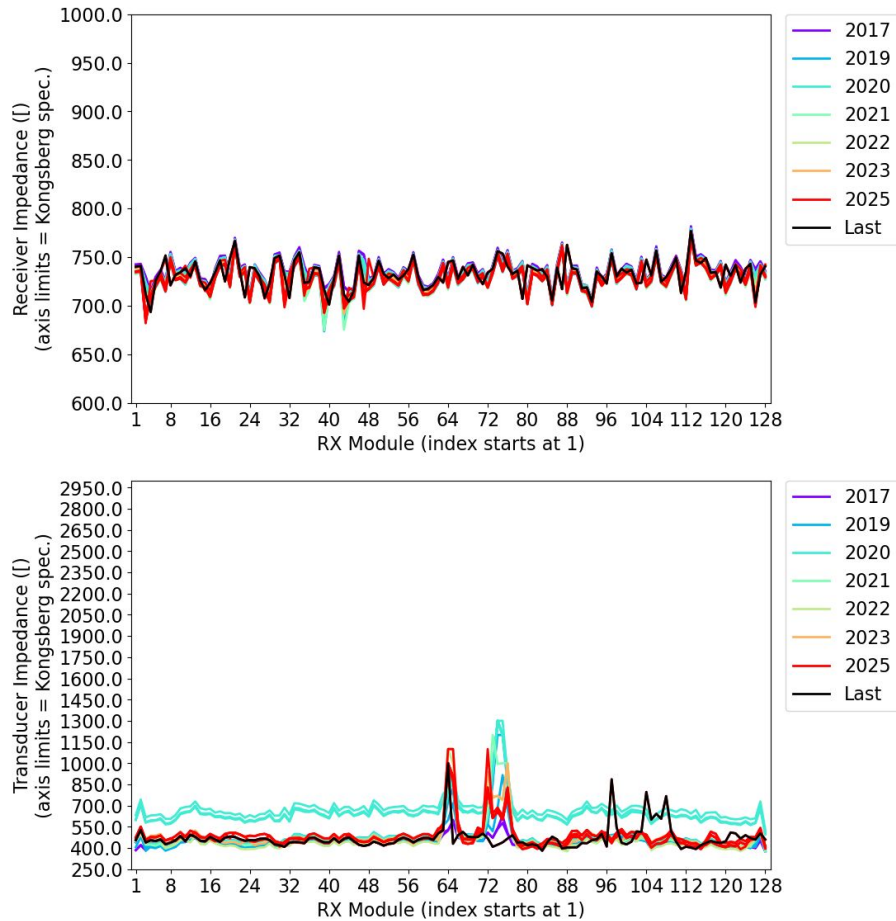
RX Channels BIST
EM710 (S/N 219)
Years: 2017-2025 (19 BISTs)
Frequency: 70-100 kHz

- EM710 RX channels impedance data for the receiver (top) and transducer (bottom) are shown for all available BISTs (2017-2025); the last BIST plotted (black) is from 2025-08-15
- These plots show consistent trends for each module in the array and no significant changes for the receiver impedance in the 19 available files
- The transducer impedance history shows an increase across the array in 2020, possibly associated with temperature, that returned to its baseline in 2021
- The history also shows upward trends for several clusters in the middle of the array; while these clusters have not degraded significantly since 2021, they should be monitored with routine BISTs

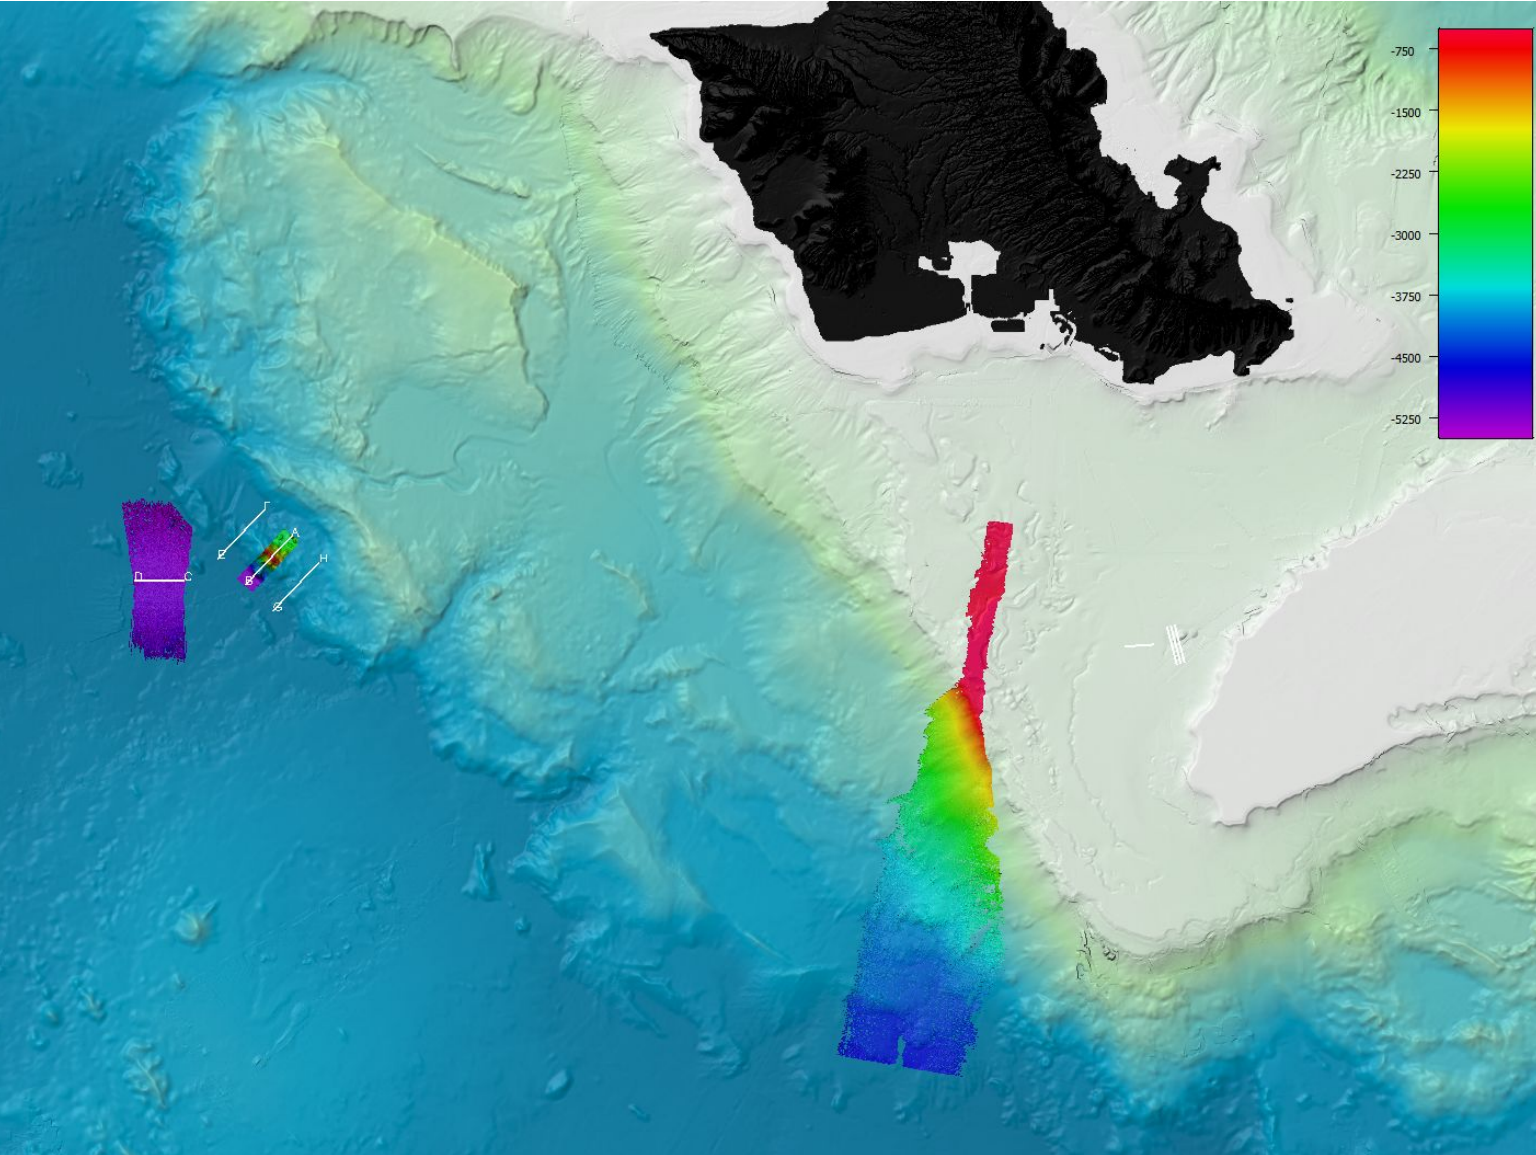
1. EM122 swath coverage testing was conducted in three segments during the 2025 QAT:

Segment 1: heading offshore and crossing contours from 200-4500 m at a $\sim 45^\circ$ angle (shown at left), resulting in some biases from slopes facing toward / away from the EM122

2. Due to the high transit speed (11 kts) and correspondingly high noise levels, swath coverage plots shown here may under-represent the 'typical' coverage achieved at lower survey speeds

Note: the calibration site is shown at left for reference; the color scale applies to the swath coverage dataset

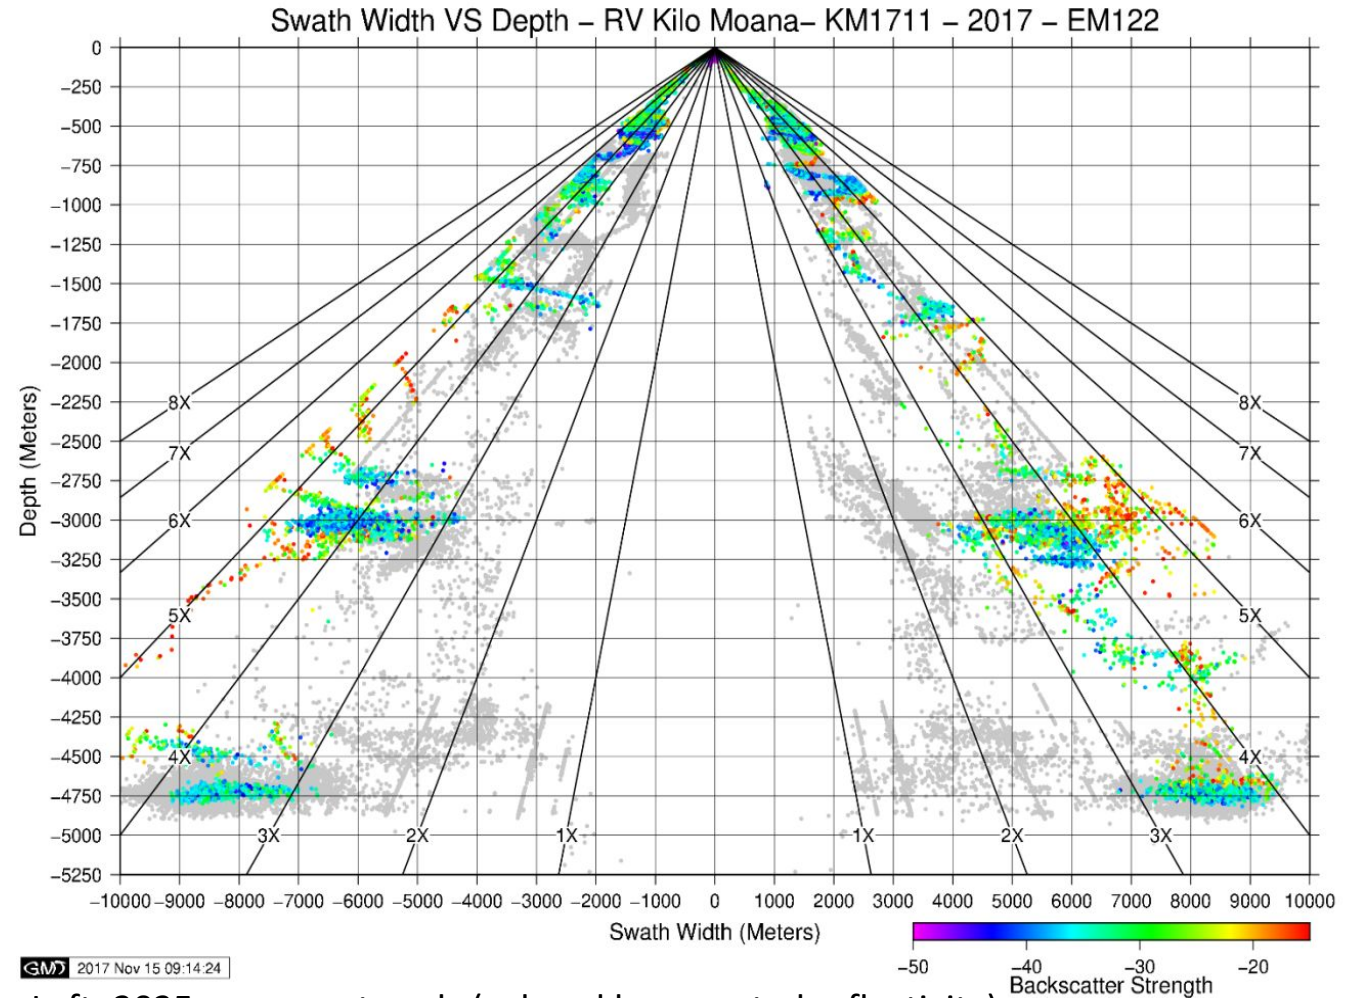
Left: 2025 coverage trends (colored by reported reflectivity)

Right: 2017 results (colored by reported reflectivity) versus 2012 (gray)

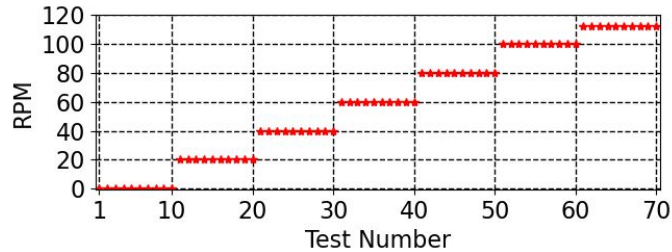
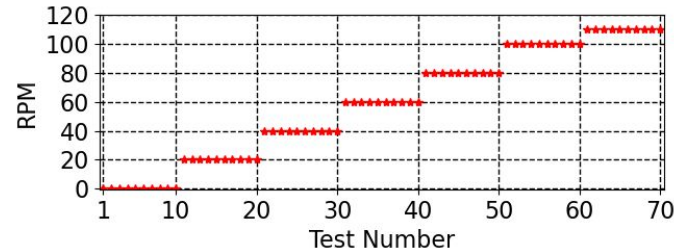
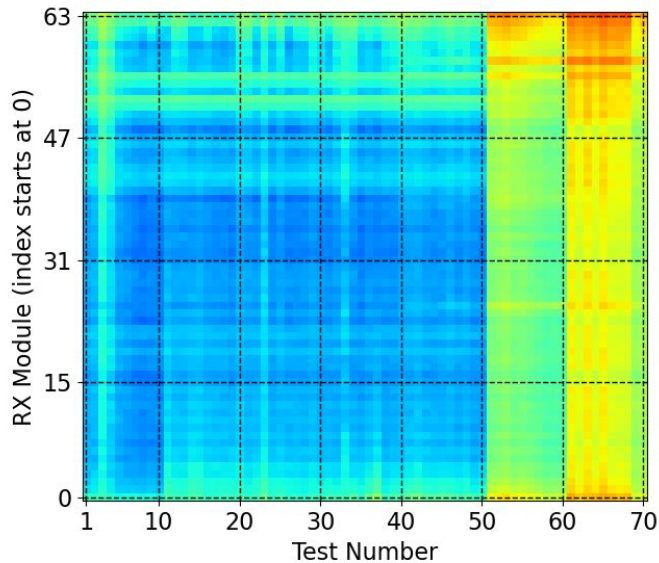
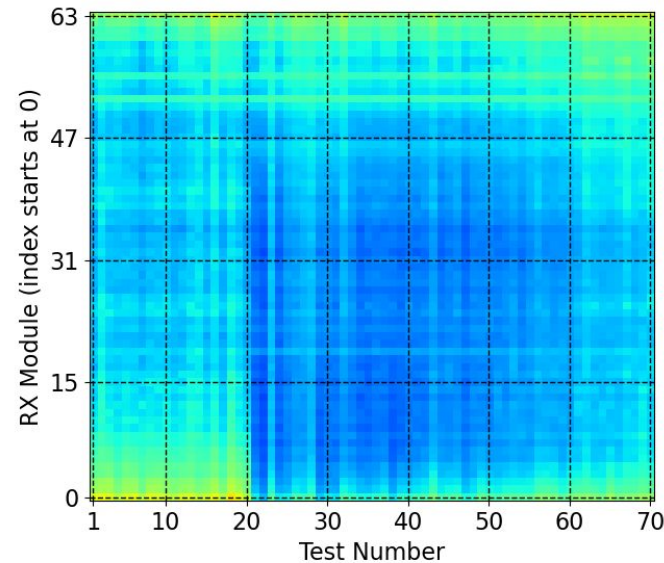
Pre- and post-shipyard RX noise test results fall in line with the history of this EM122 installation over most of the speed range; notably, the 2025 tests clearly show higher levels at 100+ RPM that could impact multibeam swath quality and coverage at these speeds (e.g., during transit mapping)

Overall, the 2024-25 data show important reductions from 2023 data collected with severe biofouling on the arrays/hull (next)

6. RX noise testing confirmed low / improved levels for the EM710 and increases for the EM122 at shaft speeds of 100-112 RPM compared to 2023-24; this may result from higher flow noise due to biofouling (unlikely if the hull was cleaned in the shipyard) or potentially new 12 kHz interference from machinery at high shaft speeds

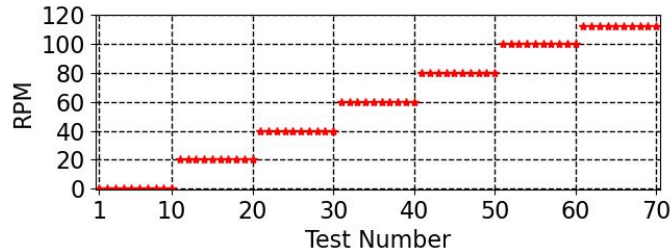
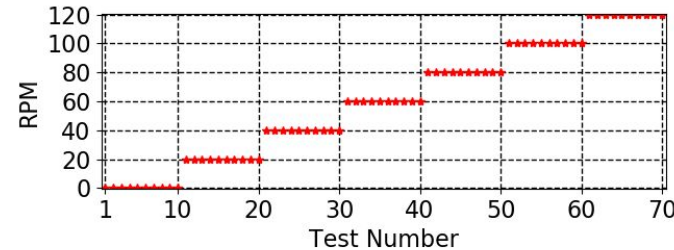
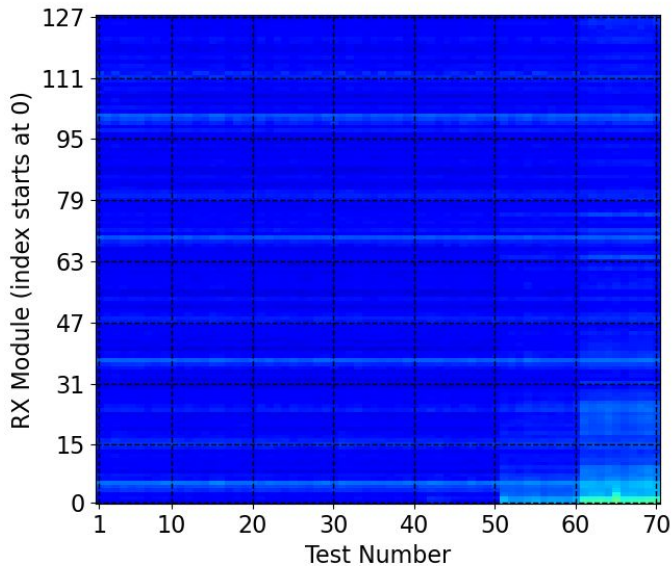
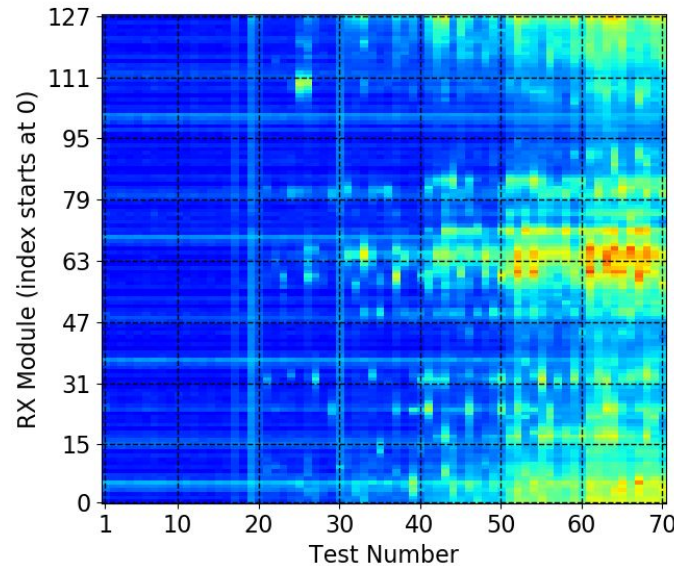
As with the EM122, post-shipyard RX noise test results show typical levels for the EM710 compared to pre-cleaning tests in 2023

Although no pre-shipyard tests are available from 2024, the 2025 post-shipyard files suggest no appreciable changes (or damage)

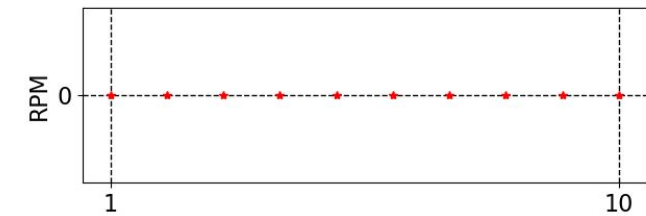
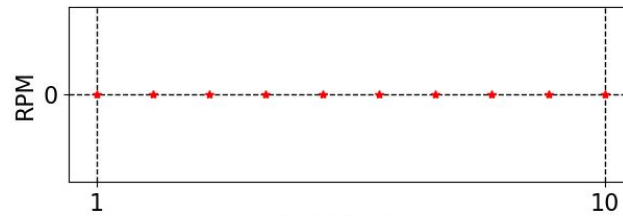
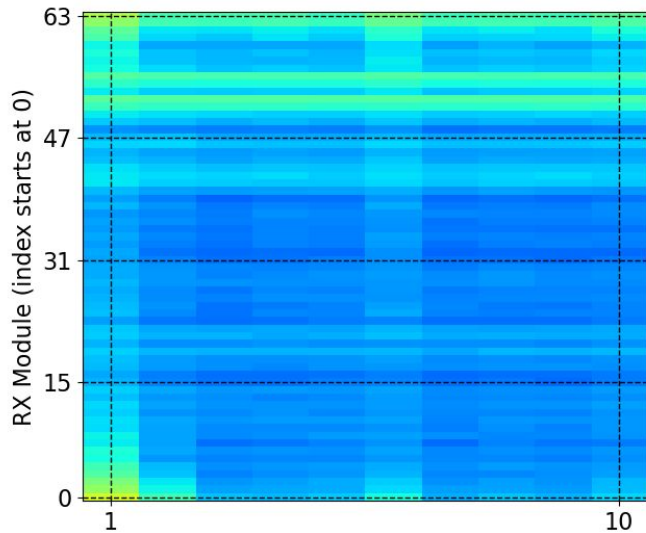
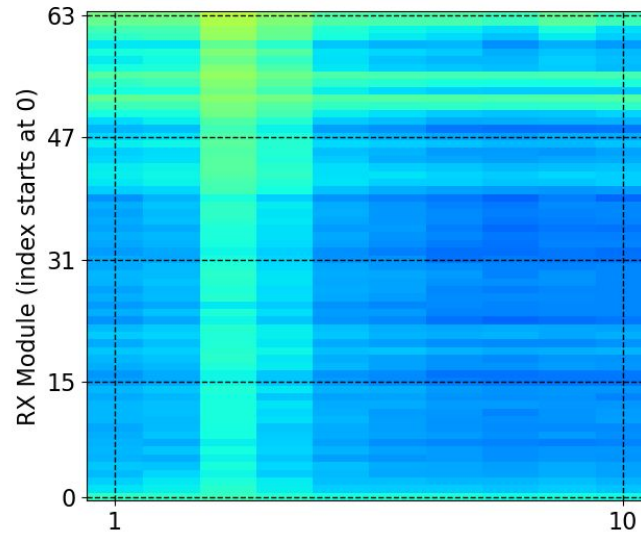
In July 2025, additional EM122 noise testing was conducted while holding station to check baseline machinery noise in absence of flow noise (left) and examine impacts of the ADCP and Dynamic Positioning system (right)
