Optimizing Sonar Performance by Managing Acoustics

November 20, 2014

Marisa Yearta and Timothy Gates

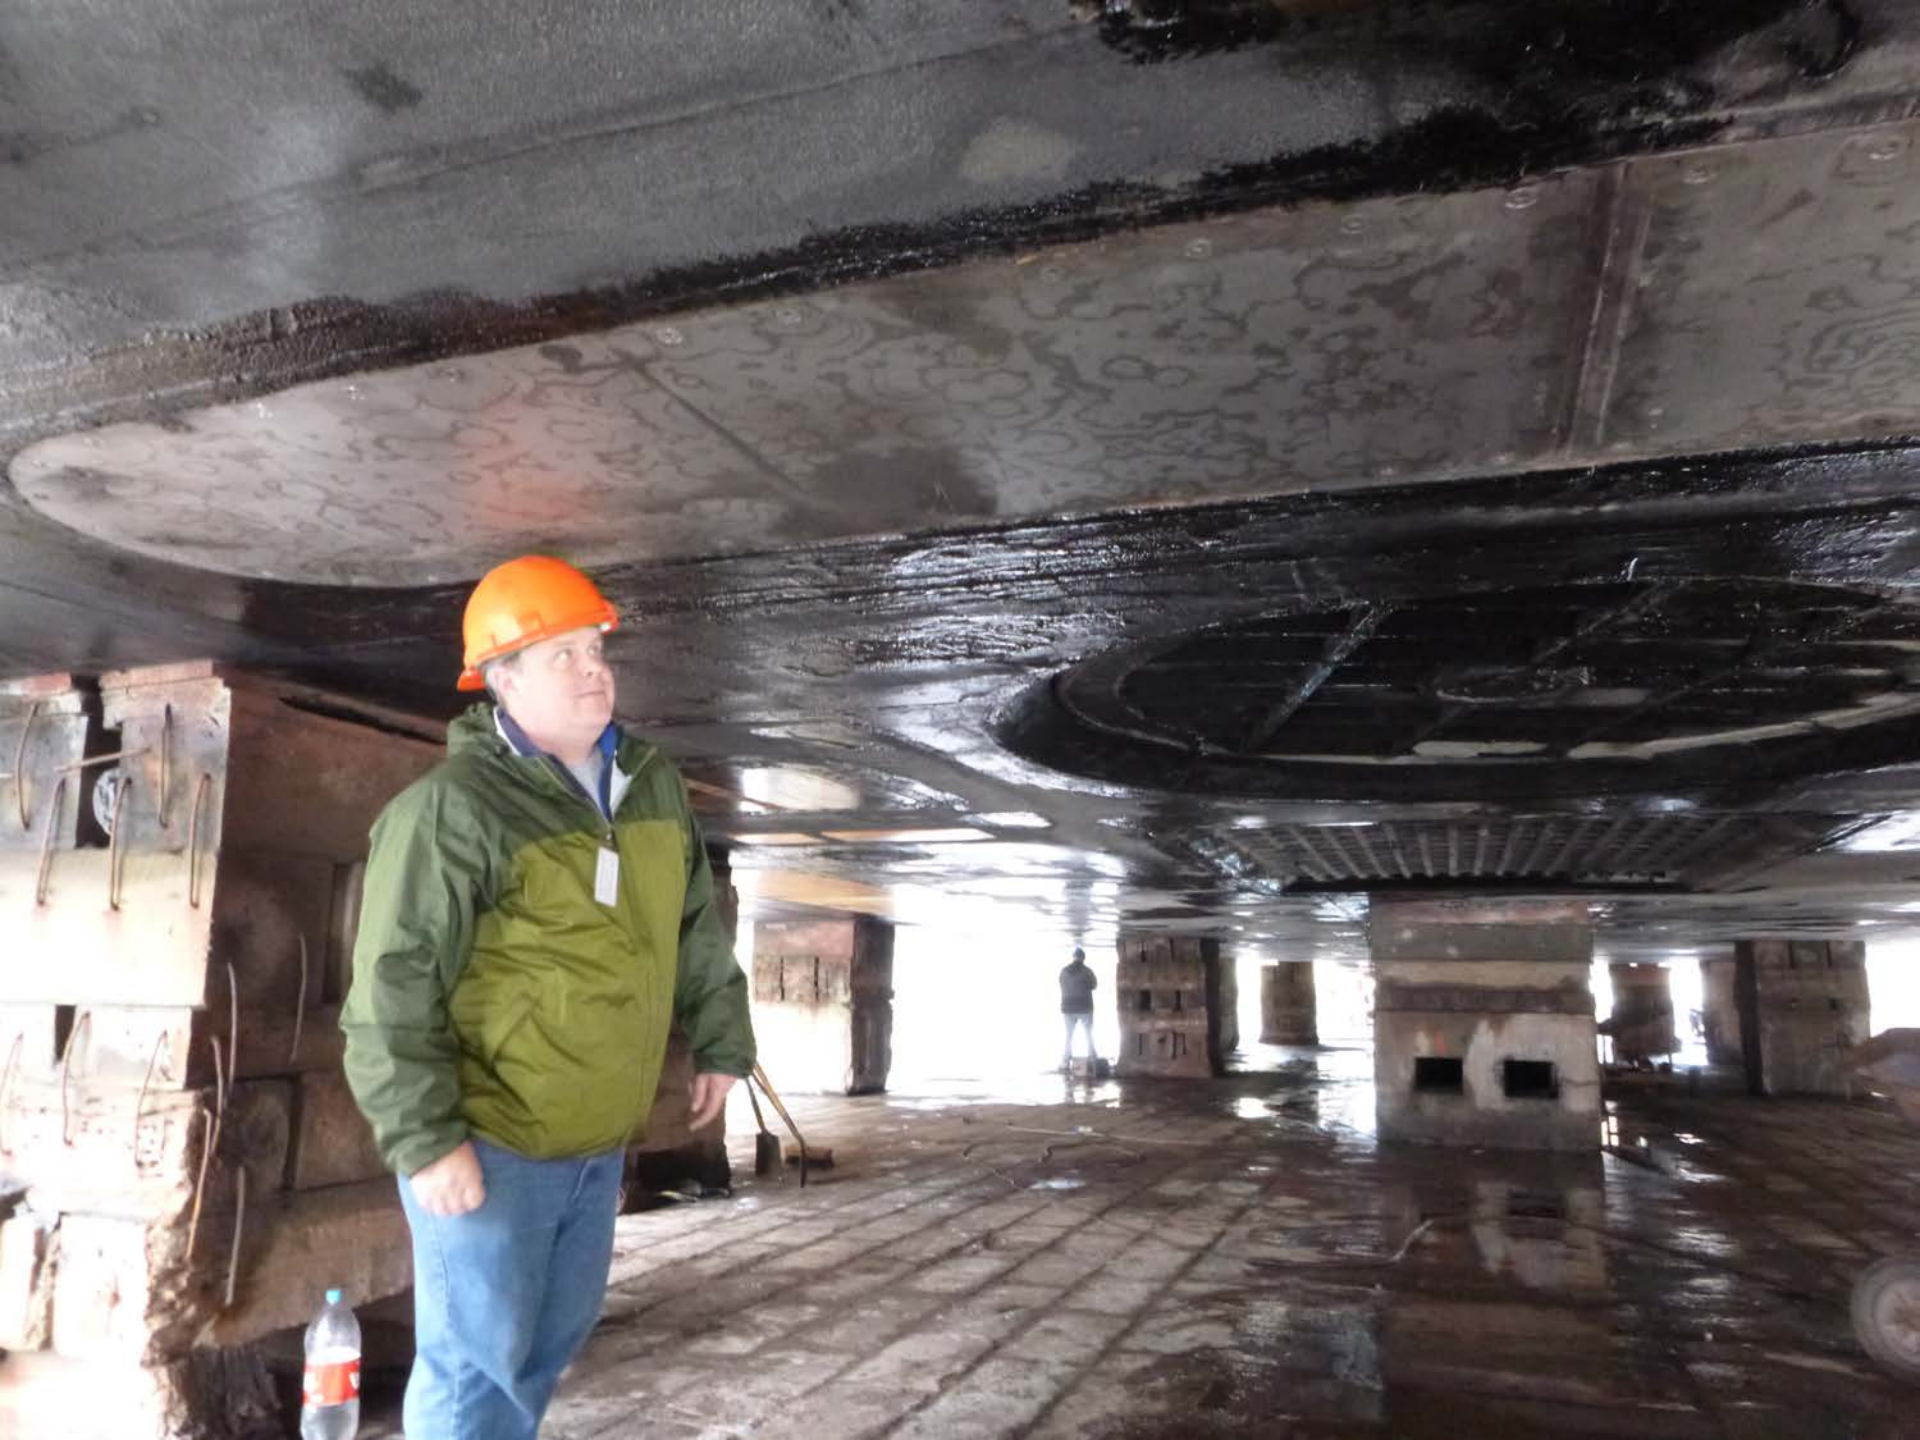
R/V SIKULIAQ

- SIKULIAQ was significantly fouled during baseline acoustic testing
- Sonar levels were completely controlled by hydrodynamic flow noise at vessel of 3 knots and above
